AGREEMENT NO. CE 45/2008 (CE)
LIANTANG/HEUNG YUEN WAI
BOUNDARY CONTROL POINT AND ASSOCIATED WORKS

MONTHLY ENVIRONMENTAL MONITORING AND AUDIT
REPORT (NO.49) – AUGUST 2017

PREPARED FOR
CIVIL ENGINEERING AND DEVELOPMENT DEPARTMENT
(CEDD)

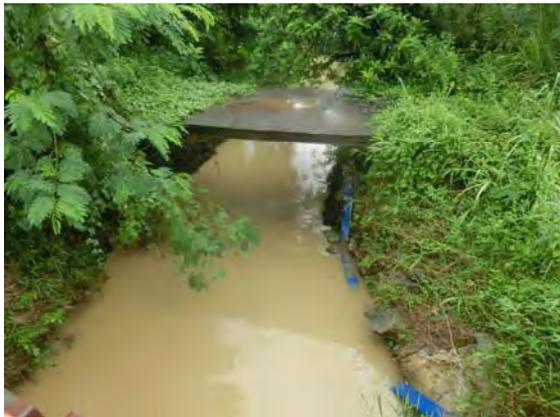
Photo 1

On 2 August 2017, muddy water was observed at WM2A(a) and the water sampling was conducted after rainstorm.

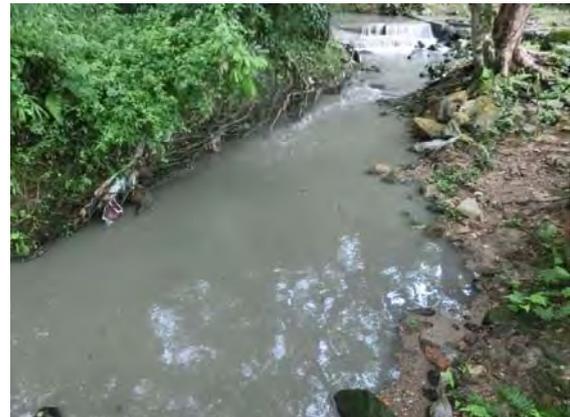
Photo 2

On 2 August 2017, muddy water was observed at WM2A-C and the water sampling was conducted after rainstorm.

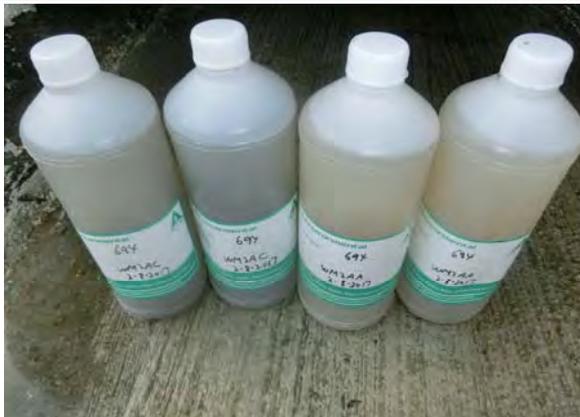
Photo 3

The water samples collected at WM2A(a) and WM2A-C on 2 August 2017 were turbid.

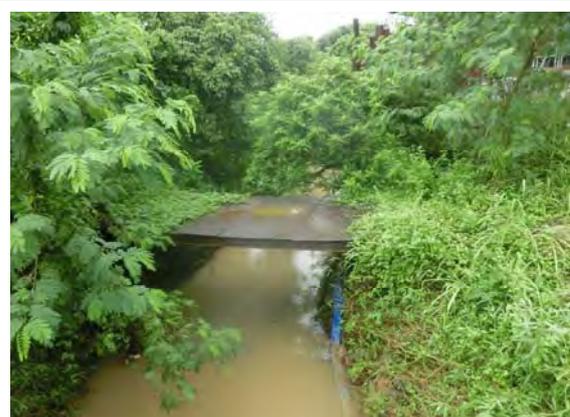
Photo 4

On 3 August 2017, muddy water was observed at WM2A(a).

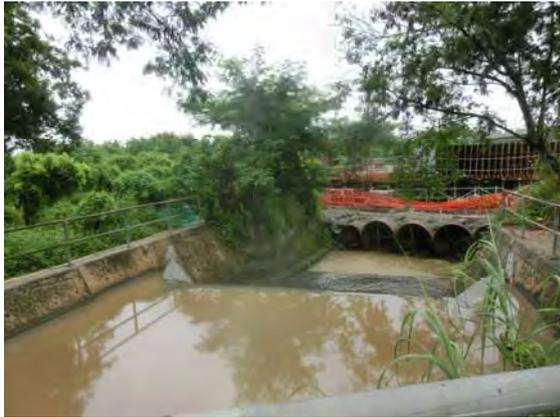
Photo 7

On 3 August 2017, it was observed that the nylon dam was deflated and muddy water was flowing to downstream before the water sampling.

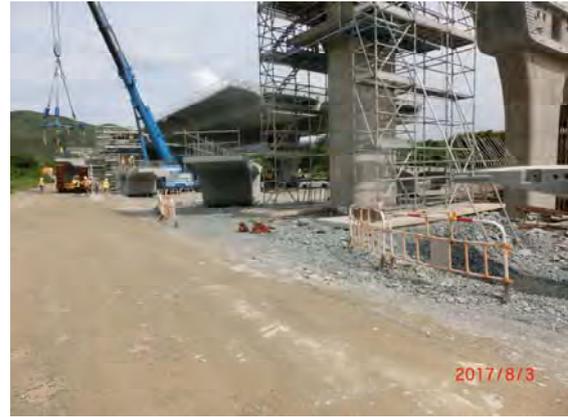
Photo 8

During site inspection on 3 August 2017, construction works carried out at Bridge D was mainly segment installation and there was no discharge due to nature of works.

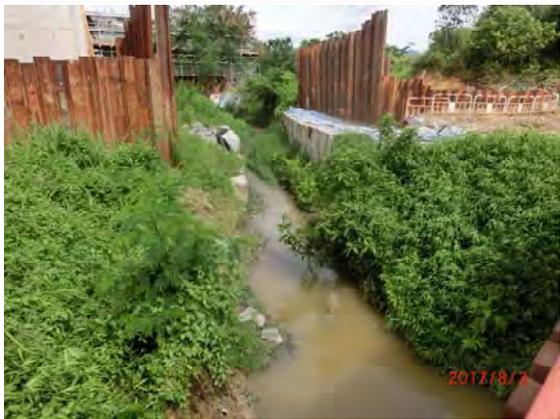
Photo 9

During site inspection on 3 August 2017, it was observed that the existing river water was slightly turbid even without the impact from the construction work.

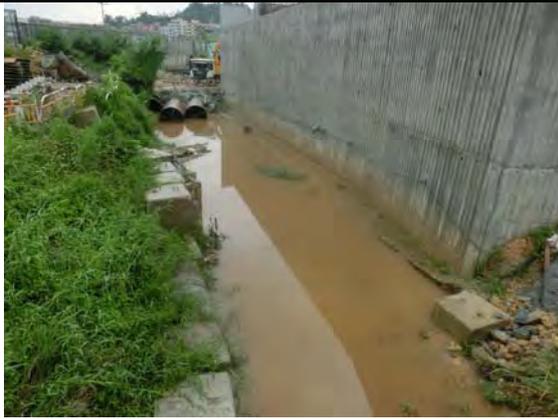
Photo 1

On 2 August 2017, muddy water was observed at WM1 and the water sampling was conducted after rainstorm.

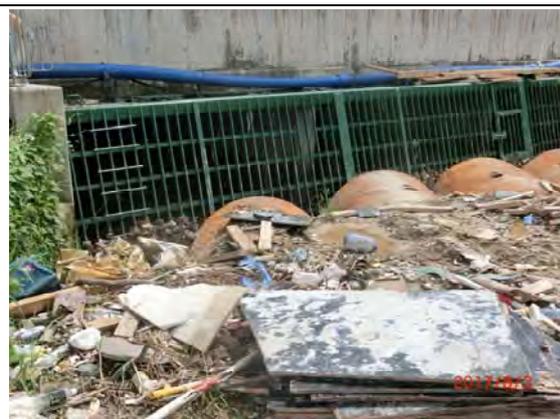
Photo 6

Weekly site inspection was carried out by the ET on 3 August 2017, it was observed that large amount of rubbish was cumulated near at the water gate near WM1 which suspected flushed from upstream during rainstorm.

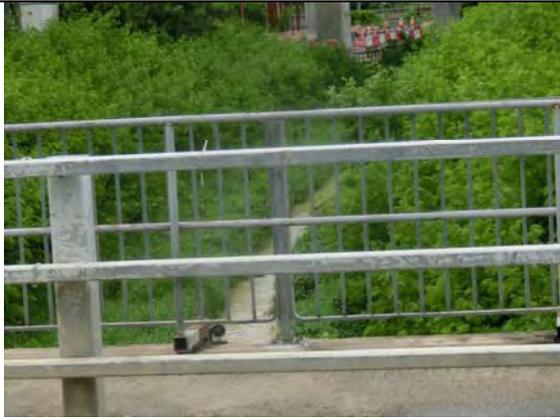
Photo 1

During water quality monitoring on 10 August 2017, muddy water was observed at WM4.

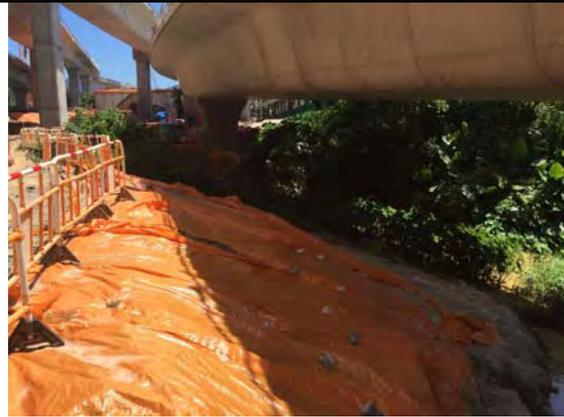
Photo 20

During site inspection on 15 August 2017, it was observed that the open slope was fully covered by tarpaulin sheet and no runoff from site area was observed.

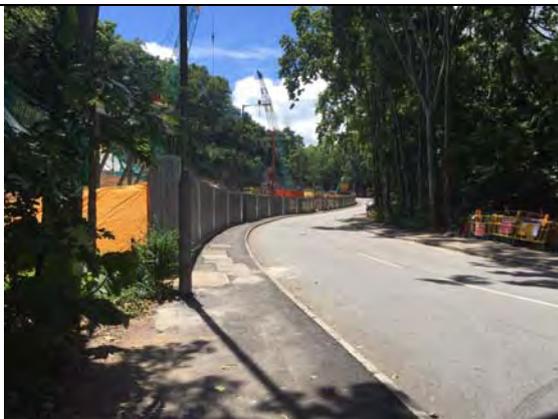
Photo 21

An ArchSD site was found in Kiu Tau Road and it is one of the construction sites in Kiu Tau Road and adjoined Tai Wo Service Road West. Since the site could not be got in, it was not known whether the muddy water came from that ArchSD site, other construction sites in Kiu Tau Road or any other sources.

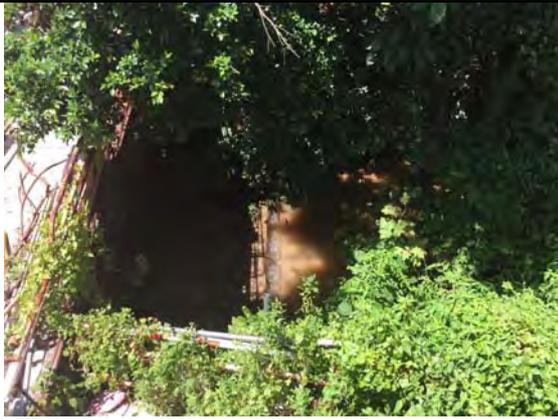
Photo 19

During site inspection on 15 August 2017, muddy water was observed at the opening of BC02. It was suspected that the muddy water was via an underground pipe which connecting the box culvert in Kiu Tau Road (outside C3) to BC02 (under Contract 3).

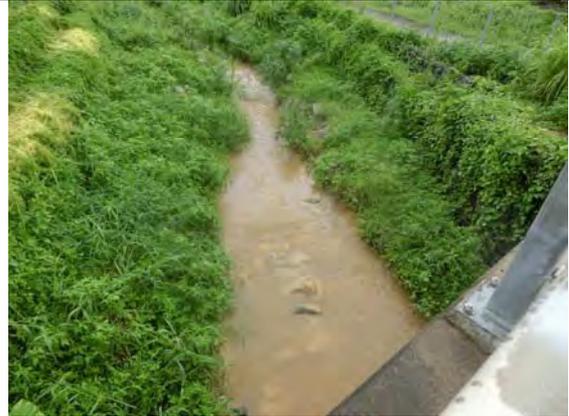
Photo 2
During water sampling on 2 August 2017, muddy water was observed at WM3-C.

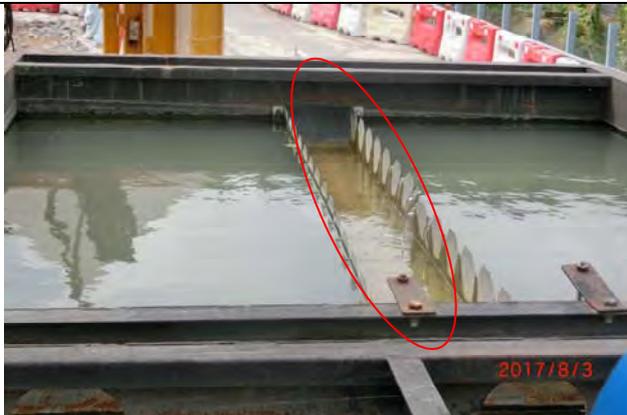
Photo 3
Joint site inspection was conducted on 3 August 2017. It was observed that wastewater treatment facilities were properly in place and the discharge water was clear.

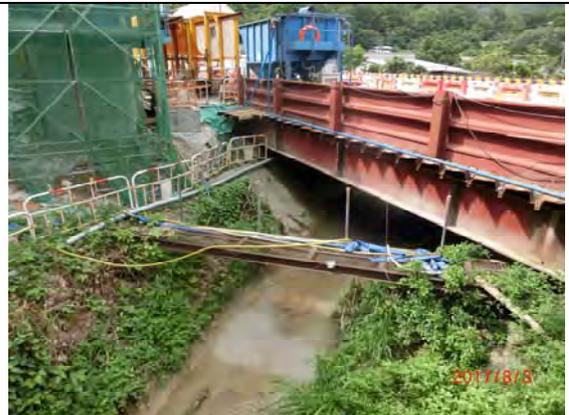
Photo 4
Joint site inspection was conducted on 3 August 2017. The construction site was general in order and no adverse water quality impact was observed.

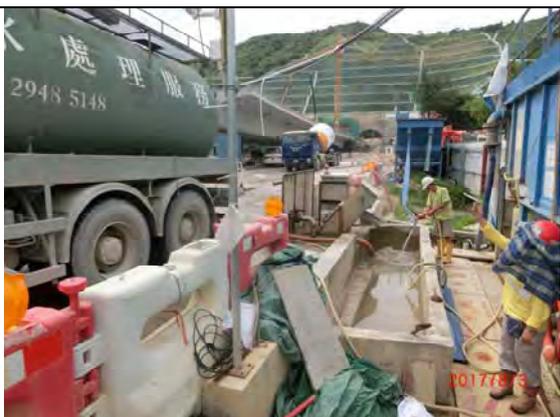
Photo 5
Joint site inspection was conducted on 3 August 2017. It was observed that de-sludge of the wastewater treatment tank was conducted to maintain the treatment system to function efficiently.

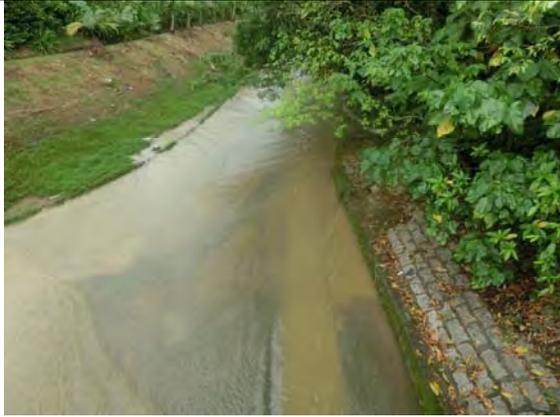
Photo 1
During water sampling on 2 August 2017, muddy water was observed at WM3x.

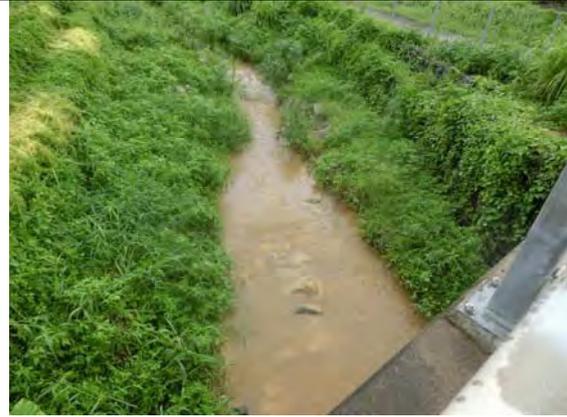
Photo 2
During water sampling on 2 August 2017, muddy water was observed at WM3-C.

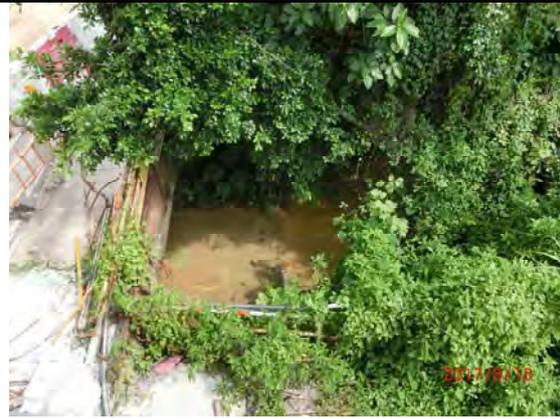
Photo 8

On 16 August 2017, it was observed that unknown source of muddy water attributed to site area and the muddy water was finally entered Ma Wat River and got detected at WM4. It was suspected that the muddy water was via an underground pipe which connecting the box culvert in Kiu Tau Road (outside C3) to BC02 (under Contract 3).

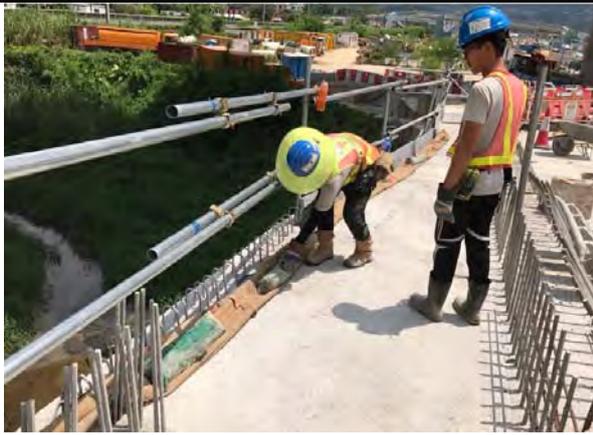
Photo 11
The Contractor had erected sand bags at the edge of the viaduct deck as mitigation measures.

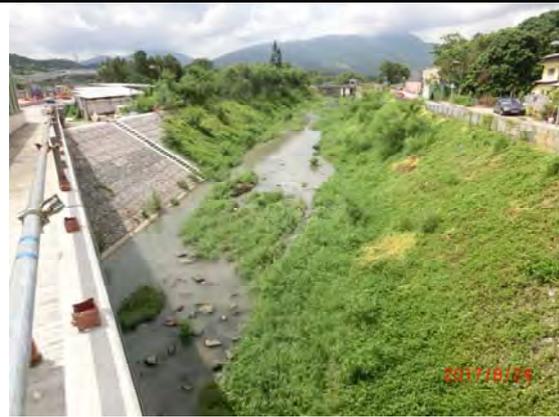
Photo 12
On 24 August 2017, turbid water was observed at the control station WM4-CB.

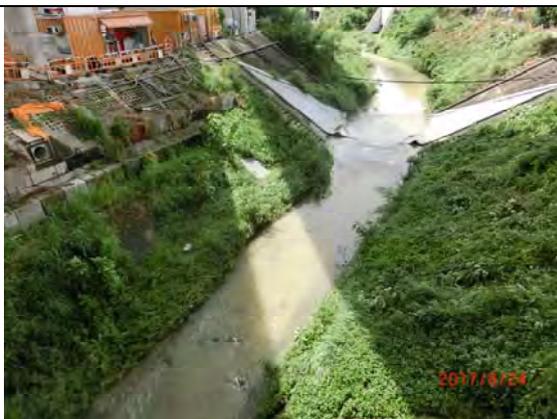
Photo 13
On 24 August 2017, it was observed that the water flowing from box culverts ID4 and ID5 (middle of the site area) were slightly turbid as well.

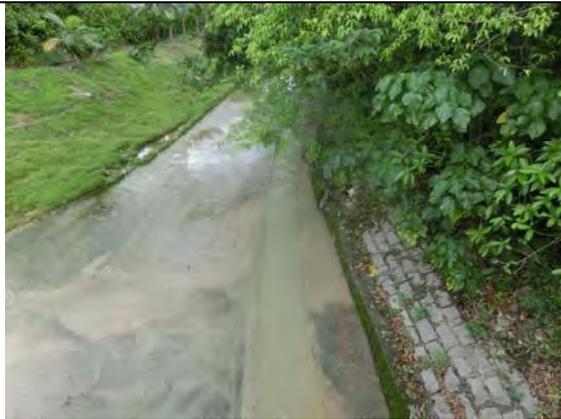
Photo 1

During water sampling on 24 August 2017, turbid water was observed at WM3x. It was noted that the monitored channel was also received the storm water from road surface of Sha Tau Kok Road and the water quality at WM3x was highly affected by the road runoff especially during rainy day.
