**AGREEMENT NO. CE 45/2008 (CE)
LIANTANG/HEUNG YUEN WAI
BOUNDARY CONTROL POINT AND ASSOCIATED WORKS**

**MONTHLY ENVIRONMENTAL MONITORING AND AUDIT
REPORT (NO.56) – MARCH 2018**

**PREPARED FOR
CIVIL ENGINEERING AND DEVELOPMENT DEPARTMENT
(CEDD)**

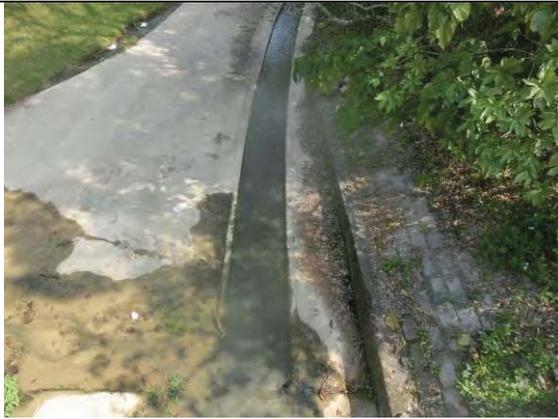
Photo 1
During water sampling on 1 March 2018, the water quality observed at WM3x was slightly turbid.

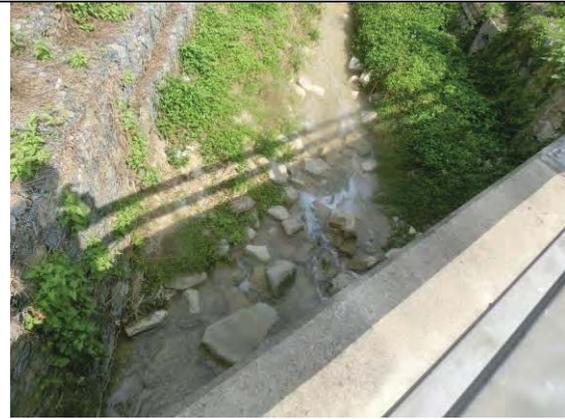
Photo 2
During water sampling on 1 March 2018, the water quality flowing at WM3-C was clear.

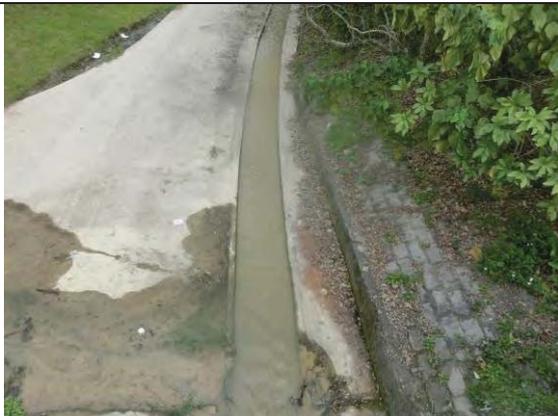
Photo 3
During water sampling on 3 March 2018, the water quality observed at WM3x was turbid.

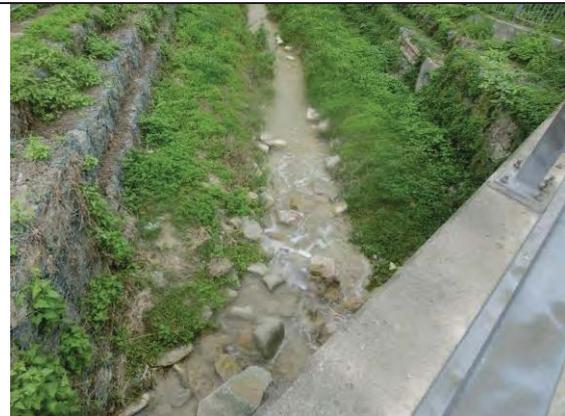
Photo 4
During water sampling on 3 March 2018, the water quality flowing at WM3-C was clear.

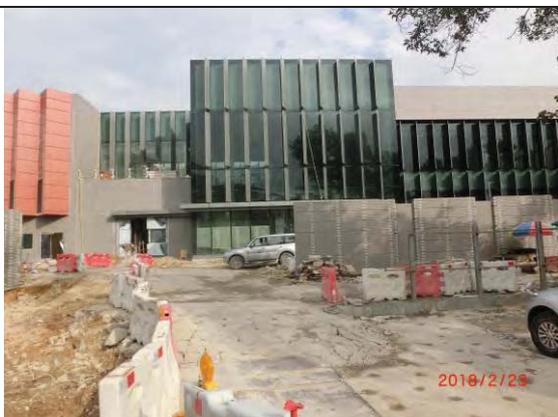
Photo 5
At Admin Building Site, it was observed that site area was mostly hard paved and wastewater generated from the construction works was limited.

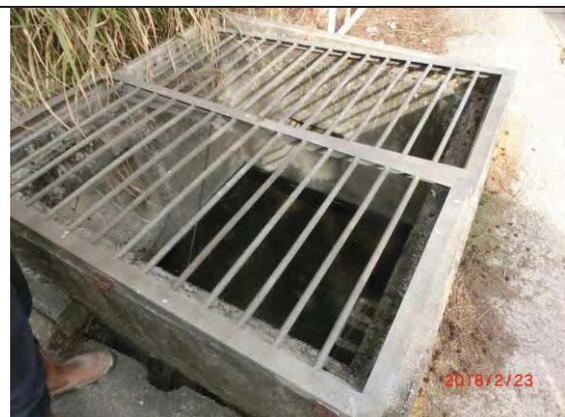
Photo 6
The adjacent channel and catch pit receiving the wastewater from Admin Building and upstream area were clear and no adverse water quality impact was identified during site inspection.

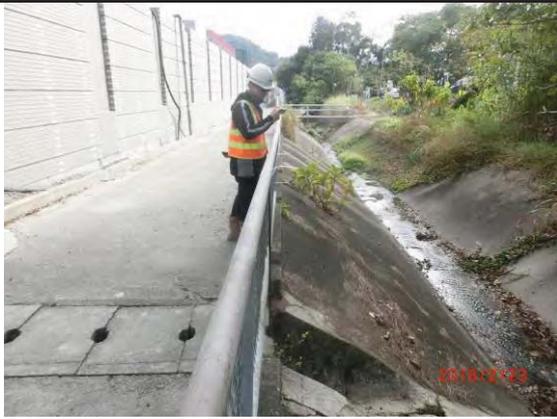
**Photo 7**

The adjacent channel and catch pit receiving the wastewater from Admin Building and upstream area were clear and no adverse water quality impact was identified during site inspection.

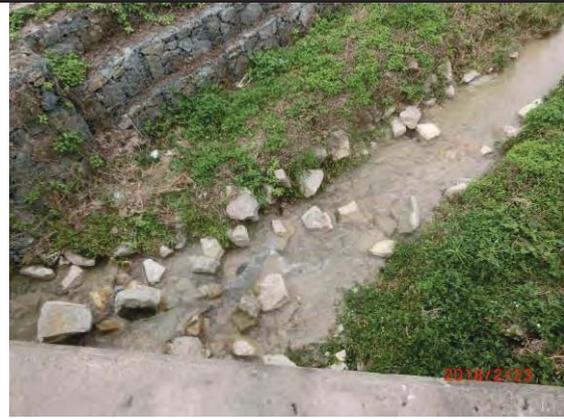
**Photo 8**

Joint site inspection was conducted on 23 February 2018, the water quality outside the discharge point at downstream Loi Tung Stream was visually clear.

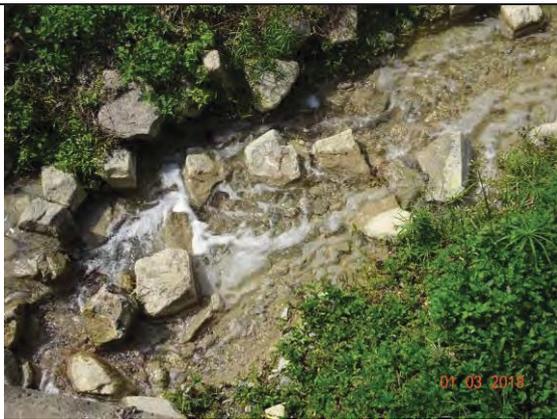
**Photo 9**

Joint site inspection was conducted on 1 March 2018, the water quality outside the discharge point at downstream Loi Tung Stream was visually clear.

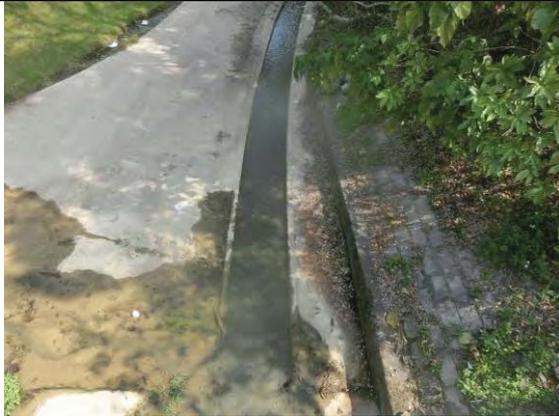
**Photo 1**

During water sampling on 1 March 2018, the water quality observed at WM3x was slightly turbid.

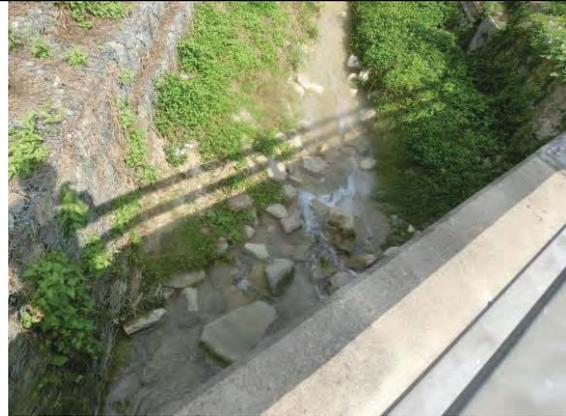
**Photo 2**

During water sampling on 1 March 2018, the water quality flowing at WM3-C was clear.

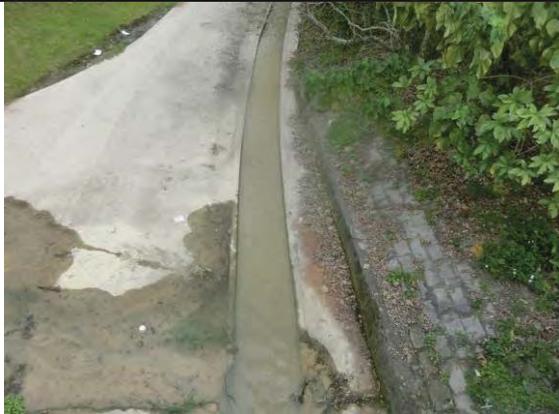
**Photo 3**

During water sampling on 3 March 2018, the water quality observed at WM3x was turbid.

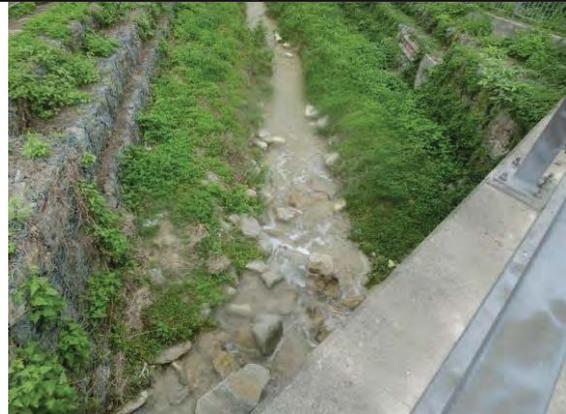
**Photo 4**

During water sampling on 3 March 2018, the water quality flowing at WM3-C was clear.

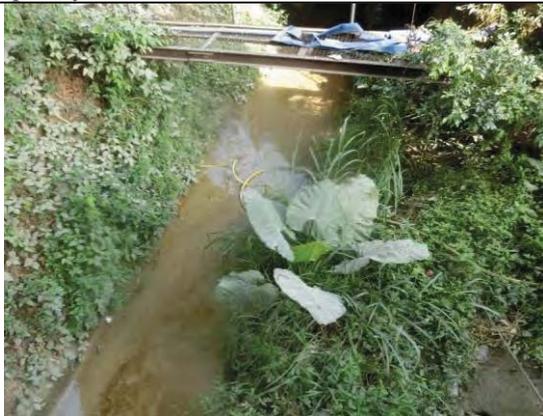
**Photo 5**

On 1 March 2018, it was observed that the water quality in the channel of South Portal Site was clear and no deteriorated water quality was noted from South Portal Site.

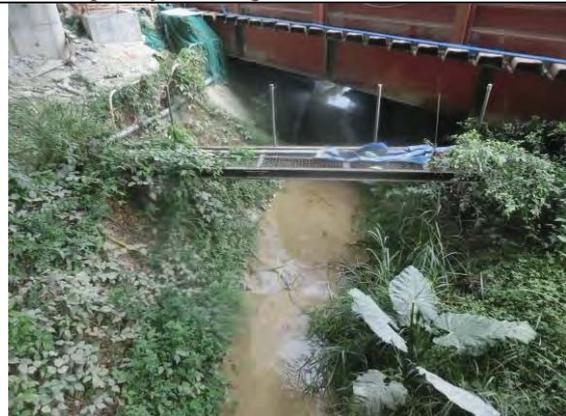
**Photo 6**

On 3 March 2018, it was observed that the water quality in the channel of South Portal Site was clear and no deteriorated water quality was noted from South Portal Site.

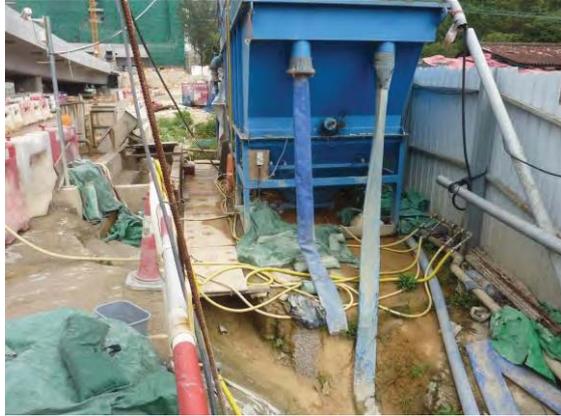
Photo 7

Joint site inspection was conducted on 2 March 2018. It was observed that wastewater treatment facilities at South Portal were function properly and the effluent was clear.

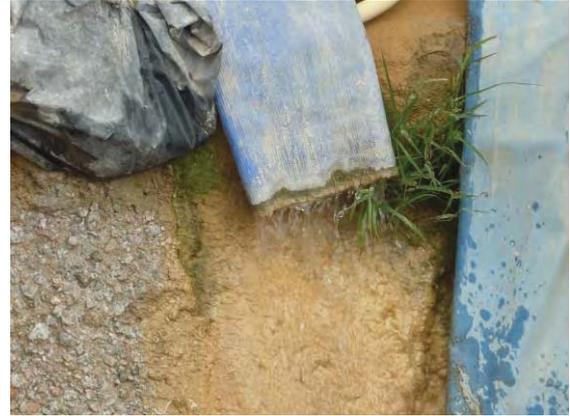
Photo 8

Joint site inspection was conducted on 2 March 2018. It was observed that wastewater treatment facilities at South Portal were function properly and the effluent was clear.

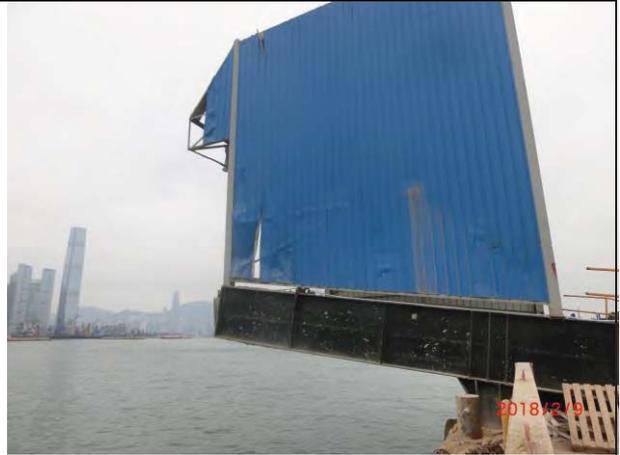
Photo 2

- (c) During the site investigation on 9th February 2018, it was observed that the tipping hall of the jetting (area of unloading from trucks to barges) was enclosed with top and two sides to minimise fugitive dust emission. (*Photo 2*) Water sprinklers were also provided as dust suspension measures. (*Photo 3*)

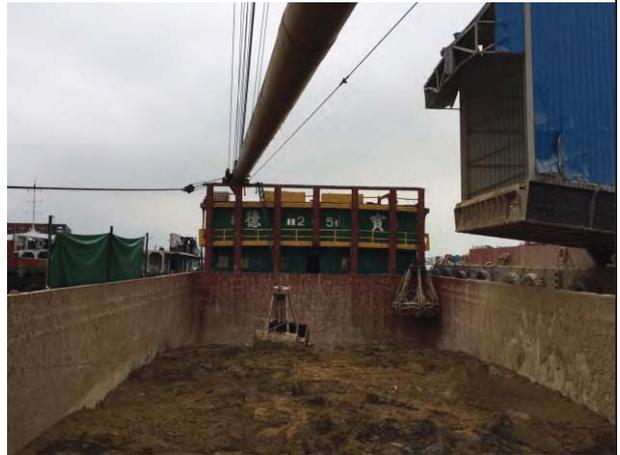
Photo 4

- (d) To avoid the spoil from dropping into the sea through the gap between the barge and jetting, each barge was closely oriented to the berth and dropping height was minimized. (*Photo 4*). Moreover, erection of tarpaulin on the opposite site of the barge was provided to avoid spoil spurting out (*Photo 5*).

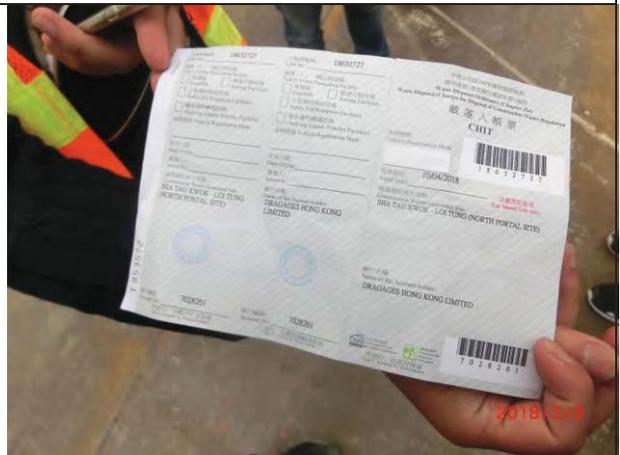
Photo 6

- (e) In regard to the excavated materials delivery by vessel to the Fill Banks, specific vessel chits have been applied by DHK under trip-ticket system (TTS) (*Photo 6*). As advised by DHK, each barge currently deployed is registered with CEDD for delivery of spoils to TM38/TKO137. Transfer of spoil from one barge to another barge in the middle of the sea is not required. In additional, unloading operation onto registered barges are closely supervised by DHK and its Subcontractor's supervisor to avoid such maloperation.

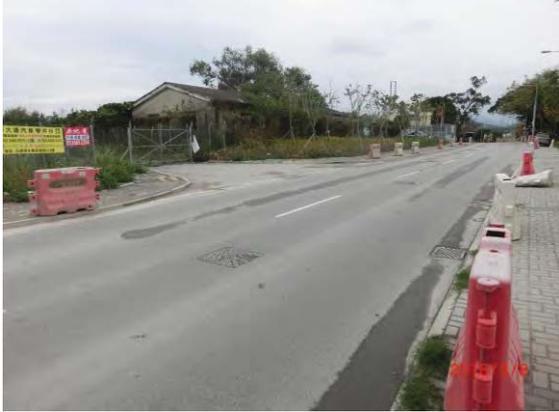
Photo 1 (Unknown Exit 1)

The condition of unknown site exit 1 was fair but some mud and debris were found on the kerbs of LMH road. The maintenance party/ ownership of the site exit is unknown.

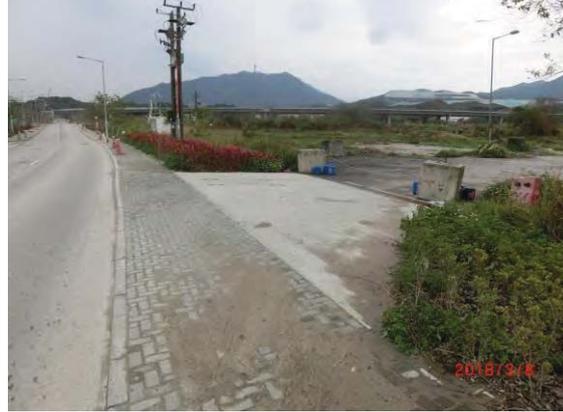
Photo 2 (Unknown Exit 2)

The condition of unknown site exit 2 was dusty in which mud and debris were found at site exit and kerbs of LMH road. The maintenance party/ ownership of the site exit is unknown.

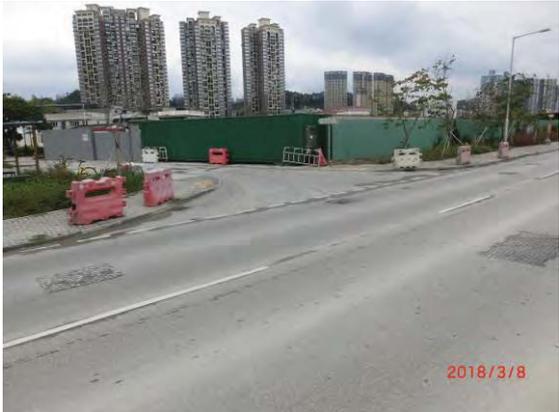
Photo 3 (Unknown Exit 3)

The condition of unknown site exit 3 was fair but some mud and debris were found on the kerbs of LMH road. The maintenance party/ ownership of the site exit is unknown.

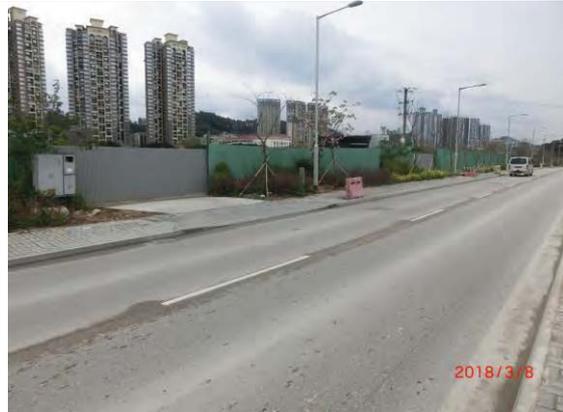
Photo 4 (Unknown Exit 4)

The condition of unknown site exit 4 was fair but some mud and debris were found on the kerbs and middle of LMH road. The maintenance party/ ownership of the site exit is unknown.

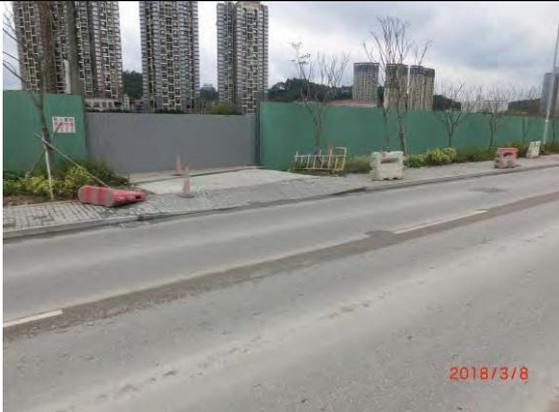
Photo 5 (Unknown Exit 5)

The condition of unknown site exit 5 was fair but some mud and debris were found on the kerbs and middle of LMH road. The maintenance party/ ownership of the site exit is unknown.

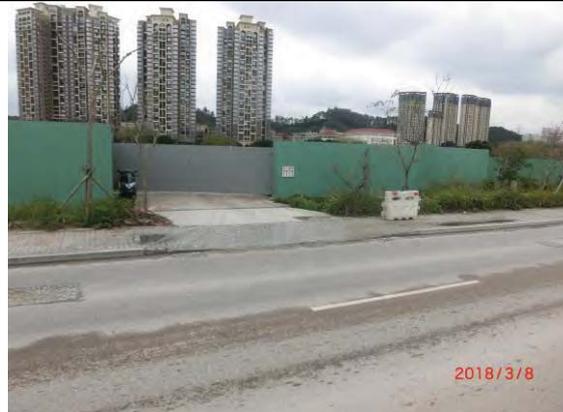
Photo 6 (Unknown Exit 6)

The condition of unknown site exit 6 was fair but some mud and debris were found on the kerbs and middle of LMH road. The maintenance party/ ownership of the site exit is unknown.

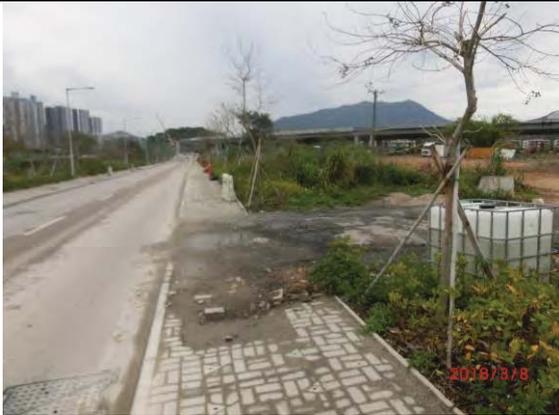
Photo 7 (Unknown Exit 7)

The condition of unknown site exit 7 was dusty in which mud and debris were found at site exit and kerbs of LMH road. The maintenance party/ownership of the site exit is unknown.

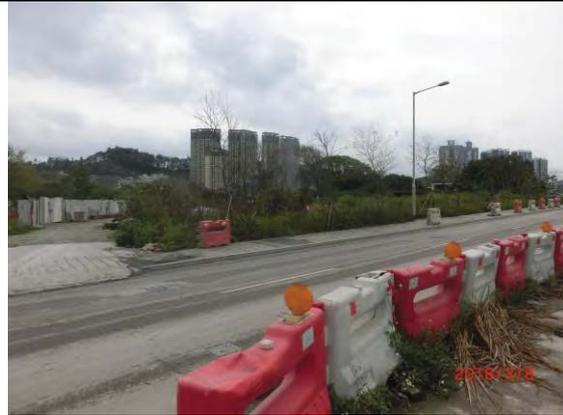
Photo 8 (Unknown Exit 8)

The condition of unknown site exit 8 was fair but some mud and debris were found on the kerbs and middle of LMH road. The maintenance party/ownership of the site exit is unknown.

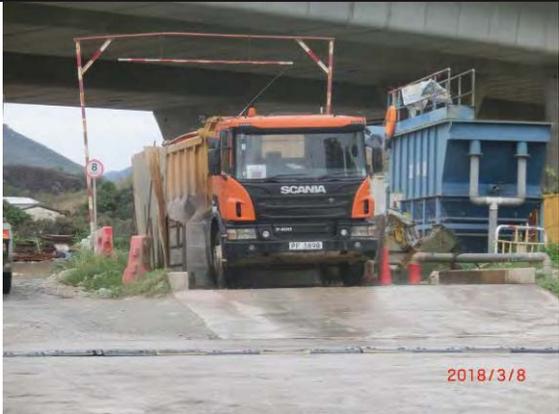
Photo 9 (Bridge D Site Exit under LT/C6)

Wheel washing facilities were provided for Bridge D site exit and properly maintained by CCKJV. A bund was provided to prevent muddy water from flowing out of the site.

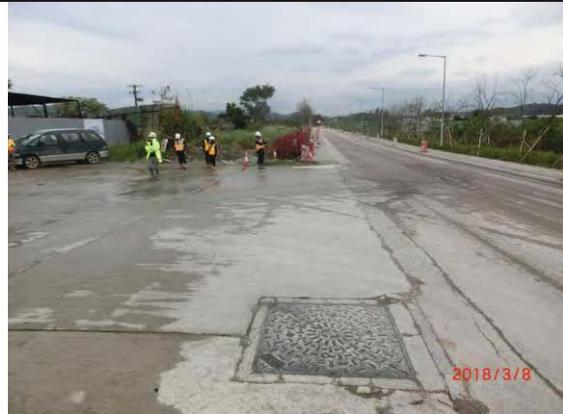
Photo 10 (Bridge D Site Exit under LT/C6)

The condition of Bridge D Site Exit under LT/C6 and adjoined LMH road was satisfactory without mud and debris.

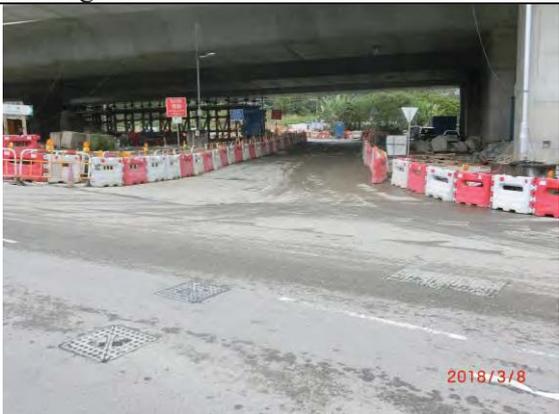
Photo 11 (Chuk Yuen Rd Site exit under LT/C6)

Wheel washing facilities were provided for Chuk Yuen Rd site exit and properly maintained by CCKJV. The condition of Chuk Yuen Rd Site Exit and adjoined LMH road was satisfactory without mud and debris.

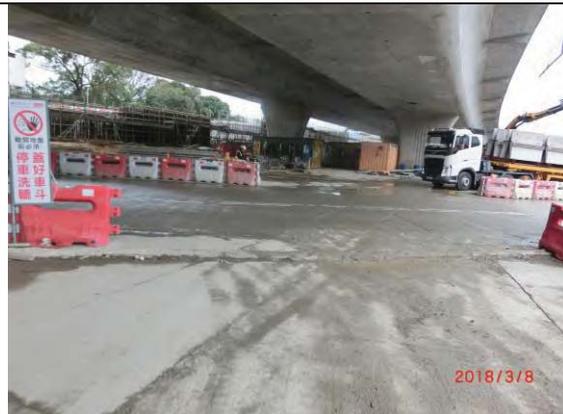
Photo 12 (Bridge Y Site Exit under LT/C6)

Wheel washing facilities were provided for Bridge Y site exit and properly maintained by CCKJV. The condition of Bridge Y site exit and adjoined LMH road was satisfactory without mud and debris.

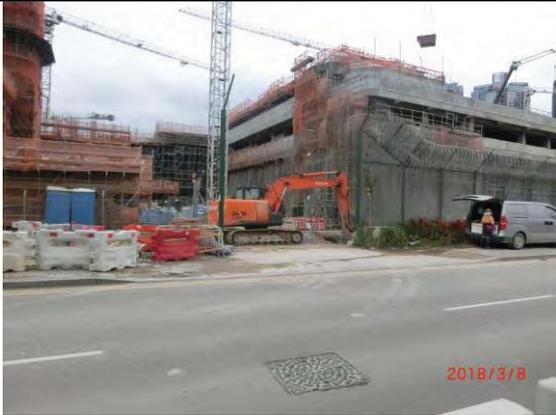
Photo 13 (Gate 1)

Wheel washing facilities were provided for Gate 1 site exit which maintained by CCKJV. It was observed that offloading of sub base was conducted at Gate 1 and some of sub base was dropped on the footpath at the site exit.

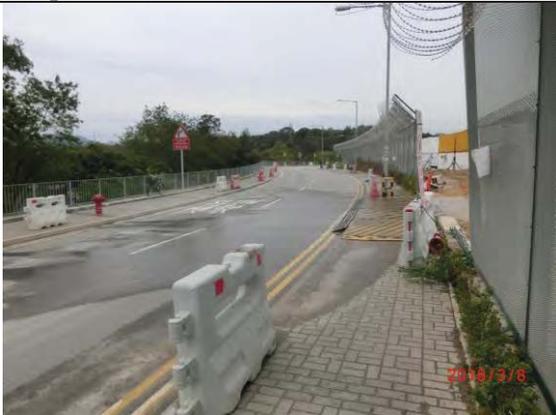
Photo 15 (Gate 2)

Wheel washing facilities were provided for Gate 2 site exit and properly maintained by CCKJV. The condition of Gate 2 and adjoined LMH road was satisfactory without mud and debris.

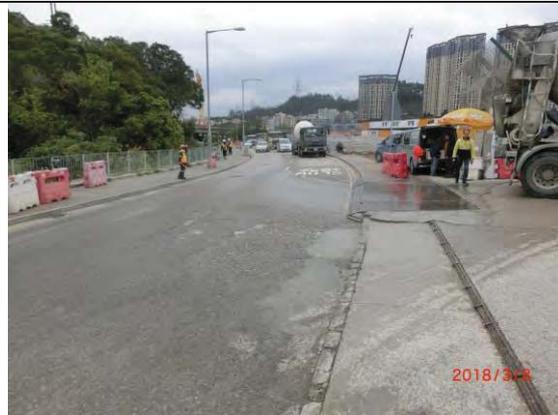
Photo 16 (Gate 3)

Wheel washing facilities were provided for Gate 2 site exit and properly maintained by Leighton. The condition of Gate 3 and adjoined LMH road was satisfactory without mud and debris.

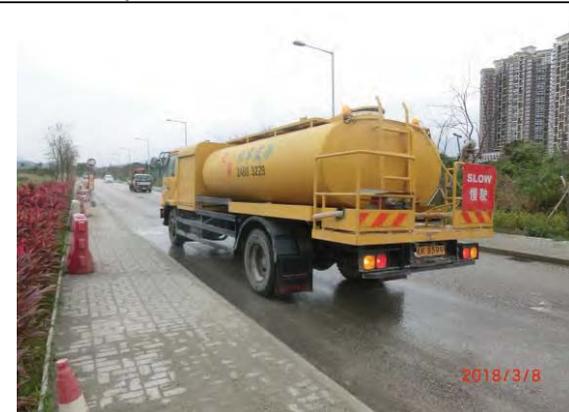
Photo 17

During the regular site inspection, it was observed that the road surface of LMH Road was wetted by water bowsers to suppress fugitive dust. No over-water spraying and slurry was observed after road washing.

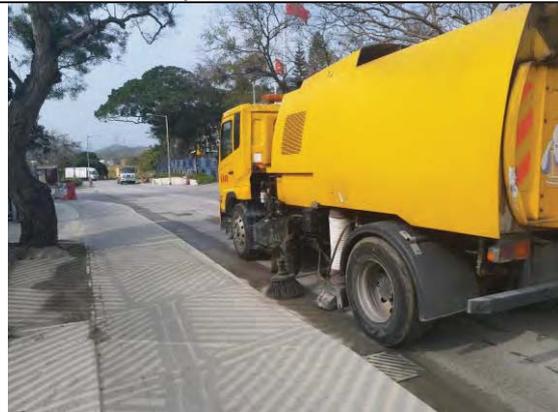
Photo 18

Road sweeper was also deployed by CCKJV to enhance the road cleaning work in order to remove debris and gravels on road surface.

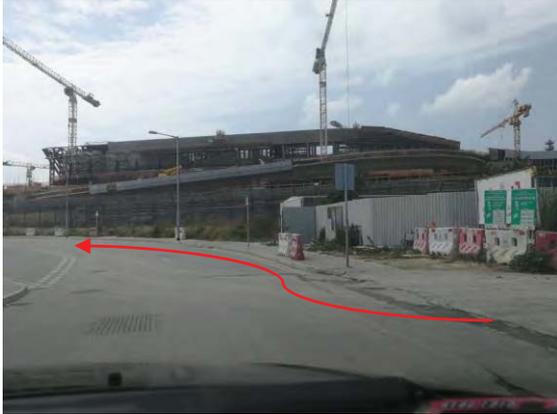
Photo 1

According to the photo provided by the complainant, muddy trails were observed at the site exit of Contract 7.

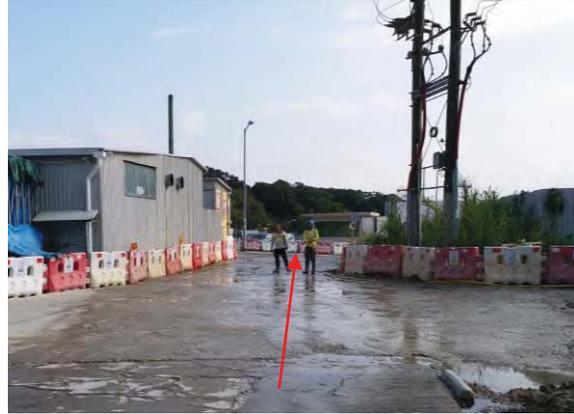
Photo 2

There was only one vehicular site exit under Contract 7 to access BCP works area. Wheel washing facilities including water jet were provided at exit site and wheel washing was carried out on a concrete ground before leaving the site.

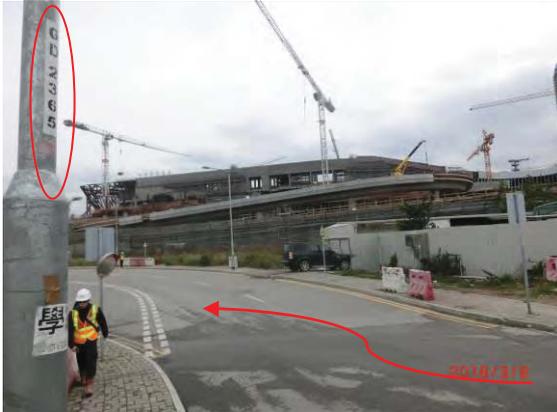
Photo 3

During investigation conducted on 8th March 2018, it was observed that the site exit of Contract 7 and the adjoining LMH road near lamp post GD2365 was kept clear of mud and debris.

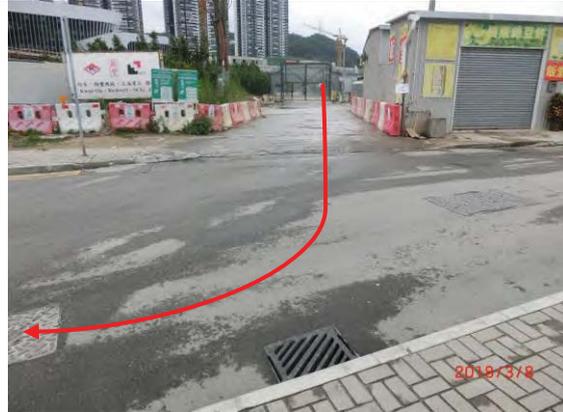
Photo 4

During investigation conducted on 8th March 2018, it was observed that the site exit of Contract 7 and the adjoining LMH road near lamp post GD2365 was kept clear of mud and debris.

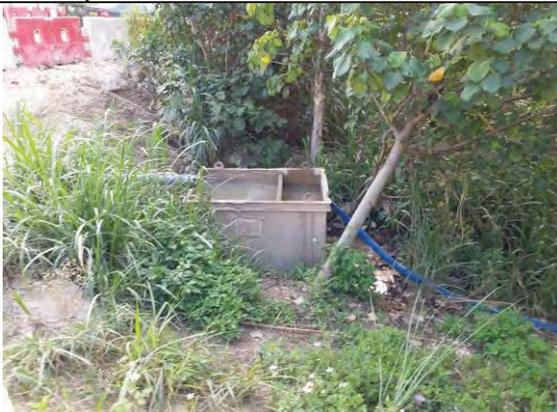
Photo 5

During site inspection on 9 March 2018, it was observed that wheel washing facilities and wastewater treatment system were properly maintained.

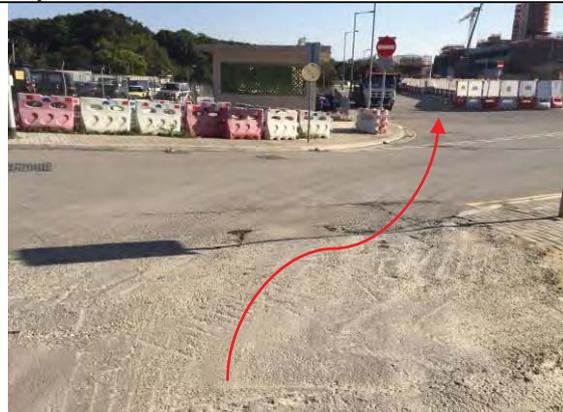
Photo 6

During site inspection on 9 March 2018, no muddy trails and debris was observed at the site exit and adjoining LMH Road.

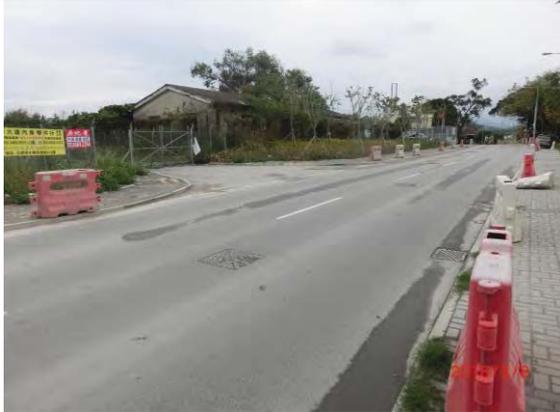
Photo 1 (Unknown Exit 1)

The condition of unknown site exit 1 was fair but some mud and debris were found on the kerbs of LMH road. The maintenance party/ ownership of the site exit is unknown.

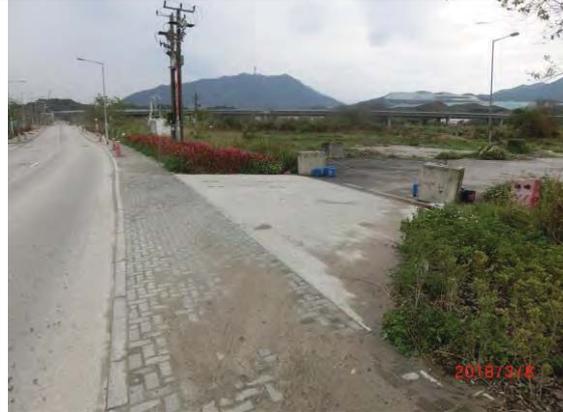
Photo 2 (Unknown Exit 2)

The condition of unknown site exit 2 was dusty in which mud and debris were found at site exit and kerbs of LMH road. The maintenance party/ ownership of the site exit is unknown.

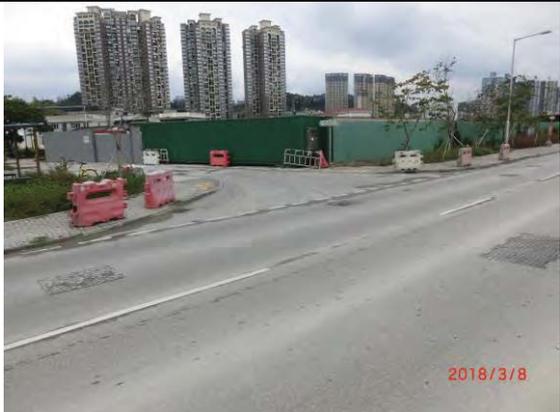
Photo 3 (Unknown Exit 3)

The condition of unknown site exit 3 was fair but some mud and debris were found on the kerbs of LMH road. The maintenance party/ ownership of the site exit is unknown.

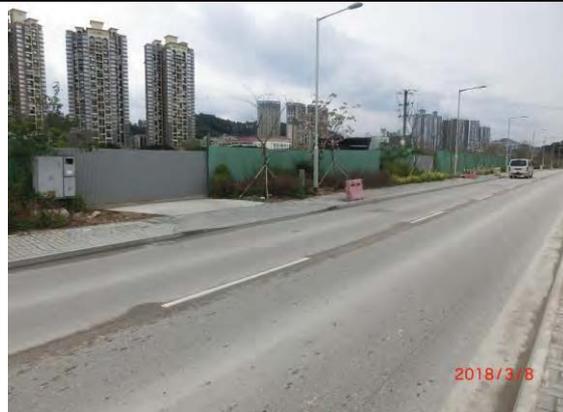
Photo 4 (Unknown Exit 4)

The condition of unknown site exit 4 was fair but some mud and debris were found on the kerbs and middle of LMH road. The maintenance party/ ownership of the site exit is unknown.

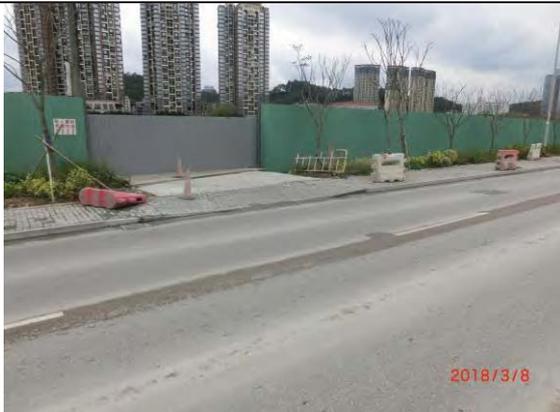
Photo 5 (Unknown Exit 5)

The condition of unknown site exit 5 was fair but some mud and debris were found on the kerbs and middle of LMH road. The maintenance party/ ownership of the site exit is unknown.

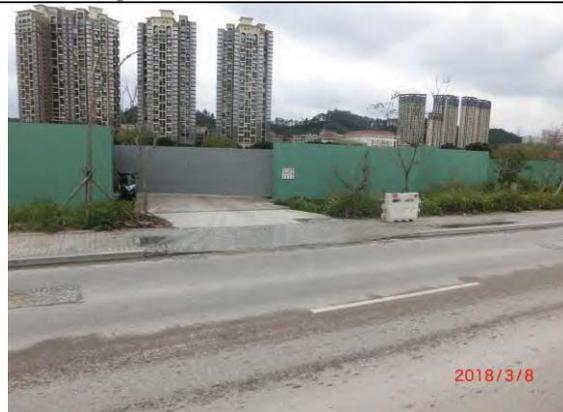
Photo 6 (Unknown Exit 6)

The condition of unknown site exit 6 was fair but some mud and debris were found on the kerbs and middle of LMH road. The maintenance party/ ownership of the site exit is unknown.

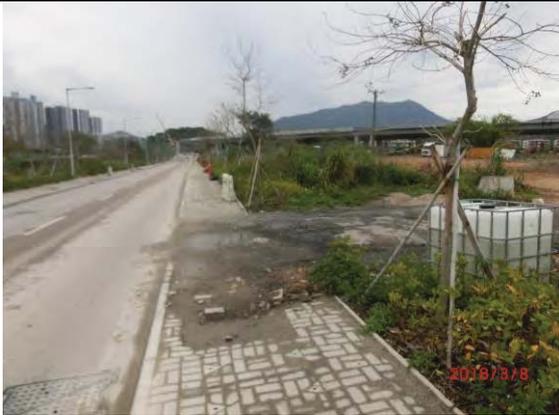
Photo 7 (Unknown Exit 7)

The condition of unknown site exit 7 was dusty in which mud and debris were found at site exit and kerbs of LMH road. The maintenance party/ownership of the site exit is unknown.

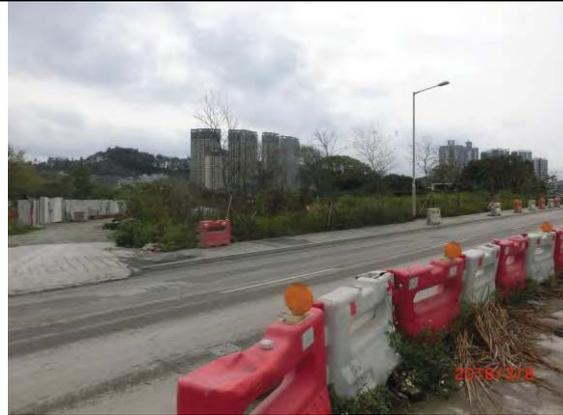
Photo 8 (Unknown Exit 8)

The condition of unknown site exit 8 was fair but some mud and debris were found on the kerbs and middle of LMH road. The maintenance party/ownership of the site exit is unknown.

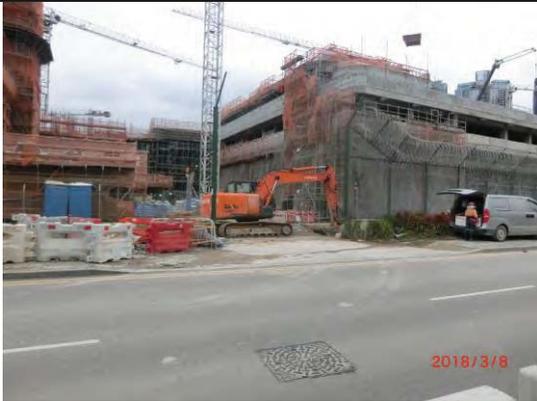
Photo 9 (Gate 1)

Wheel washing facilities were provided for Gate 1 site exit which maintained by CCKJV. It was observed that offloading of sub base was conducted at Gate 1 and some of sub base was dropped on the footpath at the site exit.

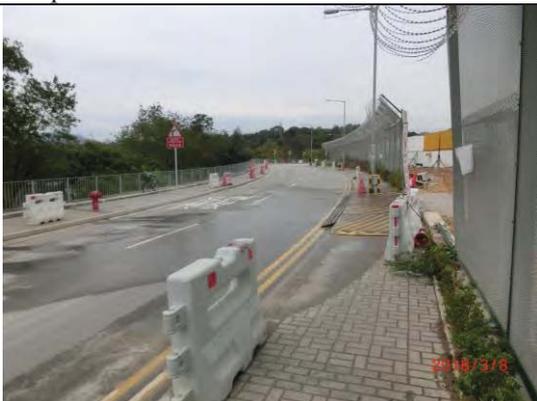
Photo 11 (Gate 2)

Wheel washing facilities were provided for Gate 2 site exit and properly maintained by CCKJV. The condition of Gate 2 and adjoined LMH road was satisfactory without mud and debris.

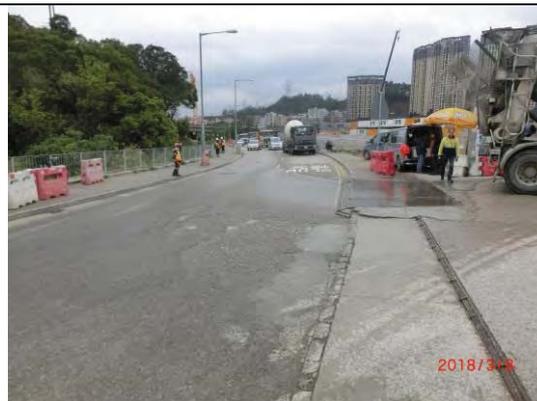
Photo 12 (Gate 3)

Wheel washing facilities were provided for Gate 2 site exit and properly maintained by Leighton. The condition of Gate 3 and adjoined LMH road was satisfactory without mud and debris.

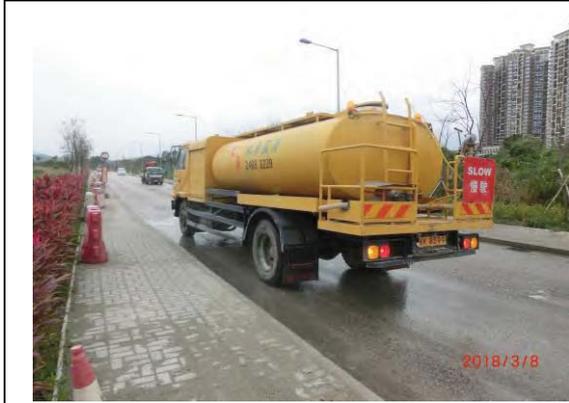
Photo 13

During the regular site inspection, it was observed that the road surface of LMH Road was wetted by water bowsers to suppress fugitive dust. No over-water spraying and slurry was observed after road washing.

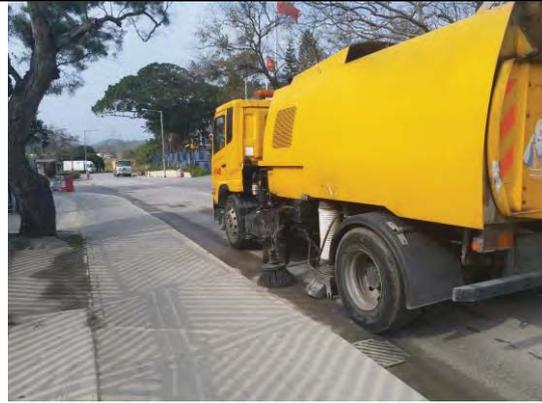
Photo 14

Road sweeper was also deployed to enhance the road cleaning work in order to remove debris and gravels on road surface.

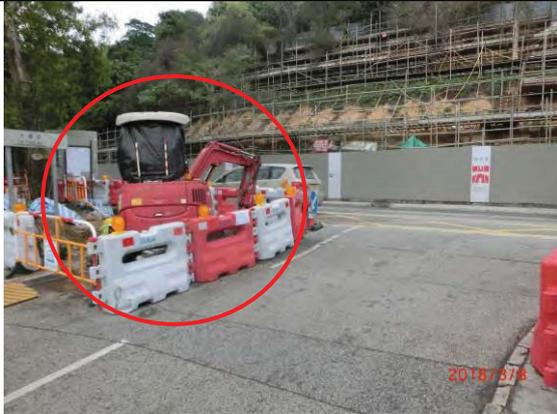
Photo 1

There was a temporary road side work area under LT/C6 located at Tai Tong Wu adjoined to STK Road for underground utility investigation work.

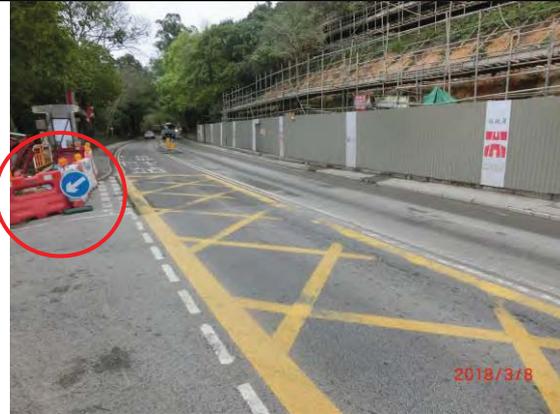
Photo 2

It was observed that the condition of STK Road was not dusty and no muddy water/ slurry was found near the works area.

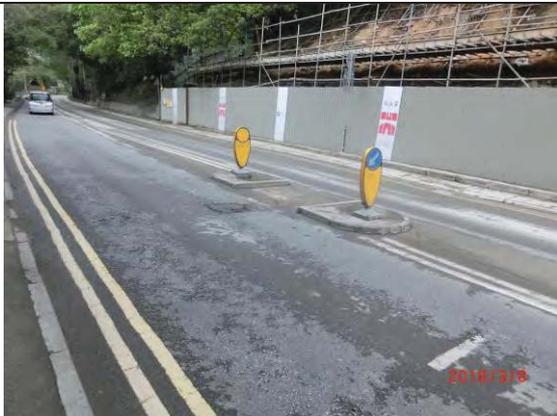
Photo 3

Road debris was observed at both middle and edges of the STK road which suspected to be caused by frequent use of vehicle.

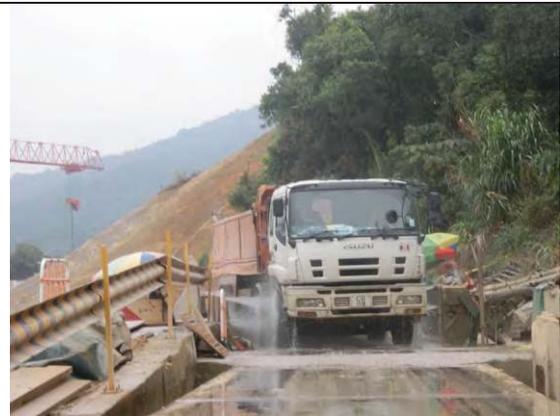
Photo 4 (North Portal under C2)

The vehicle site exit of North Portal Site Area (LT/C2) was located on STK Road. Wheel washing was provided within the construction site to ensure all site vehicles were washed prior leaving the site.

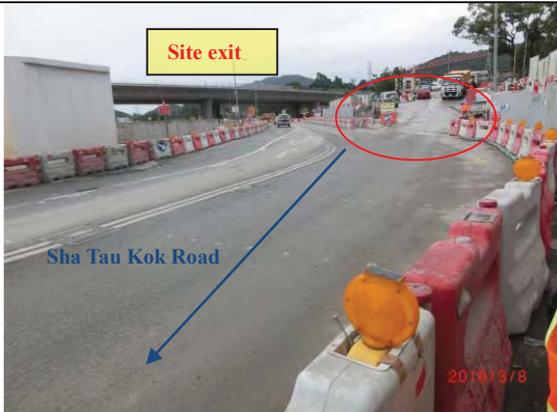
Photo 5 (North Portal under C2)

No muddy water/ slurry was found at the site exit after the wheel washing facilities. However, mud and debris was observed at both middle and edges of the STK road which suspected to be caused by frequent use of vehicle.

| | <p>(c) Another vehicle site exit for LT/C2 was Admin Building which located on Wo Keng Shan (WKS) Road. Wheel washing facilities was provided at the concrete ground within the construction site. (Photo 6) The wastewater from wheel washing was collected by a pit and pumped to wastewater treatment facility. No muddy water/slurry was found at the site exit after the wheel washing facilities. (Photo 7) Moreover, no muddy trails and dust and soil carrying by site vehicles to public road were observed outside the site exit. (Photo 8)</p> <p>(d) There was no site exit belong to LT/C6 on STK Road and the main vehicle site exit for works area of Contract 6 was located on Wo Keng Shan (WKS) Road. Wheel washing facilities was provided concrete ground within the construction site and no muddy water/slurry was found at the site exit after the wheel washing facilities. (Photos 9 & 10) No muddy trails and dust and soil carrying by site vehicles to public road were observed outside the site exit. (Photo 11)</p> <p>(e) Road washing/ cleaning by water tanker was provided along Wo Keng Shan Road to Sha Tau Kok Road as dust suppression measures. The condition of STK Road after road washing was in normal condition without excessive water/ slurry on road surface. (Photo 12) As advised by both Contractors, road washing was carried out in every normal working day (Mon-Sat), except for rainy day. Moreover, road sweeping has been deployed on the concerned roads twice a week to maintain cleanliness of the roads.</p> <p>3. In addition, monitoring programme was executed under the project to closely monitor the air quality at the air sensitive receivers and immediate action would be undertaken in case of exceedance. Having reviewed the air quality monitoring results in the recent months on January and February 2018, no exceedances were triggered at the air quality monitoring location AM7b which located outside North Portal Site of Contract 2 and adjacent to the concern STK Road. It is considered that the dust impact arising from the project was within acceptable level.</p> <p>4. In our investigation, the Contractors have been well maintained the wheel washing facilities and no dust and soil carrying by site vehicles to STK road were observed. Having inspected the existing condition of STK Road and WKS Road which far from the construction site, soil and debris were also found at the middle and edges of the road which suspected to be caused by frequent use of dump truck transporting loose material to NENT and the majority of dump truck was not belong to LT/HYW project. Therefore, it is considered that the complaint was not valid to the project. In particular dry season, ET will closely monitor the implementation of dust mitigation measures in the subsequent site inspections.</p> |

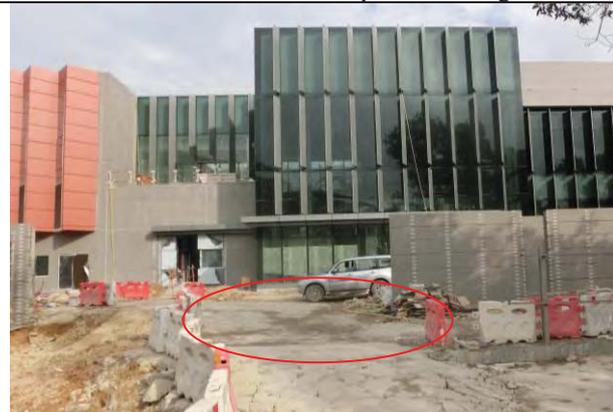
Photo 6 (Admin Building under C2)

Another vehicle site exit for LT/C2 was Admin Building which located on Wo Keng Shan (WKS) Road. Wheel washing facilities was provided at the concrete ground within the construction site.

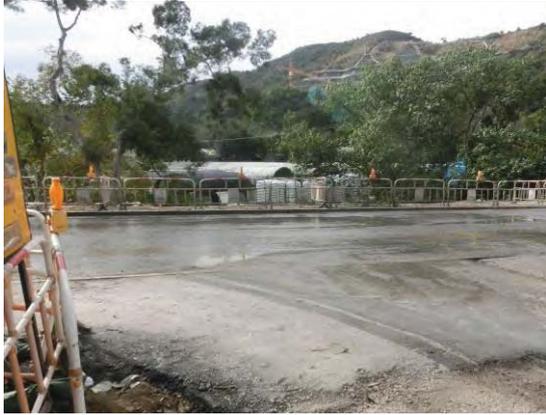
Photo 7 (Admin Building under C2)
No muddy water/ slurry was found at the site exit after the wheel washing facilities.

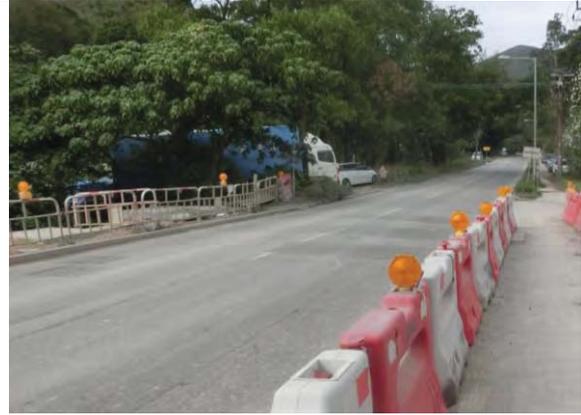
Photo 8 (Admin Building under C2)
No muddy trails and dust and soil carrying by site vehicles to public road were observed outside the site exit.

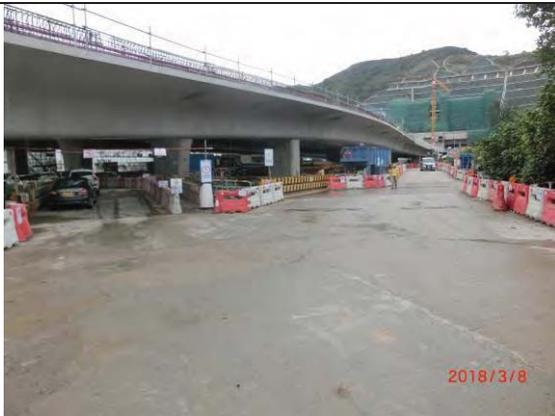
Photo 9 (South Portal under C6)
Wheel washing facilities was provided concrete ground within the construction site.

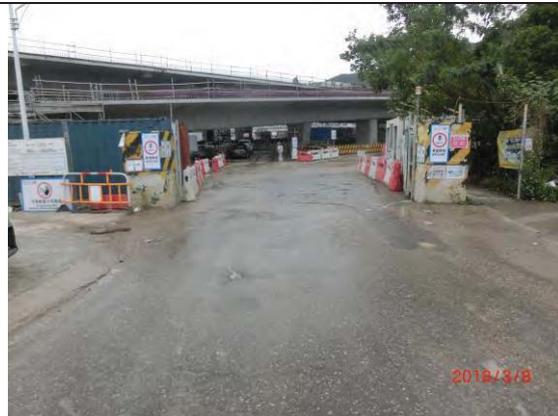
Photo 10 (South Portal under C6)
No muddy water/ slurry was found at the site exit after the wheel washing facilities.

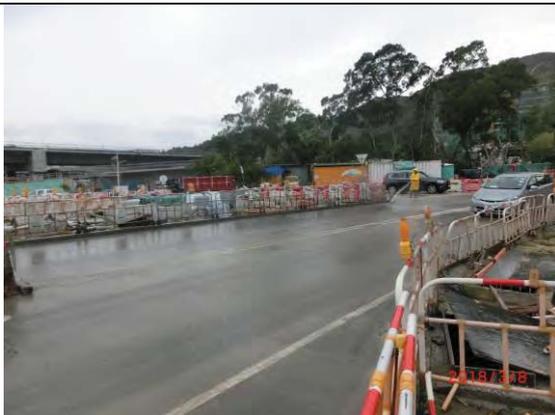
Photo 11 (South Portal under C6)
The overall view of the Wo Keng Shan Road from the site exit for both South Portal and no muddy trails and dust and soil carrying by site vehicles to public road were observed.

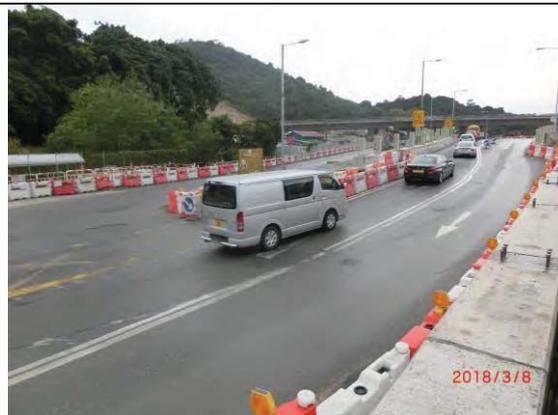
Photo 12
Road washing/ cleaning by water tanker was provided along Wo Keng Shan Road to Sha Tau Kok Road as dust suppression measures. The condition of STK Road after road washing was in normal condition without excessive water/ slurry on road surface.
