AGREEMENT NO. CE 45/2008 (CE)
LIANTANG/HEUNG YUEN WAI
BOUNDARY CONTROL POINT AND ASSOCIATED WORKS

MONTHLY ENVIRONMENTAL MONITORING AND AUDIT
REPORT (NO.58) – MAY 2018

PREPARED FOR
CIVIL ENGINEERING AND DEVELOPMENT DEPARTMENT
(CEDD)

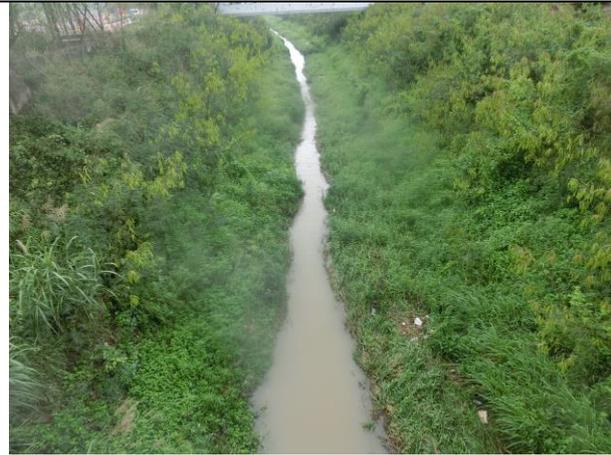
Photo 1

During water quality monitoring on 9 May 2018, turbid water was observed at WM4.

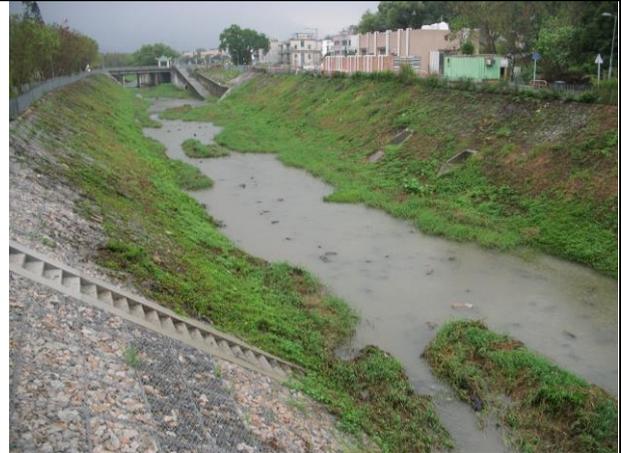
Photo 4

In the morning of 9 May 2018, Chun Wo reported that muddy water was observed at upstream of the construction site near WM4-CB.

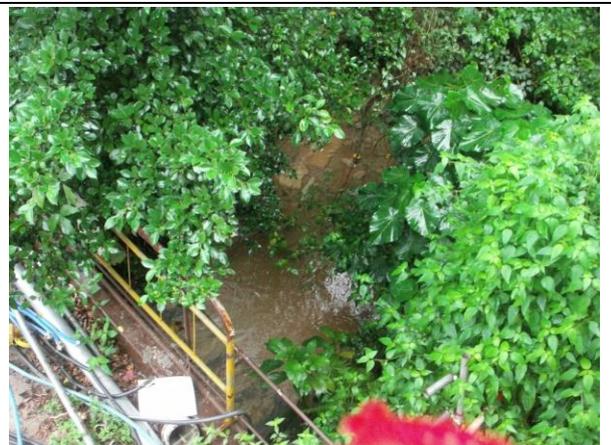
Photo 5

On 9 May 2018, Chun Wo reported that there was unknown source of muddy water attributed to site area via an underground pipe from box culvert in Kiu Tau Road (outside C3) to BC02 (under Contract 3).

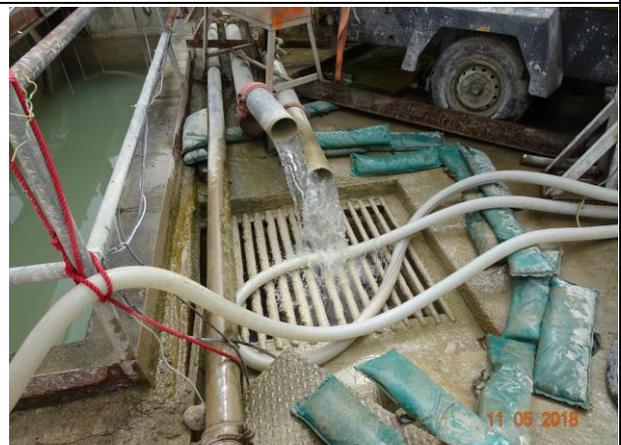
Photo 6

Weekly joint site inspection on 13 April 2018. It was observed that wastewater treatment facilities implemented in South Portal Site was functioned properly and the discharge was clear.

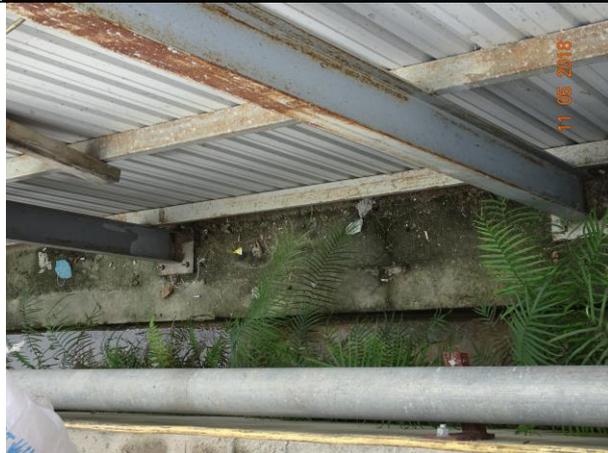
Photo 7

The site was mostly hard paved and site hoarding with sealed foots was erected along the site boundary to minimize muddy surface runoff and prevent it from flowing outside the site.

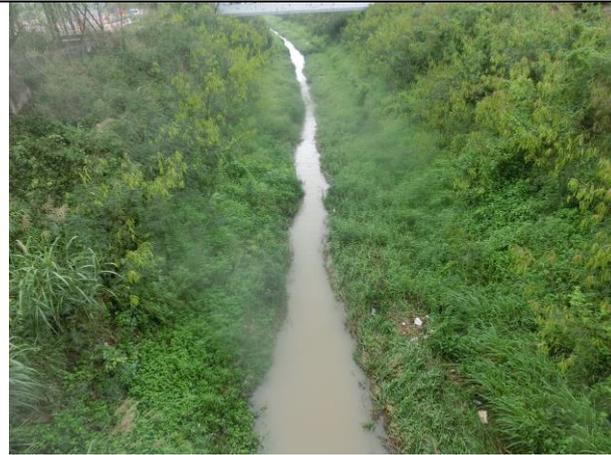
Photo 1

During water quality monitoring on 9 May 2018, turbid water was observed at WM4.

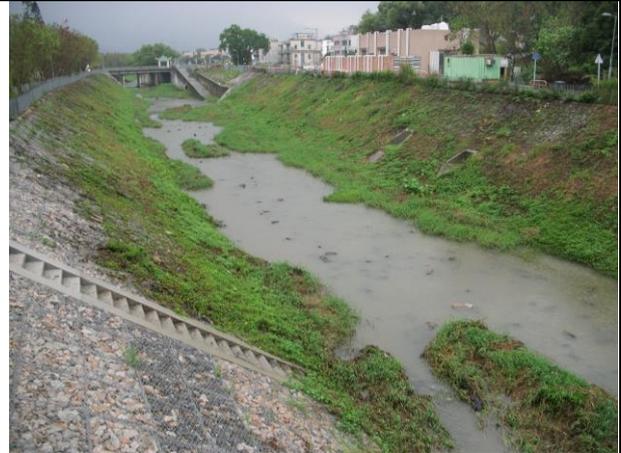
Photo 4

In the morning of 9 May 2018, Chun Wo reported that muddy water was observed at upstream of the construction site near WM4-CB.

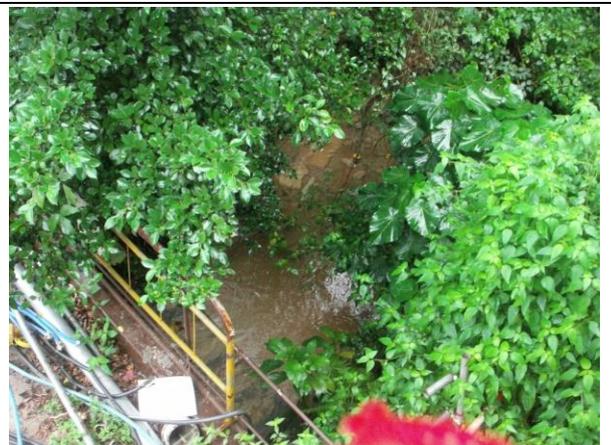
Photo 5

On 9 May 2018, Chun Wo reported that there was unknown source of muddy water attributed to site area via an underground pipe from box culvert in Kiu Tau Road (outside C3) to BC02 (under Contract 3).

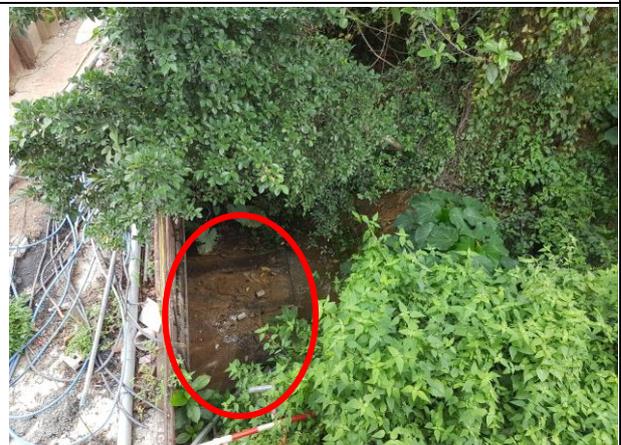
Photo 6

During site inspection on 10 May, it was observed that the water flowing through Box Culvert BC02 was clear but trace amount of sediment / mud was observed at channel bed, which suspected to be caused by the inflow of muddy water from previous days.

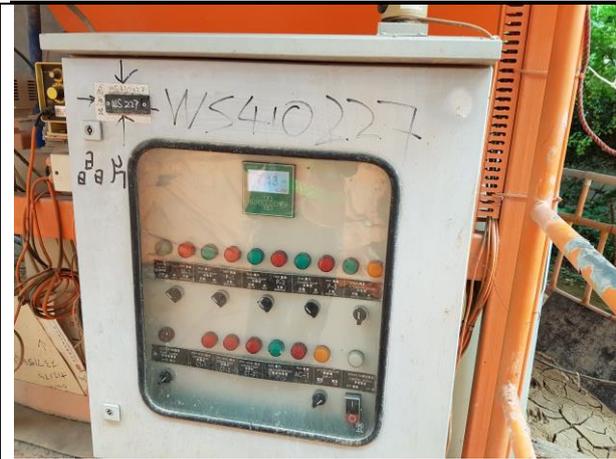
**Photo 7**

Wastewater treatment facilities implemented on-site were functioned properly and no adverse water quality impact was observed.

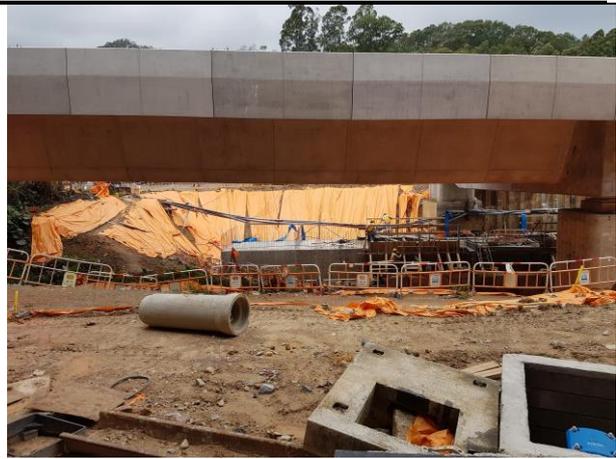
**Photo 8**

As water quality mitigation measures, the exposed surface was covered by tarpaulin sheet as far as practicable to minimize muddy runoff.

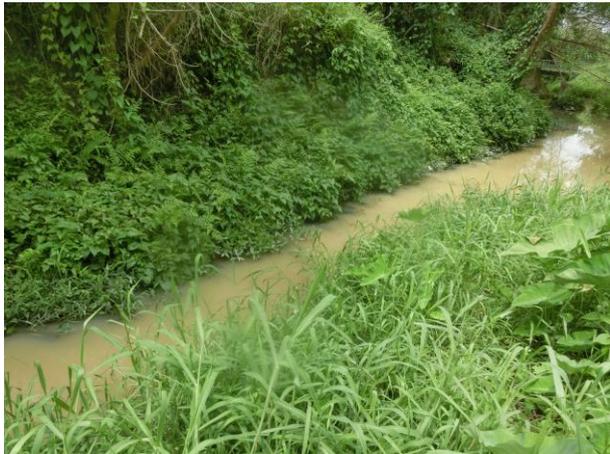
Photo 1

On 11 May 2018, muddy water was observed at WM2A(a).

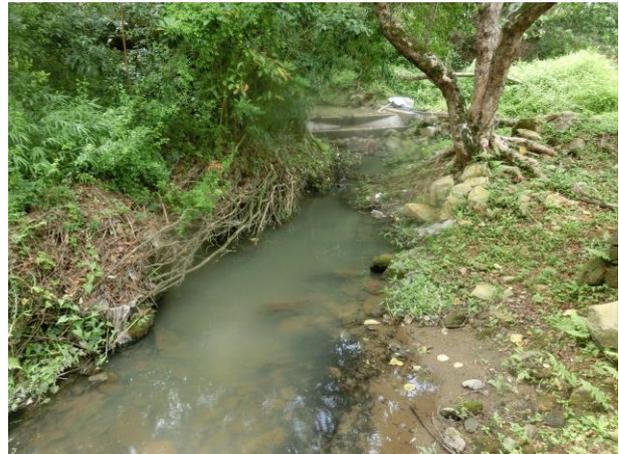
Photo 2

On 11 May 2018, the water quality observed at WM2A-C was slightly turbid.

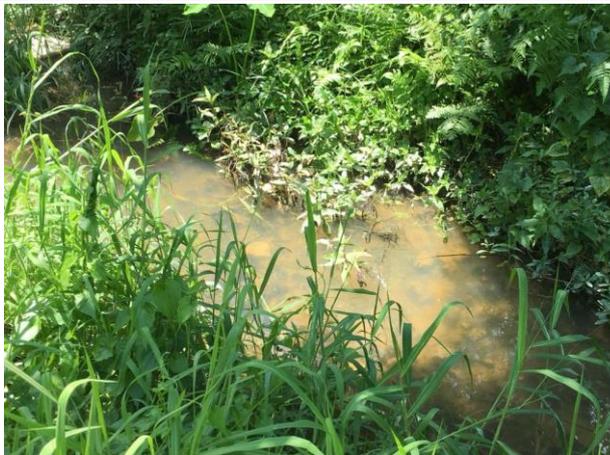
Photo 3

On 12 May 2018, the water quality observed at WM2A(a) was slightly turbid.

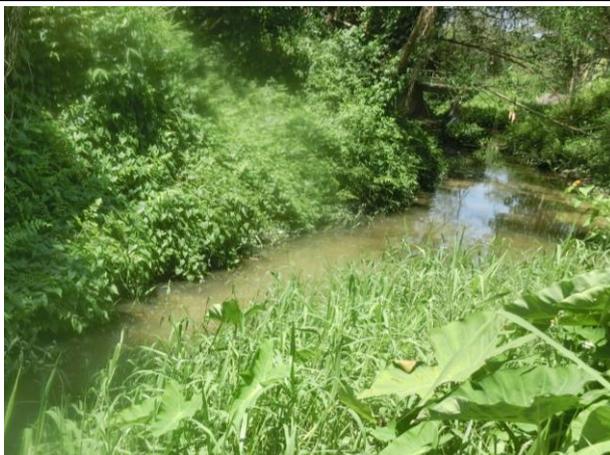
Photo 5

On 14 May 2018, the water quality observed at WM2A(a) was slightly turbid.

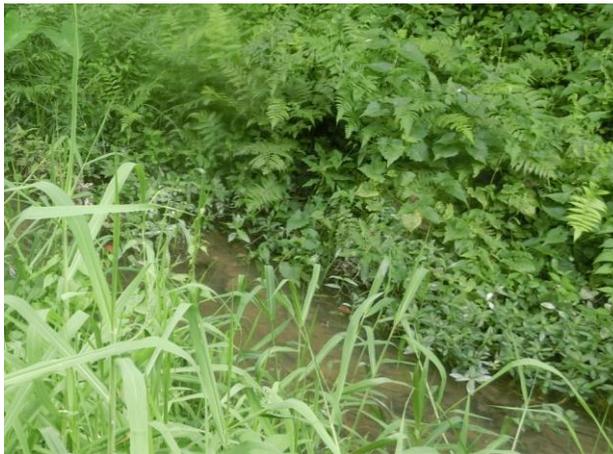
Photo 7

On 16 May 2018, the water quality observed at WM2A(a) was slightly turbid.

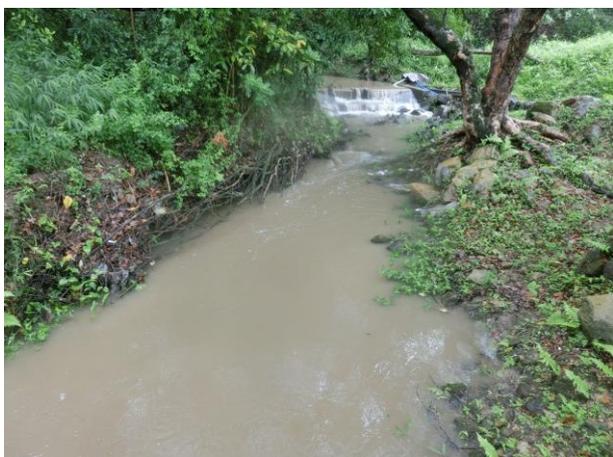
Photo 9

During water monitoring on 9 May 2018, muddy water was observed flowing from control station WM2A-C after heavy rainstorm.

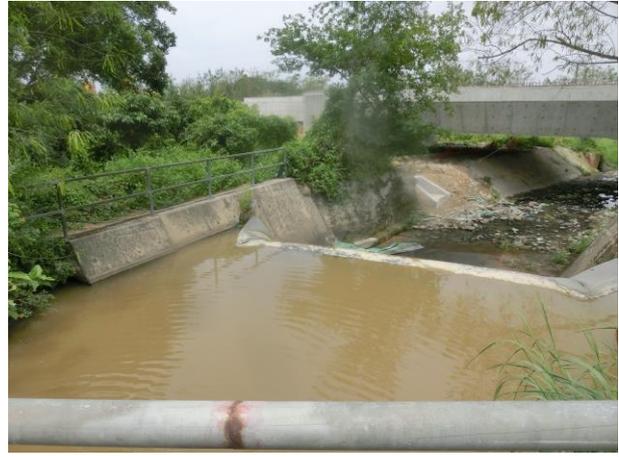
Photo 10

Muddy water from upstream after rainstorm trapped at the Nylon Dam was observed on 11 May 2018 at intermediate of the construction site.

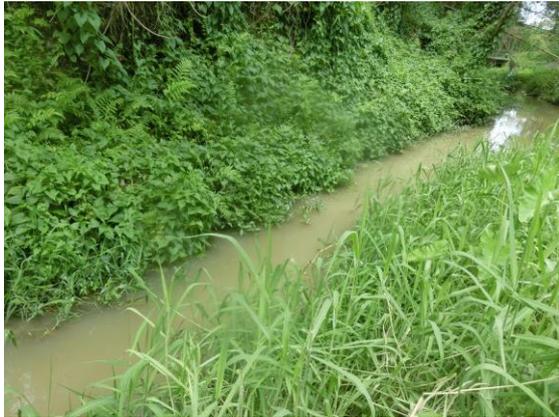
Photo 1
On 18 May 2018, muddy water was observed at WM2A(a).

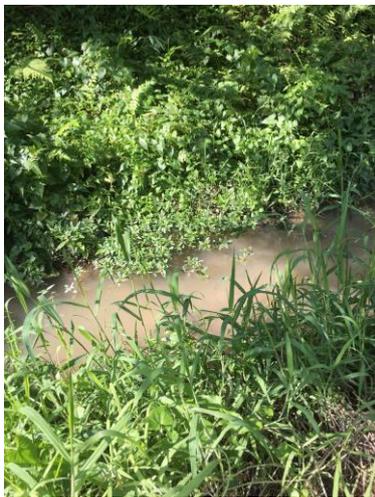
Photo 3
On 19 May 2018, muddy water was observed at WM2A(a).

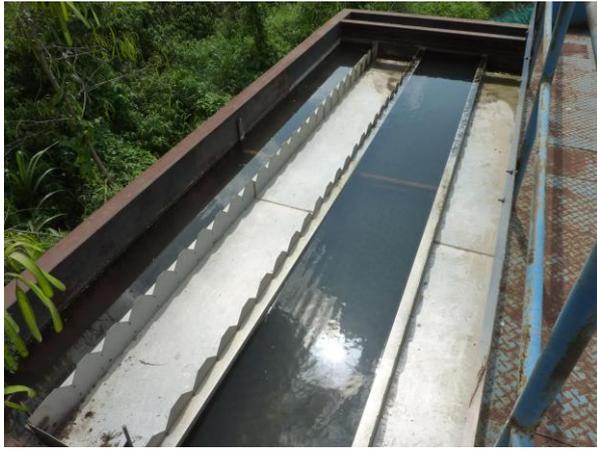
Photo 7

Checking of the wastewater treatment facility at Bridge D was conducted on 18 May 2018. It was observed that the wastewater treatment facility SH-16 was operating properly and the effluent of the wastewater treatment facility was clear.

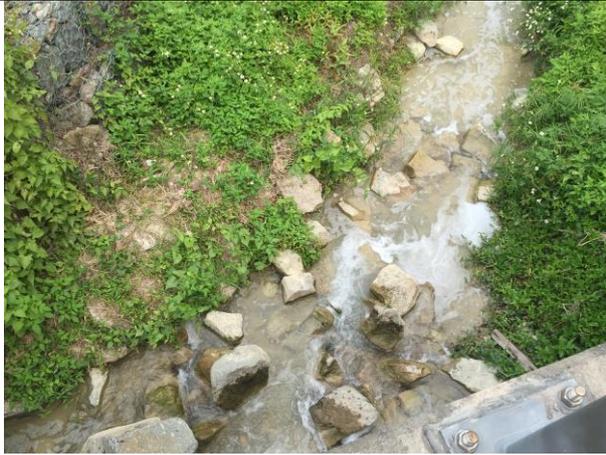
Photo 1

During inspection at Loi Tung Stream on 13 April 2018, the water flowing in the stream was clear but small amount of foam was observed

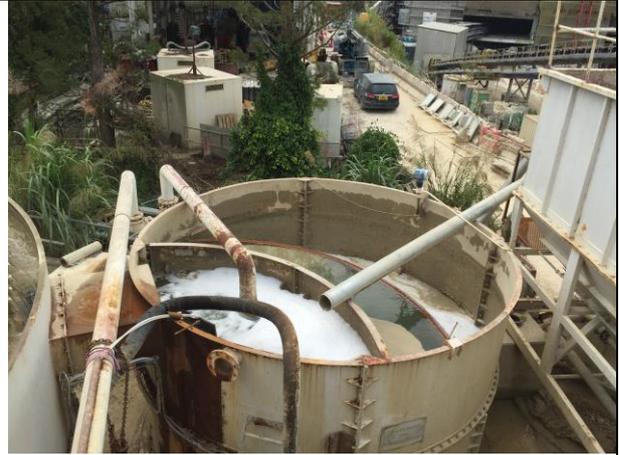
Photo 2

During inspection at North Portal Site on 13 April 2018, the wastewater treatment facilities was function properly, however, visible foam was found on the tank surfaces. DHK explained that the foam was caused by the spillage of Polyfoamer in the TBM. De-foaming agent was added to remove the foam and it took times to suppress all the foam.

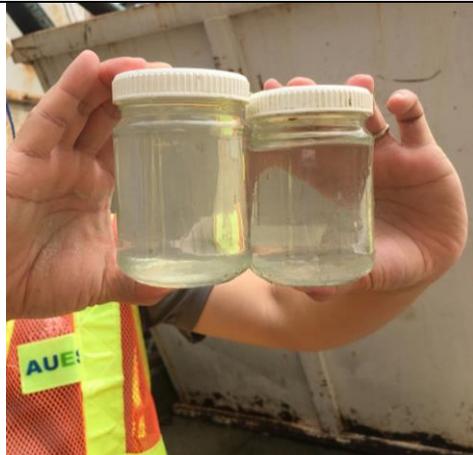
Photo 3

On-site water test for pH value and visual test for suspended solids were carried out for water retained in the recycling tank (eventually overflow off site) and no abnormal results was found in these reference test.

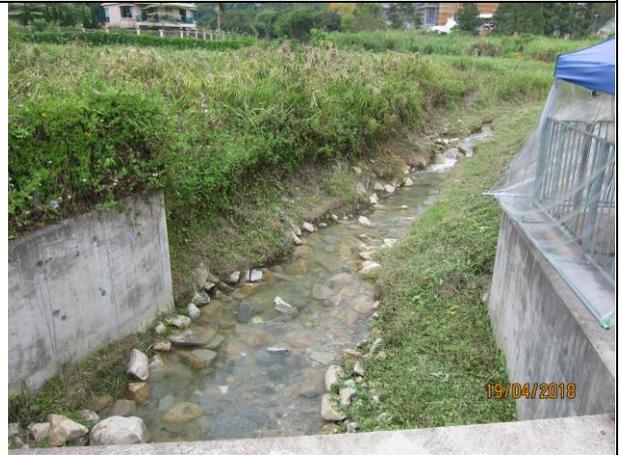
Photo 4

During subsequent site inspection on 20 April 2018 to follow up the incident, it was observed that the water quality at Loi Tung Stream was in good condition and no foam was observed.

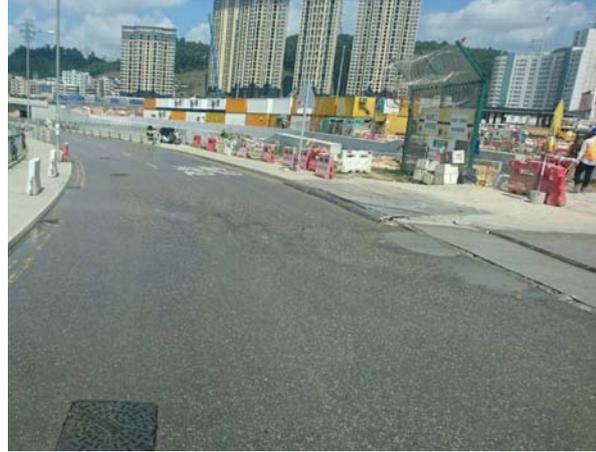
Photo 2
During site inspection on 2 May 2018, the condition of Gate 3 was satisfactory which kept clear of mud and debris. No muddy water was observed flowing from the construction site.

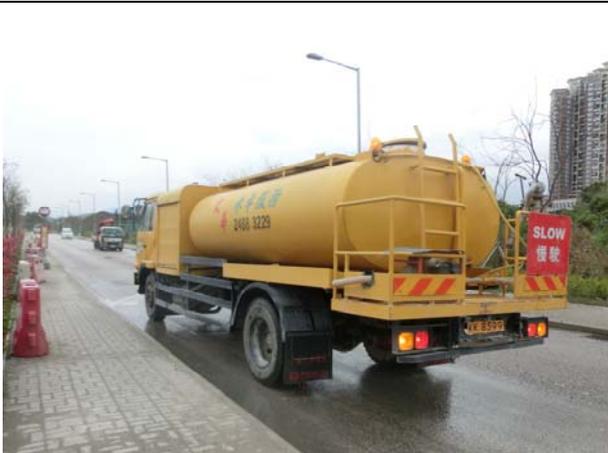
Photo 3
LCAL have deployed water tanker continuously running along LMH Road in every normal working day as dust suppression measures. No over-water spraying and slurry was observed after road washing.

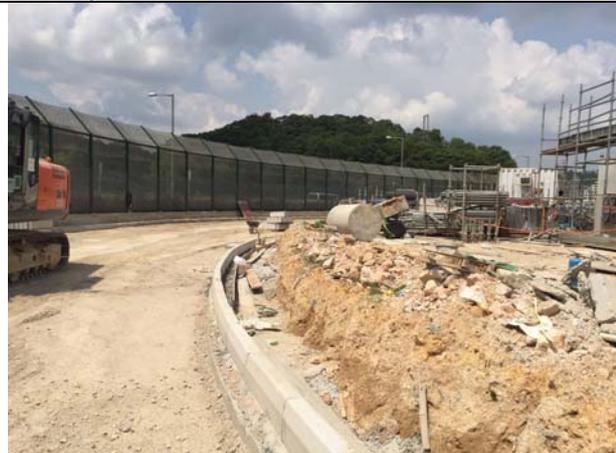
Photo 4
The boundary of Boundary Control Point (BCP) is surrounded by chain link fencing with concrete foot. Moreover, road kerb was constructed at the boundary of Contract SS C505 and no overflowing of site runoff was observed.

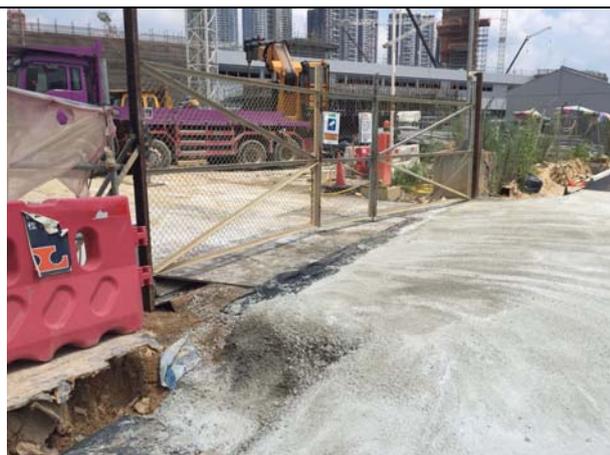
Photo 6

Gate 2 within the boundary of Contract SS C505 was closed and no overflowing of site runoff was observed.

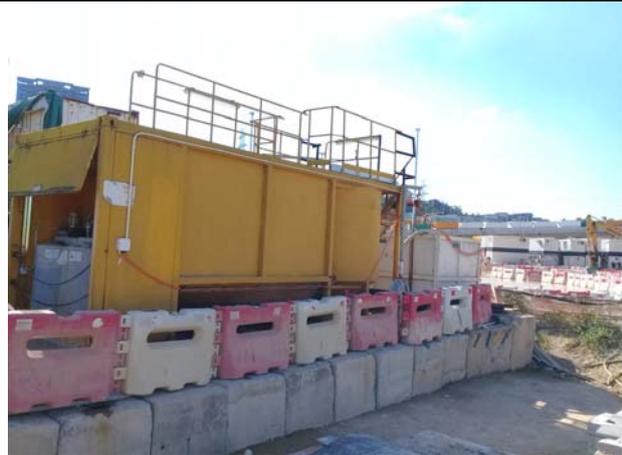
Photo 10
An Aquased is located near Gate 3.
