AGREEMENT NO. CE 45/2008 (CE)
LIANTANG/HEUNG YUEN WAI
BOUNDARY CONTROL POINT AND ASSOCIATED
WORKS

21st QUARTERLY ENVIRONMENTAL MONITORING & AUDIT SUMMARY REPORT – (August to October 2018)

CIVIL ENGINEERING AND DEVELOPMENT DEPARTMENT (CEDD)

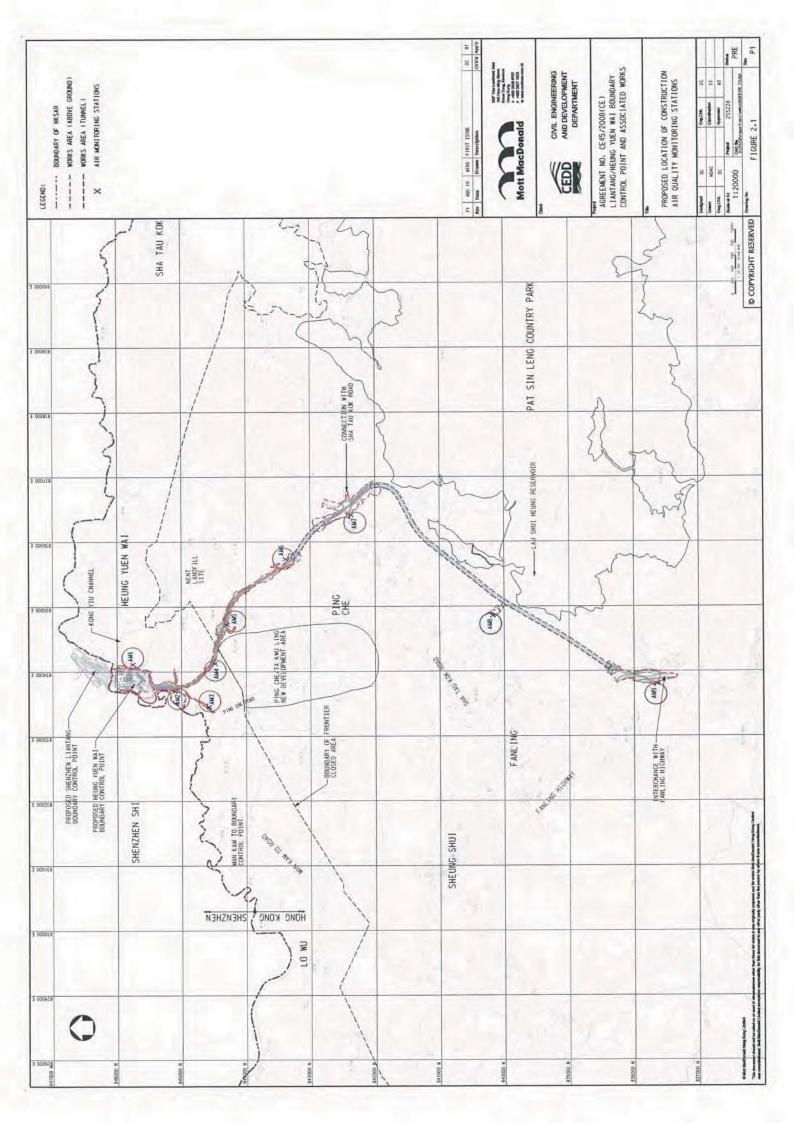
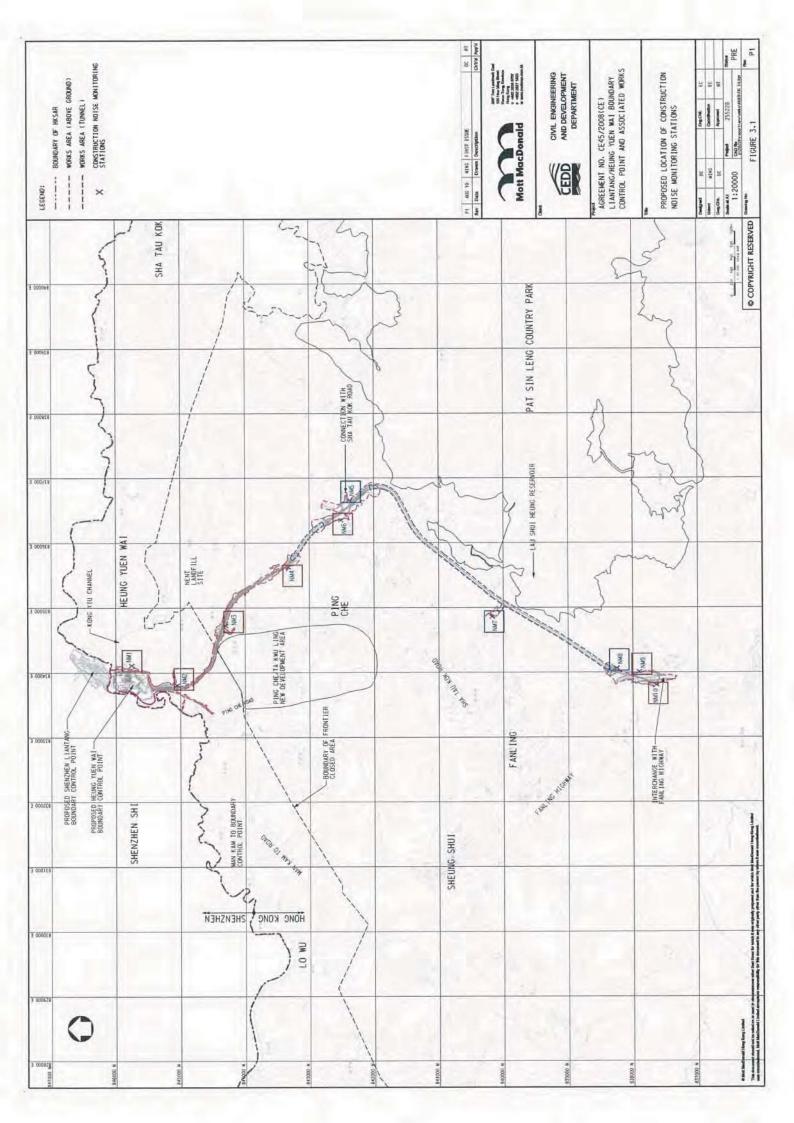
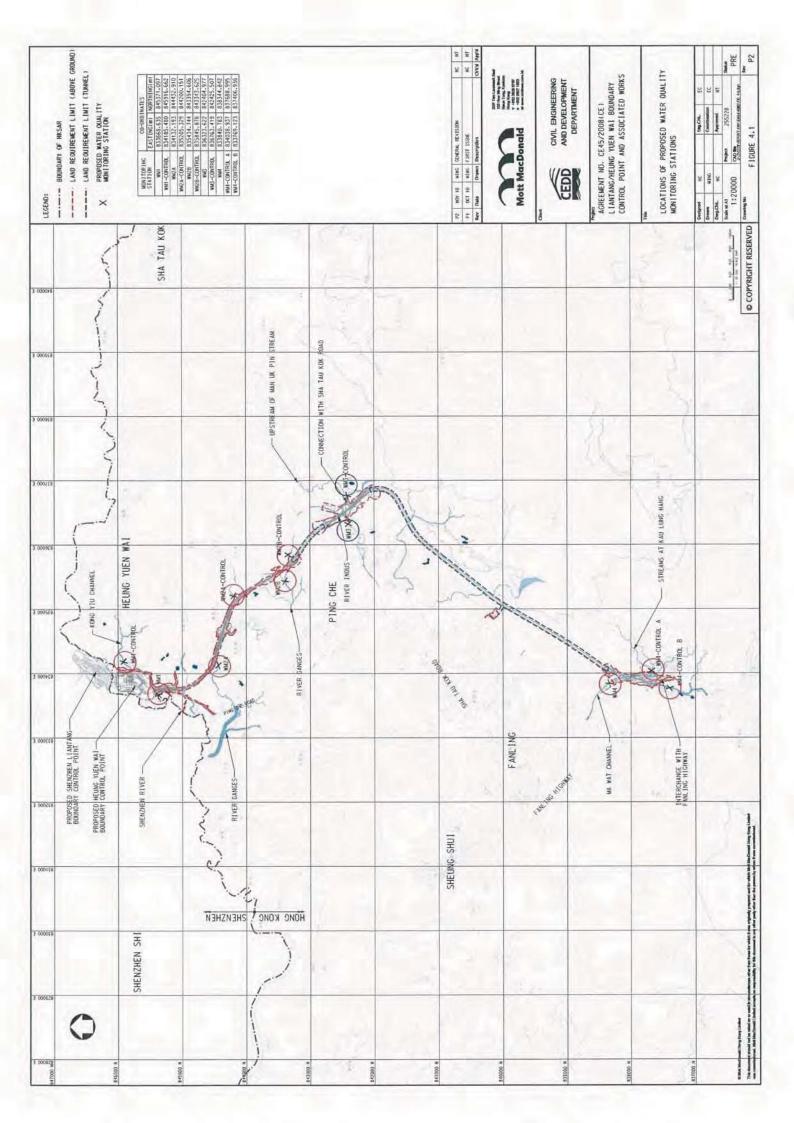
Designated Monitoring Locations as Recommended in the Approved EM&A Manual

3.3.1 The designated monitoring locations as recommended in the *EM&A Manual* are shown in *Appendix C*. As the access to some of the designated monitoring locations was questionable due to safety reason or denied by the landlords, alternative locations therefore have had proposed. The latest alternative monitoring locations has been updated in the revised EM&A Programme (Rev.7) which approved by EPD on 7 April 2017. Besides, in view of Location AM1b was demolished and returned to the landlord on 27 April 2018, alterative location AM1c was proposed by ET. The proposal for alterative location AM1c which verified by IEC on 5 June 2018 submitted to EPD for approval on 6 June 2018. EPD issued comments on 16 July 2018 and the revised proposal was submitted to EPD on 20 August 2018. Further comment was given from EPD on 13 September 2018 and the revised proposal was submitted to EPD on 31 October 2018. *Table 3-2*, *Table 3-3* and *Table 3-4* are respectively listed the air quality, construction noise and water quality monitoring locations for the Project and a map showing these monitoring stations is presented in *Appendix D*.
