JOB No.: TCS00694/13

AGREEMENT NO. CE 45/2008 (CE)  
LIANTANG/HEUNG YUEN WAI  
BOUNDARY CONTROL POINT AND ASSOCIATED WORKS

MONTHLY ENVIRONMENTAL MONITORING AND AUDIT  
REPORT (NO.64) – NOVEMBER 2018

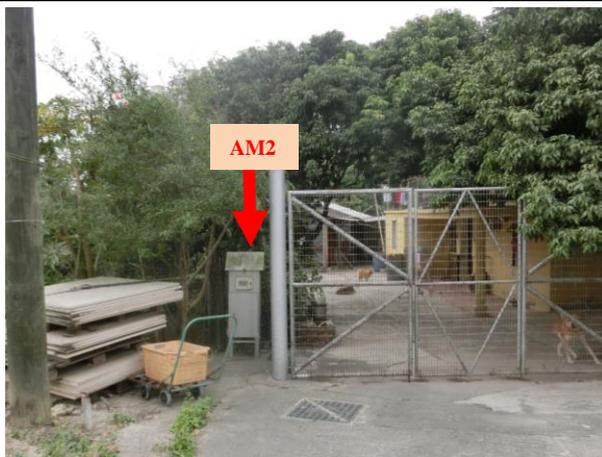
**Photo 1**  
Location AM2 was located in a village house on LMH Road and the closest works area was located on the other side of LMH.

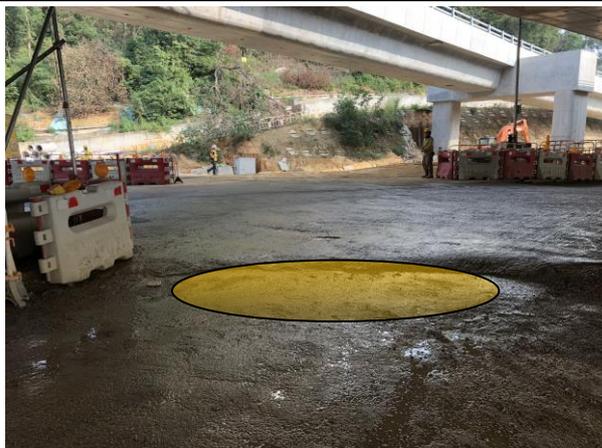
**Photo 2**  
The works area under Contract 6 and Location AM2 was separated by LMH Road. As advised by CCKJV, the number of site vehicles entering and leaving the site through Lin Ma Hang Road was limited in view of the work progress. As observed during site inspection, the main dust source was dominated by traffic dust in LMH Road.

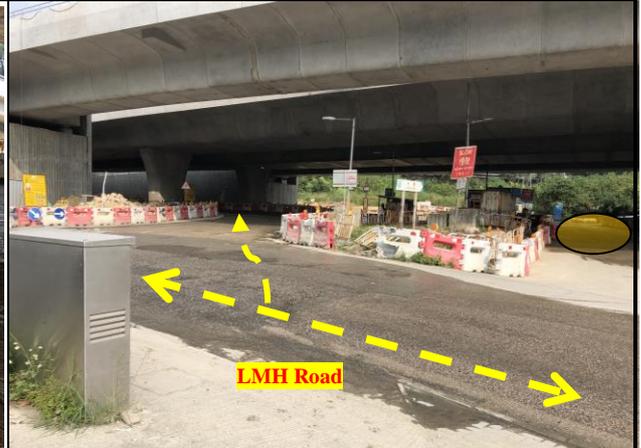
**Photo 3 (Bridge Y exit under LT/C6)**  
Wheel washing facilities were provided on a paved road within works area of Bridge Y. The condition of Bridge Y Site Exit and adjoined LMH road was satisfactory without mud and debris.

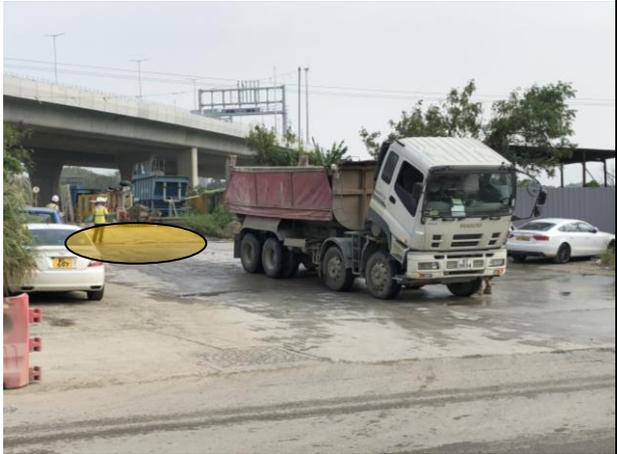
**Photo 4 (Chuk Yuen Road exit under LT/C6)**  
Wheel washing facilities were provided on a paved road within works area of Chuk Yuen Road. The condition of Chuk Yuen Road Site Exit and adjoined LMH road was satisfactory without mud and debris.

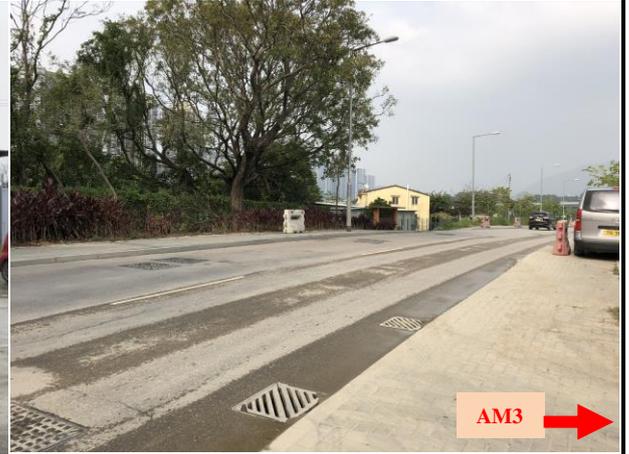
**Photo 5 (Bridge D Site Exit under LT/C6)**

Wheel washing facilities were provided on a paved road within works area of Bridge D. The condition of Bridge D Site Exit and adjoined LMH road was satisfactory without mud and debris.

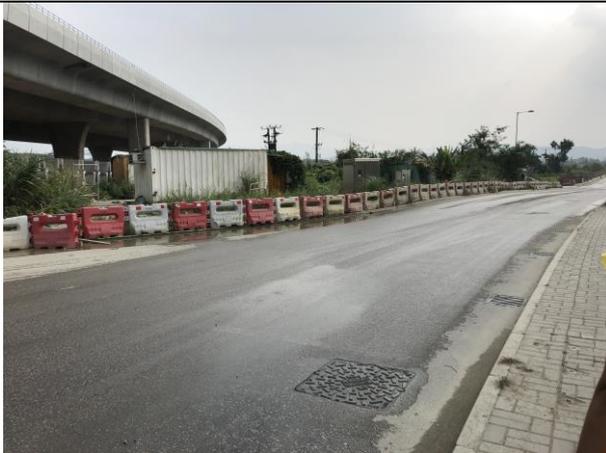
**Photo 6**

No adverse dust impact due to the project work was observed at AM3. Moreover, there were several site exits along LMH Road and maintenance party/ ownership of these site exits were unknown. Fugitive dust was observed when vehicles travelling on the road.

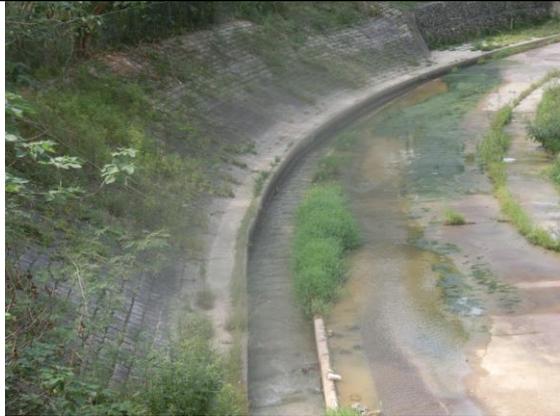
**Photo 1**

On 27 October 2018, the water quality at WM3x was turbid.

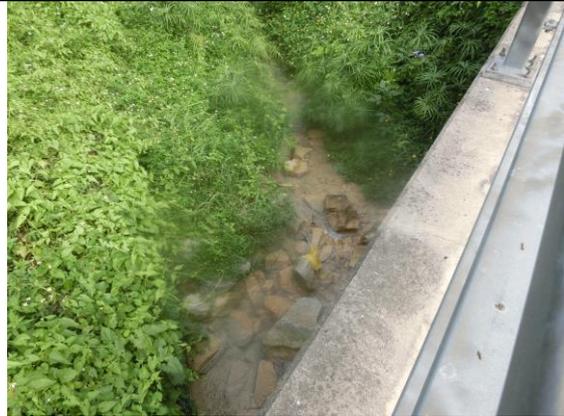
**Photo 2**

During water sampling on 27 October 2018, the water quality flowing at WM3-C was clear.

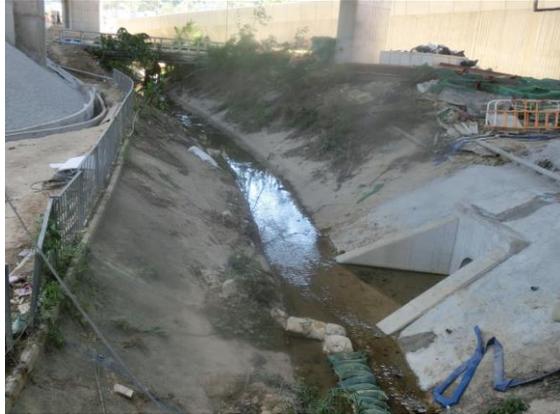
**Photo 3**

Upon detection of exceedance on 27 October 2018, inspection was carried out at the river channel crossing the works area of Contract 6 and it found that water flowing from site area of Contract 6 was clear.

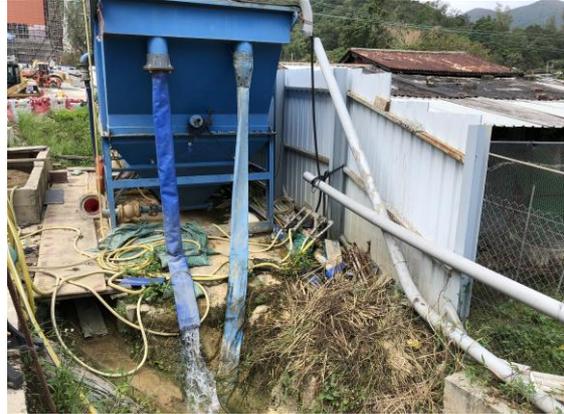
**Photo 4**

Self-checking on performance of wastewater treatment facility was conducted by CCKJV on 27 October 2018 and the discharge was clear.

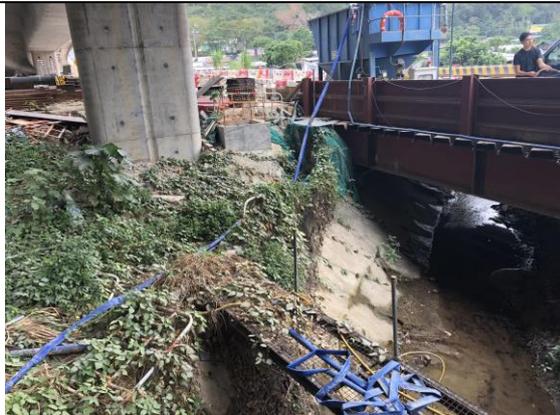
**Photo 5**

Wastewater treatment facilities at South Portal were function properly and the water flowing in river channel within the construction site was visually clear.

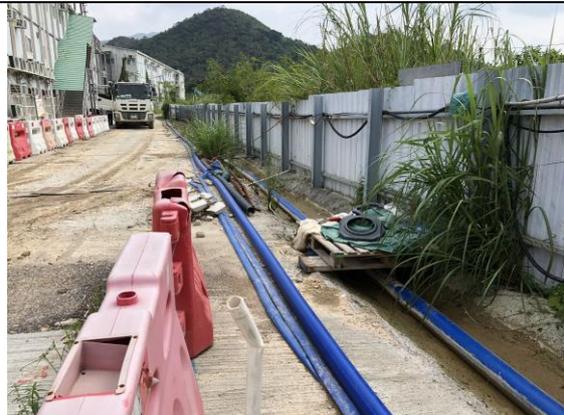
**Photo 6**

Site hoarding with footing sealed was erected at site boundary which adjacent to the stream to minimize the risk of site runoff flowing into the exiting stream.

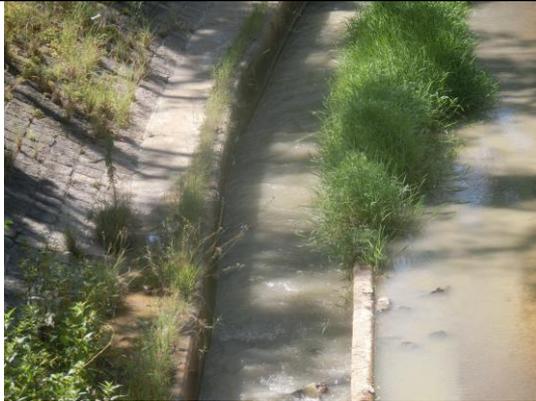
**Photo 1**

On 29 October 2018, the water quality at WM3x was turbid. Moreover, ingress of turbid water was observed from the adjacent access road of the channel.

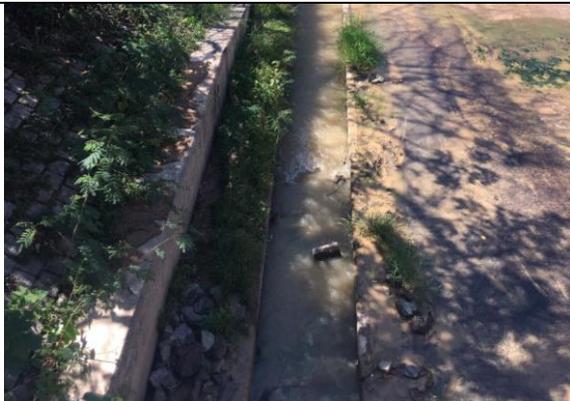
**Photo 2**

During water sampling on 29 October 2018, the water quality flowing at WM3-C was clear.

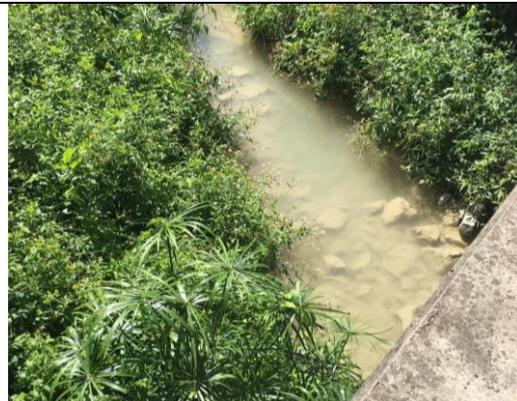
**Photo 3**

On 30 October 2018, the water quality at WM3x was turbid. Moreover, ingress of turbid water was observed from the adjacent access road of the channel.

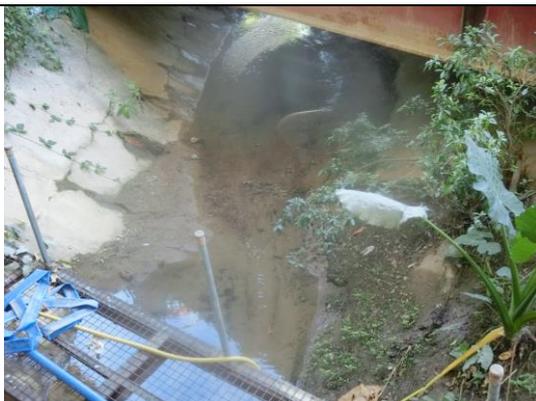
**Photo 4**

During water sampling on 30 October 2018, the water quality flowing at WM3-C was clear.

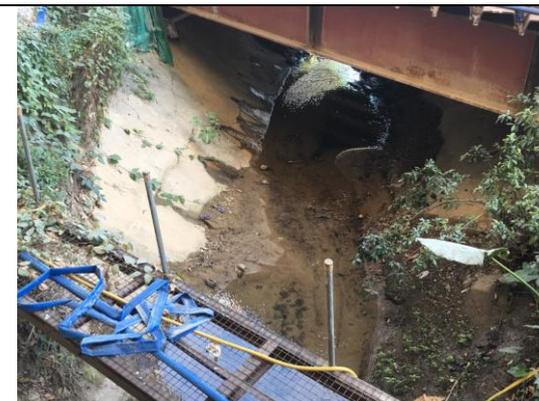
**Photo 6**

Upon detection of exceedance on 30 October 2018, inspection was carried out at the river channel crossing the works area Contract 6 and it found that water flowing from site area of Contract 6 was clear.

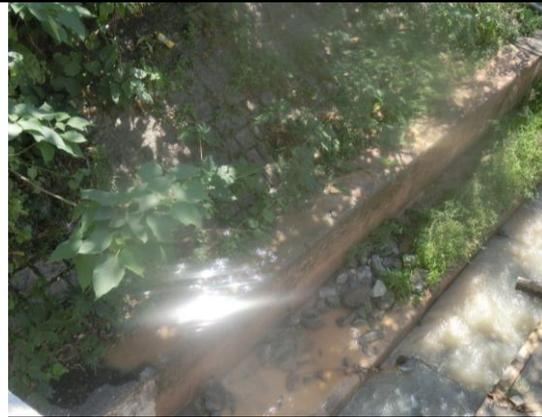
**Photo 7**

As reported by CCKJV, a fresh water supply pipe inside an excavation pit of C6's temporary site near Tai Tong Wu Village was incidentally bursted in the early morning of 29 October 2018 and the leaked water immediately filled up the excavation pit. CCKJV advised that the fresh water supply pipe was owned by WSD and maintenance work has been undertaken by WSD on the same day.

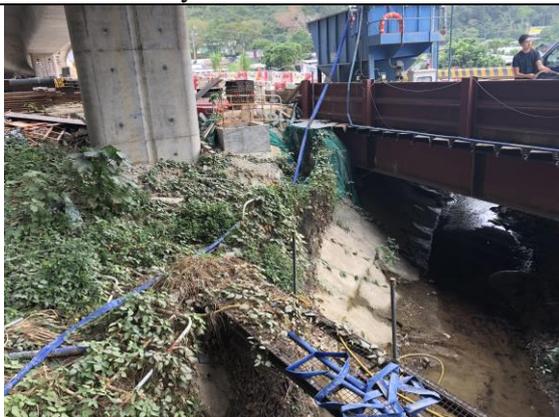
**Photo 8**

Due to large amount of uncontrolled water leakage from the water pipe, turbid water inside the excavation pit was overflowed to the adjoining channel directly. Large amount of turbid water retained at the edge of the adjoining channel which affecting the water quality at WM3x on both 29 and 30 October 2018.

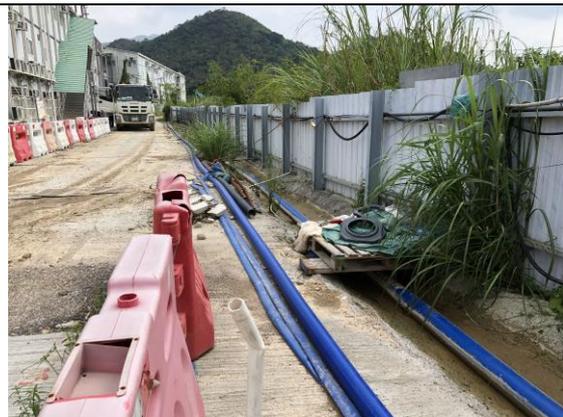
**Photo 10**

Site hoarding with footing sealed was erected at site boundary which adjacent to the stream to minimize the risk of site runoff flowing into the exiting stream.

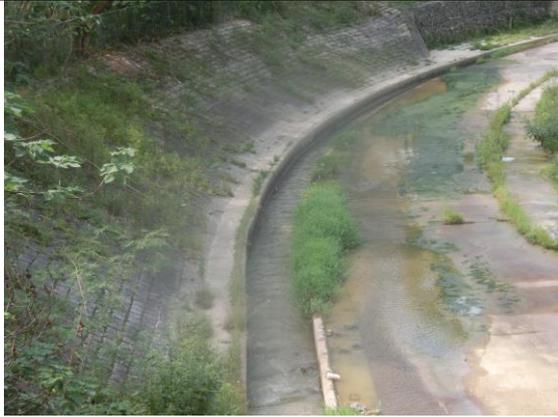
**Photo 1**

On 27 October 2018, the water quality at WM3x was turbid.

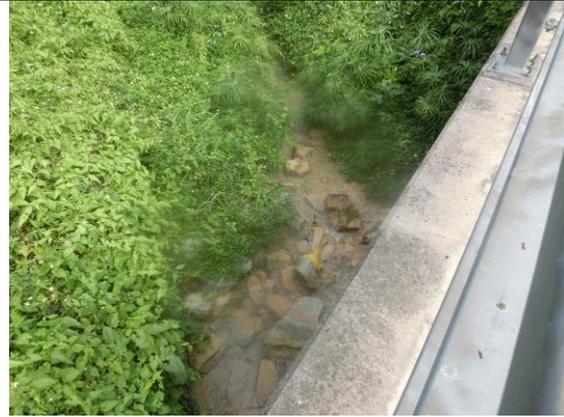
**Photo 2**

During water sampling on 27 October 2018, the water quality flowing at WM3-C was clear.

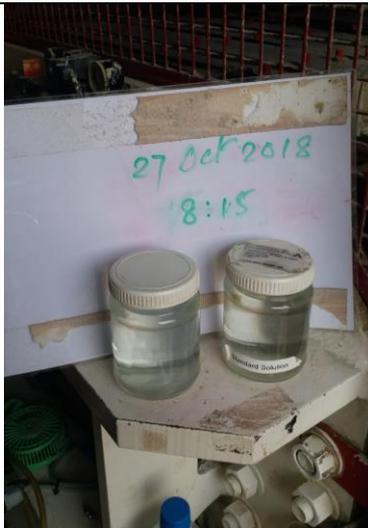
**Photo 3**

DHK conducted self-checking on the effluent quality of wastewater treatment facility at North Portal Site on 27 Oct 2018. DHK reported that the visual test result revealed that the quality of discharge was acceptable under supervision by RE.

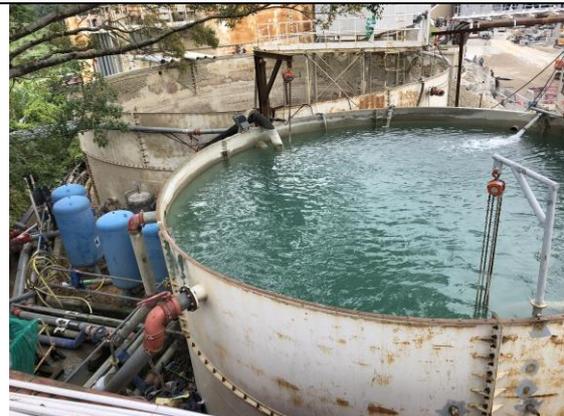
**Photo 4**

During site inspection on 2 November 2018, wastewater treatment facilities were in place at North Portal Site and the effluent quality to be discharge was visually clear.

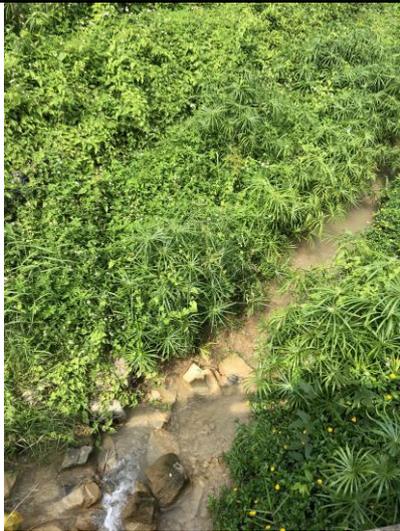
**Photo 5**

The water quality at Loi Tung stream which located at downstream of North Portal Site was visually clear.

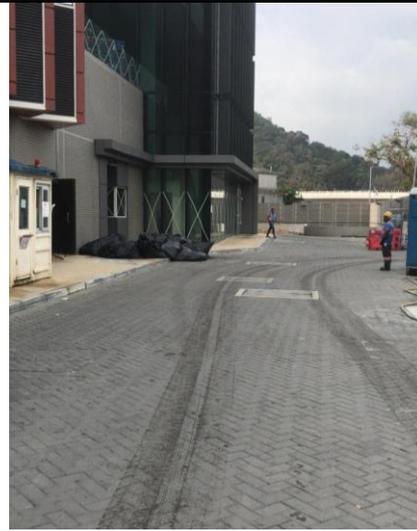
**Photo 6**

At Admin Building Site, the recent condition of site area was hard paved and wastewater generated from the construction works was limited.

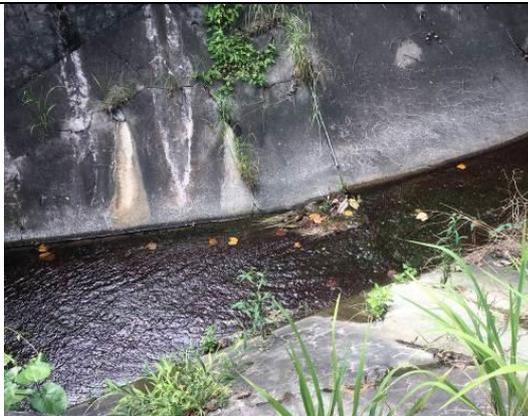
**Photo 7**

At Admin Building Site, the water quality at the adjacent channel was clear.

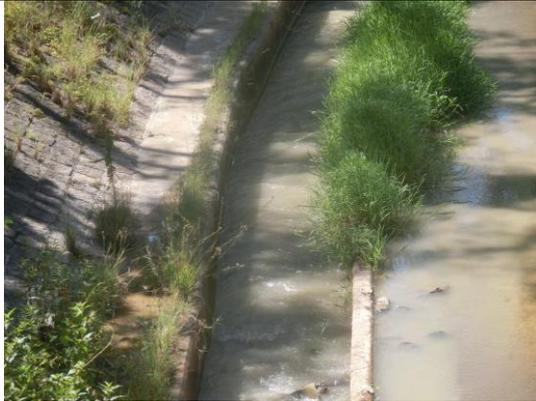
**Photo 1**

On 29 October 2018, the water quality at WM3x was turbid. Moreover, ingress of turbid water was observed from the adjacent access road of the channel.

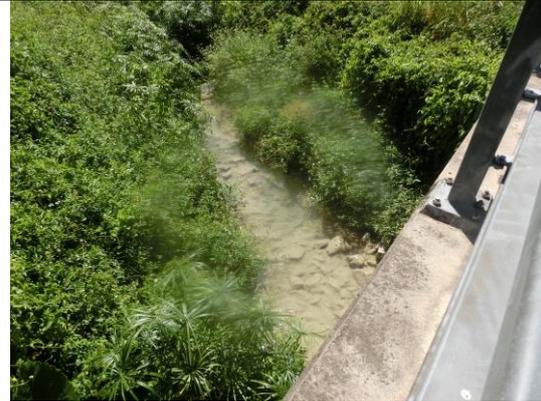
**Photo 2**

During water sampling on 29 October 2018, the water quality flowing at WM3-C was clear.

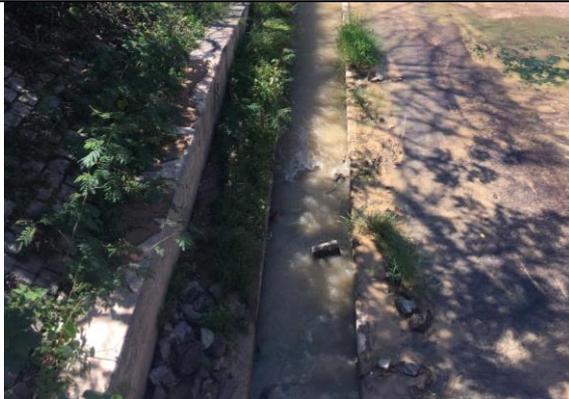
**Photo 3**

On 30 October 2018, the water quality at WM3x was turbid. Moreover, ingress of turbid water was observed from the adjacent access road of the channel.

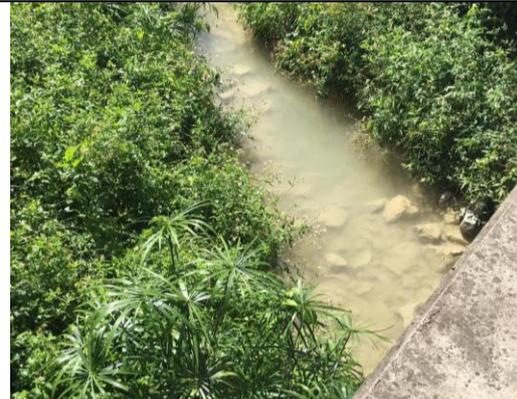
**Photo 4**

During water sampling on 30 October 2018, the water quality flowing at WM3-C was clear.

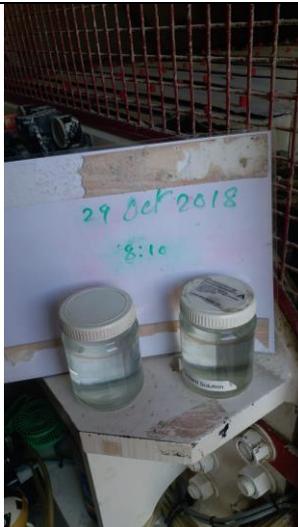
**Photo 5**

DHK conducted self-checking on the effluent quality of wastewater treatment facility at North Portal Site on 29 Oct 2018. DHK reported that the visual test result revealed that the quality of discharge was acceptable under supervision by RE.

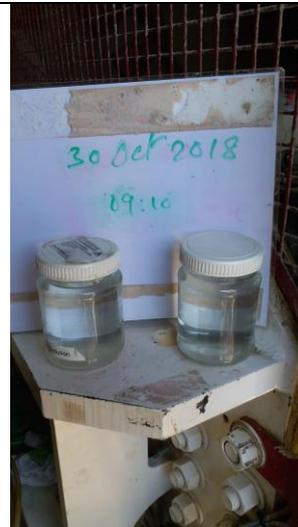
**Photo 6**

DHK conducted self-checking on the effluent quality of wastewater treatment facility at North Portal Site on 30 Oct 2018. DHK reported that the visual test result revealed that the quality of discharge was acceptable under supervision by RE.

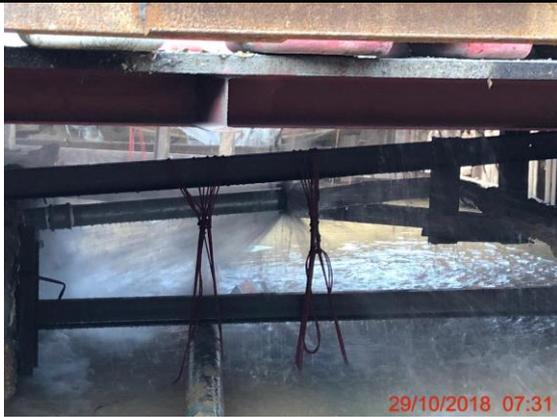
**Photo 7**

As reported by Contractor of C6, a fresh water supply pipe inside an excavation pit of C6's temporary site near Tai Tong Wu Village was incidentally bursted in the early morning of 29 October 2018 and the leaked water immediately filled up the excavation pit. CCKJV advised that the fresh water supply pipe was owned by WSD and maintenance work has been undertaken by WSD on the same day.

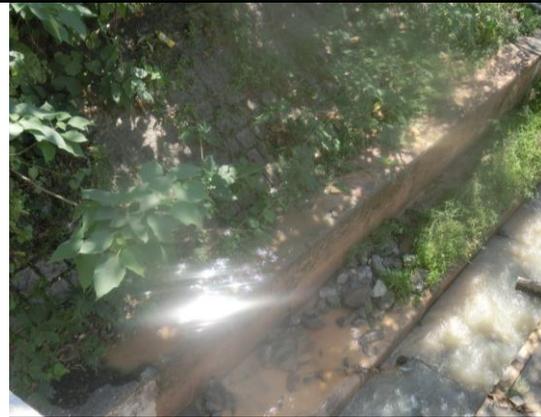
**Photo 8**

Due to large amount of uncontrolled water leakage from the water pipe, turbid water inside the excavation pit was overflowed to the adjoined channel directly. Large amount of turbid water retained at the edge of the adjoined channel which affecting the water quality at WM3x on both 29 and 30 October 2018.

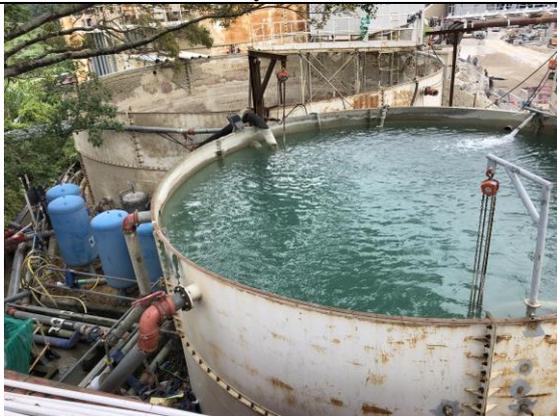
**Photo 9**

During site inspection on 2 November 2018, wastewater treatment facilities were in place at North Portal Site and the effluent quality to be discharge was visually clear.

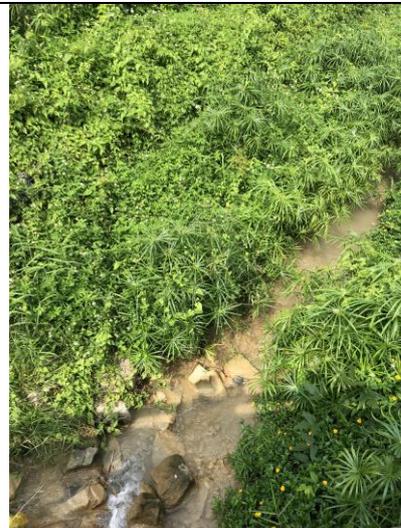
**Photo 10**

The water quality at Loi Tung stream which located at downstream of North Portal Site was visually clear.

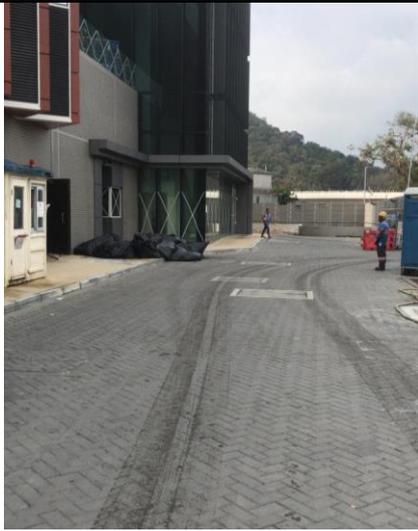
**Photo 11**

At Admin Building Site, the recent condition of site area was hard paved and wastewater generated from the construction works was limited.

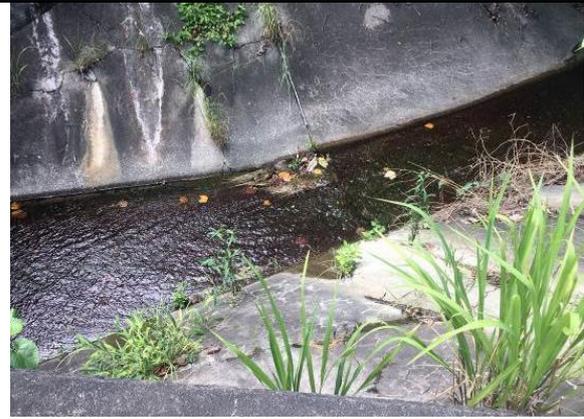
**Photo 12**

At Admin Building Site, the water quality at the adjacent channel was clear.

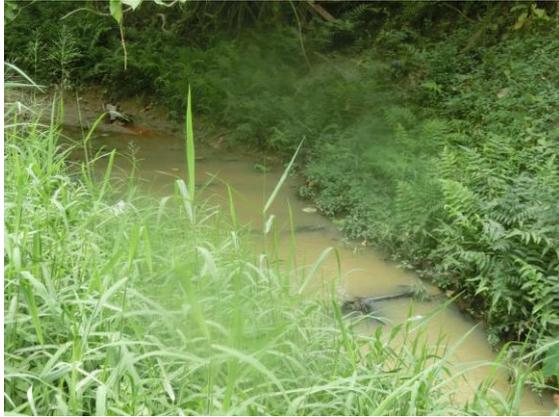
**Photo 1**

On 2 November 2018, muddy water was observed at WM2A(a).

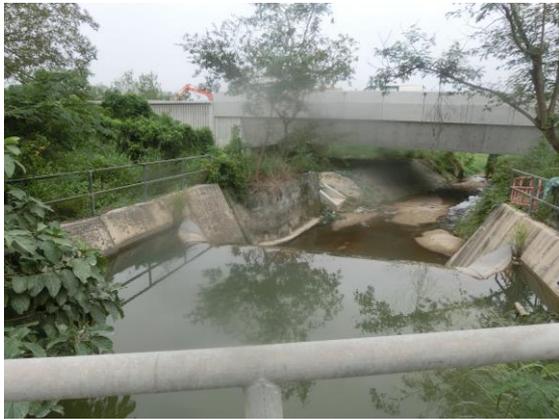
**Photo 2**

On 2 November 2018, the water quality at WM2A-C was clear.

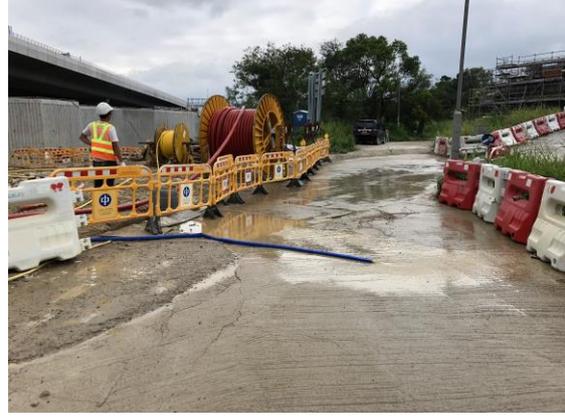
**Photo 4**

During joint site inspection on 18 October 2018, there was a construction area owned by another project discharging turbid water to the stream. As advised by CCKJV, the improper discharge from another project work was happened occasionally.

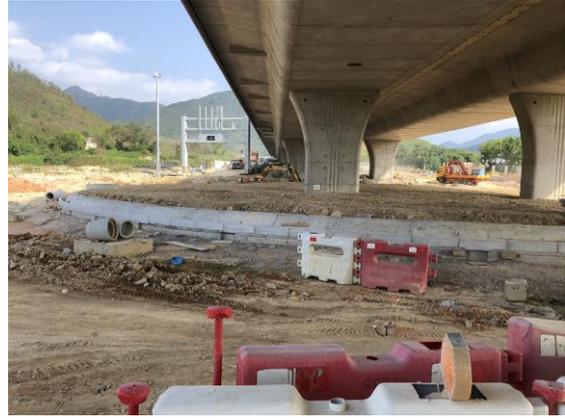
**Photo 6**

Bridge construction work was carried out at Bridge D and wastewater generated from construction works was limited.

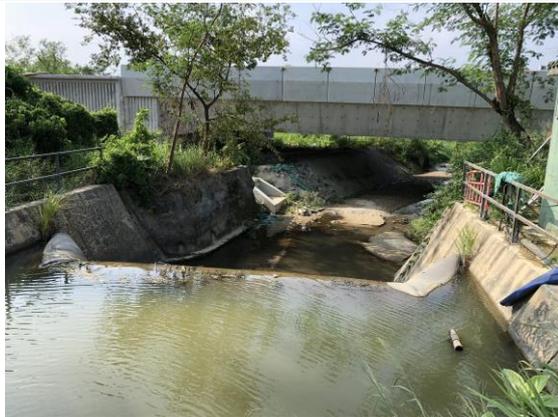
**Photo 7**

During joint site inspection on 1 November 2018, it was observed that the water quality in the existing stream near Nylon Dam was in good condition.

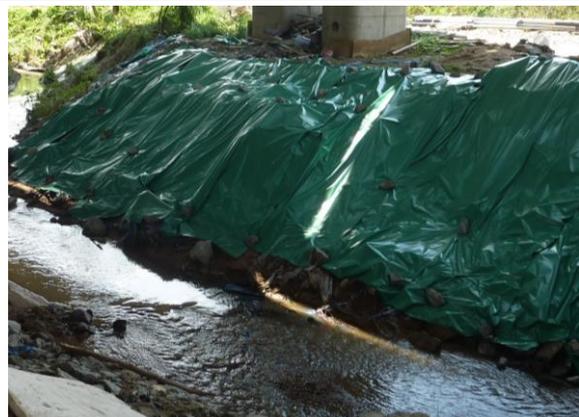
**Photo 8**

Open slopes were covered with tarpaulin sheet as far as practicable to minimize muddy runoff.

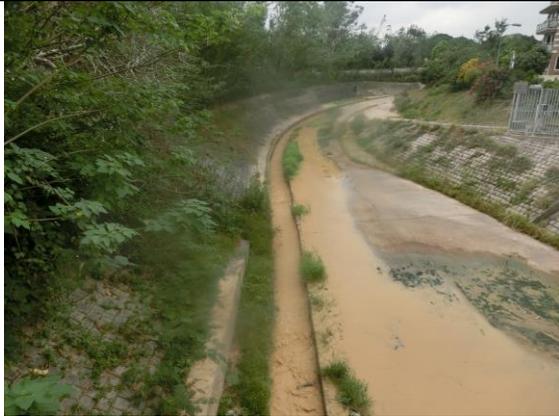
**Photo 1**

On 10 November 2018, muddy water was observed at WM3x.

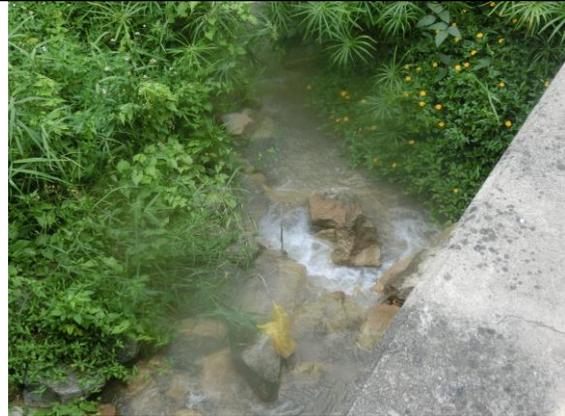
**Photo 2**

During water sampling on 10 November 2018, the water quality flowing at WM3-C was clear.

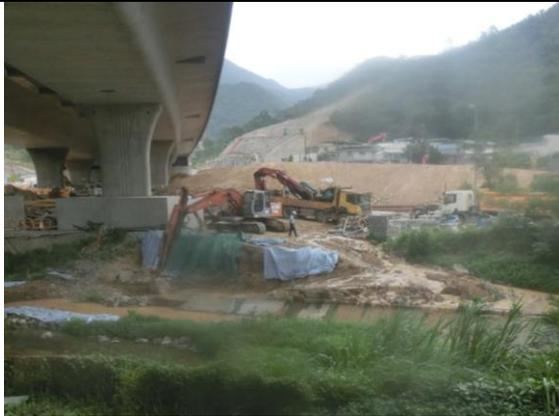
**Photo 3**

As reported by CCKJV, a temporary water supply pipe burst inside Sha Tau Kok Interchange works area in the morning of 10 November 2018. As water quality mitigation measure, the slope adjacent the works area was covered by tarpaulin sheet to minimize muddy runoff. As remedial action, CCKJV immediately diverted the muddy water to the nearby wastewater treatment facility.

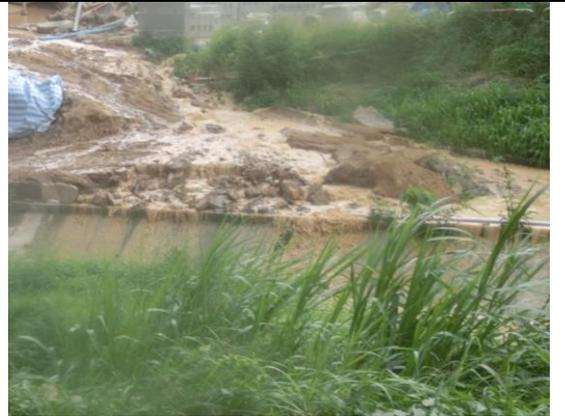
**Photo 4**

The capacity of wastewater treatment facility was insufficient to cater unexpected large amount of muddy water generated by the incident, some uncontrolled leaked water from the burst pipe washed out the soil surface of the site and led to large amount of muddy water gushed down to the adjacent channel.

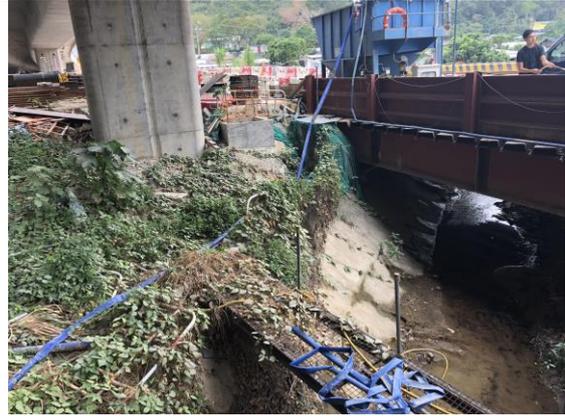
**Photo 6**

Wastewater treatment facilities at South Portal were function properly and the water flowing in river channel within the construction site was visually clear.

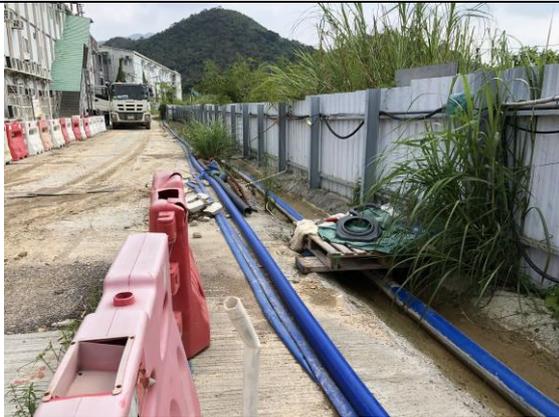
**Photo 7**

Site hoarding with footing sealed was erected at site boundary which adjacent to the stream to minimize the risk of site runoff flowing into the exiting stream.

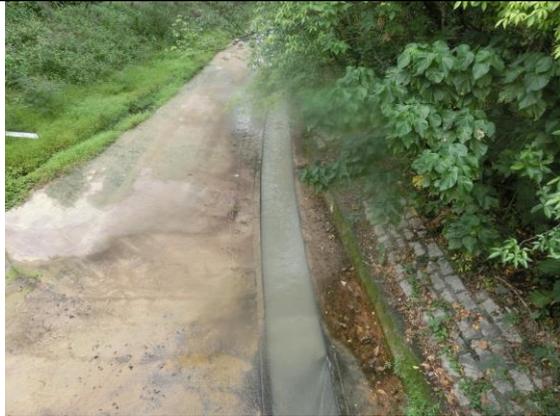
**Photo 1**

On 17 November 2018, turbid water was observed at WM3x.

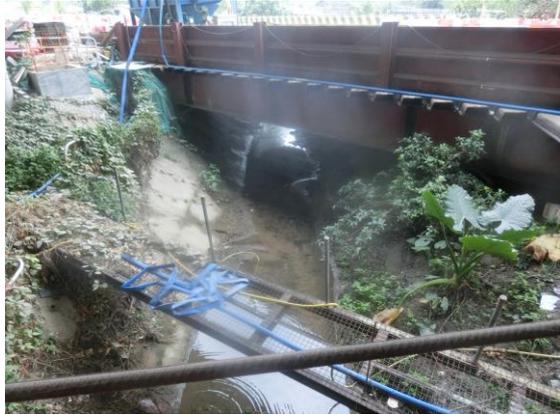
**Photo 3**

Upon detection of the exceedance on 17 November 2018, inspection was carried out at the river channel crossing the works area of Contract 6 and it found that water flowing from site area of Contract 6 was clear.

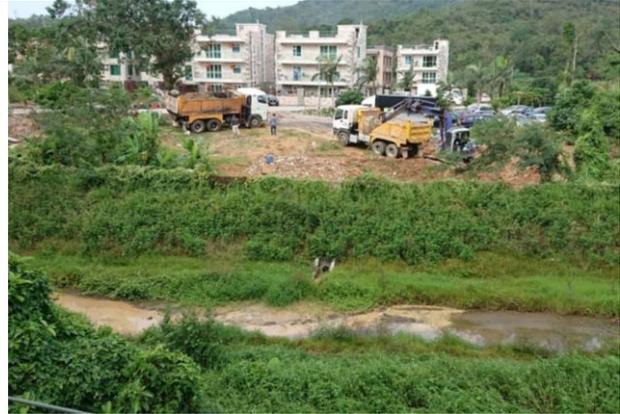
**Photo 4**

During water monitoring on 17 November 2018, it was observed that earthwork was carried out in Tai Tong Wu Village by other party and ingress of muddy water was from an outfall of Tai Tong Wu was observed.

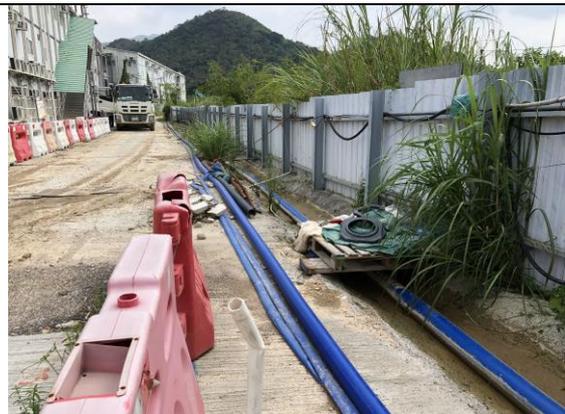
**Photo 6**

Site hoarding with footing sealed was erected at site boundary which adjacent to the stream to minimize the risk of site runoff flowing into the exiting stream.

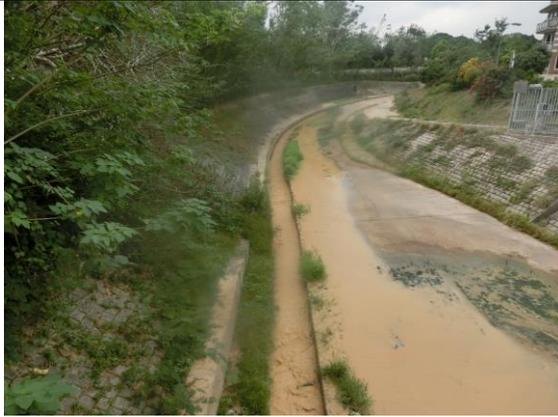
**Photo 1**

On 10 November 2018, muddy water was observed at WM3x.

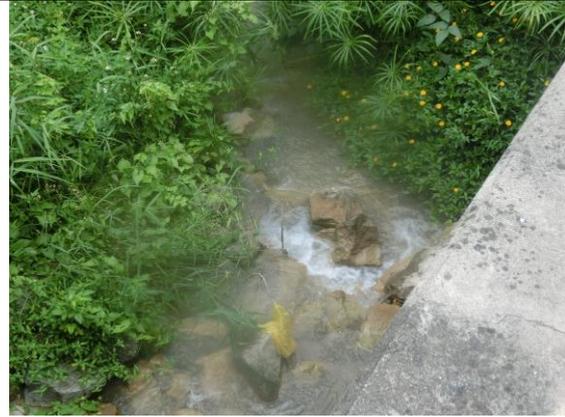
**Photo 2**

During water sampling on 10 November 2018, the water quality flowing at WM3-C was clear.

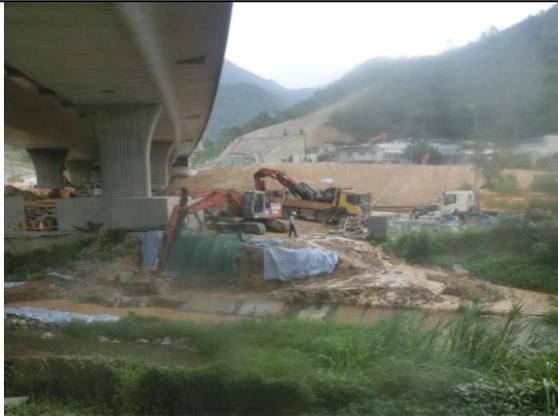
**Photo 3**

As reported by CCKJV, a temporary water supply pipe burst inside Sha Tau Kok Interchange works area in the morning of 10 November 2018. As water quality mitigation measure, the slope adjacent the works area was covered by tarpaulin sheet to minimize muddy runoff. As remedial action, CCKJV immediately diverted the muddy water to the nearby wastewater treatment facility.

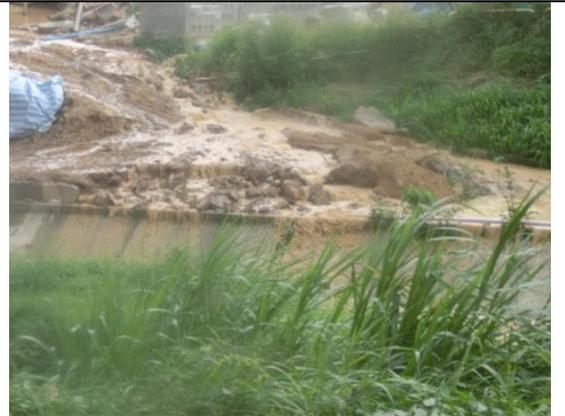
**Photo 4**

The capacity of wastewater treatment facility was insufficient to cater unexpected large amount of muddy water generated by the incident, some uncontrolled leaked water from the burst pipe washed out the soil surface of the site and led to large amount of muddy water gushed down to the adjacent channel.

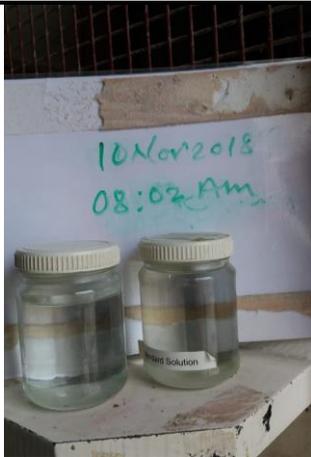
**Photo 5**

DHK conducted self-checking on the effluent quality of wastewater treatment facility at North Portal Site on 10 November 2018. DHK reported that the visual test result revealed that the quality of discharge was acceptable under supervision by RE.

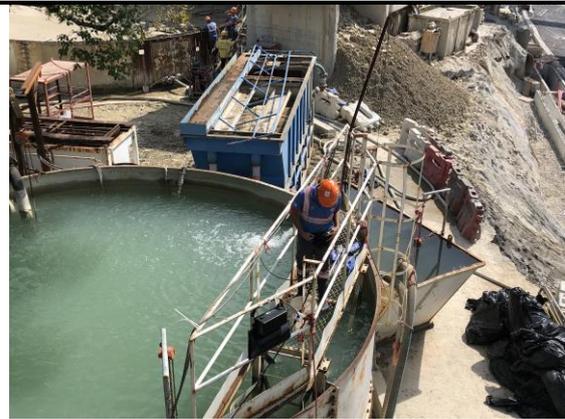
**Photo 6**

During site inspection on 9 November 2018, wastewater treatment facilities were in place at North Portal Site and the effluent quality to be discharge was visually clear.

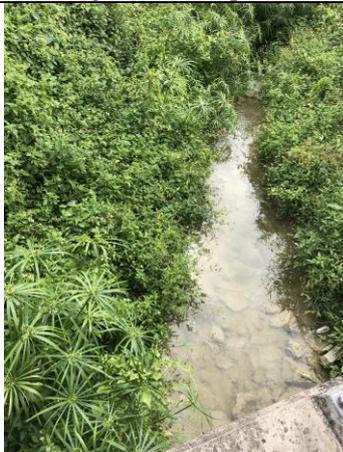
**Photo 7**

The water quality at Loi Tung stream which located at downstream of North Portal Site was visually clear.

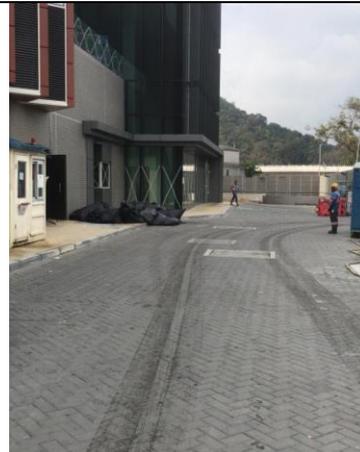
**Photo 8**

At Admin Building Site, the recent condition of site area was hard paved and wastewater generated from the construction works was limited.

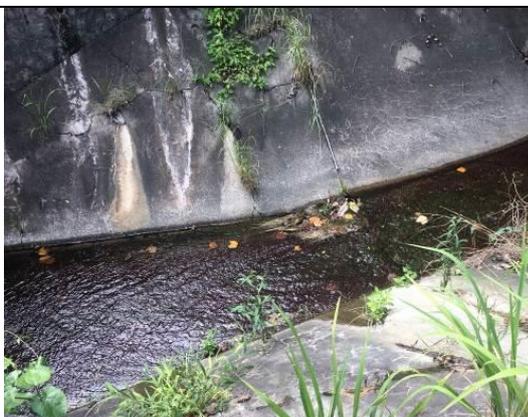
**Photo 9**

At Admin Building Site, the water quality at the adjacent channel was clear.

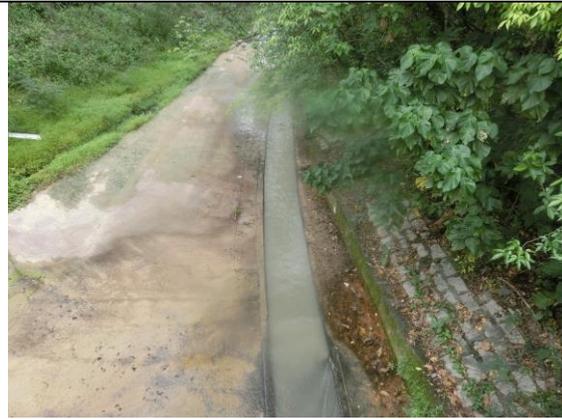
**Photo 1**

On 17 November 2018, turbid water was observed at WM3x.

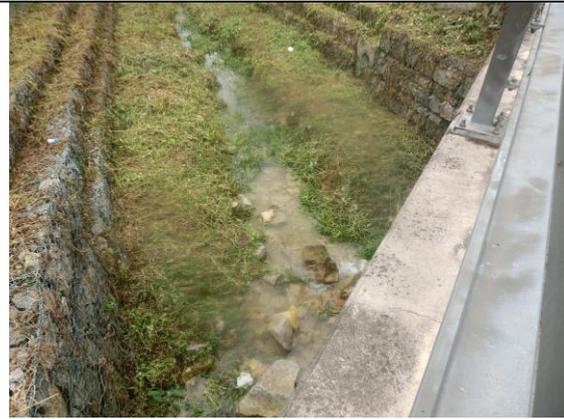
**Photo 2**

During water sampling on 17 November 2018, the water quality flowing at WM3-C was clear.

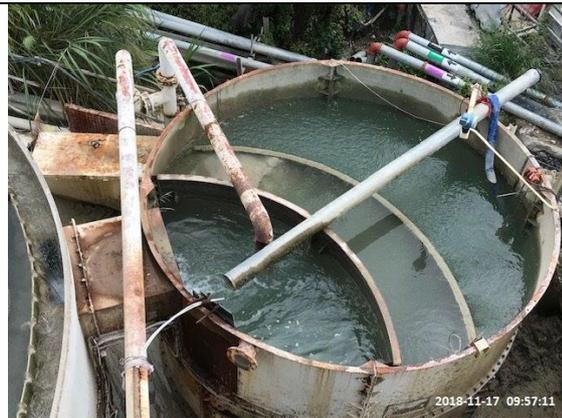
**Photo 3**

DHK conducted self-checking on the effluent quality of wastewater treatment facility at North Portal Site on 17 November 2018 and the quality of treated water was clear. No adverse comment from AECOM's daily inspection

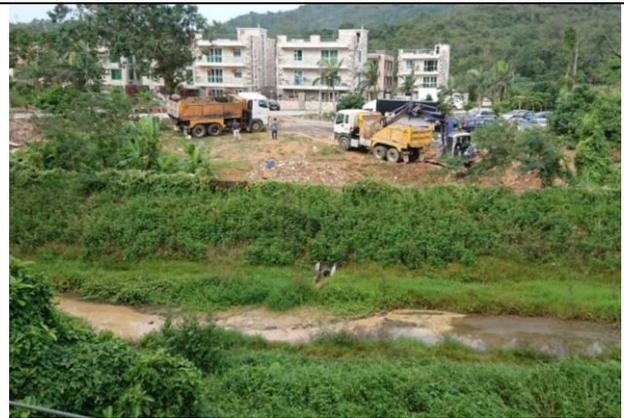
**Photo 4**

During water monitoring on 17 November 2018, it was observed that earthwork was carried out in Tai Tong Wu Village and ingress of muddy water was from an outfall of Tai Tong Wu was observed.

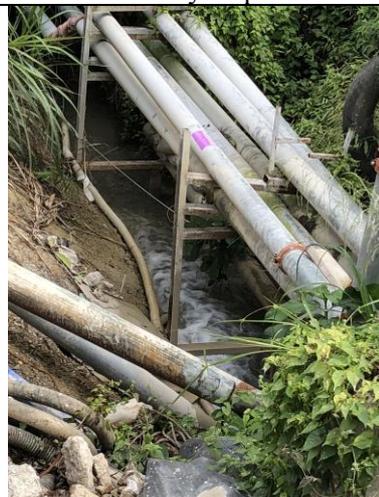
**Photo 5**

During site inspection on 16 November 2018, wastewater treatment facilities were in place at North Portal Site and the effluent quality was visually clear.

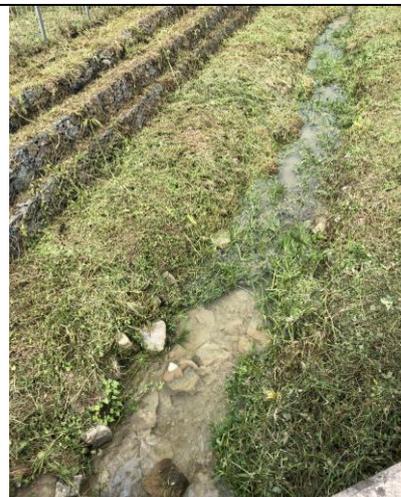
**Photo 6**

The water quality at Loi Tung stream which located at downstream of North Portal Site was visually clear.

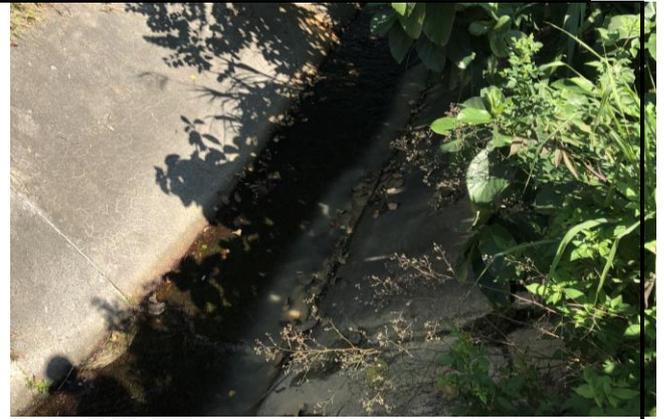
**Photo 8**

At Admin Building Site, the water quality at the adjacent channel was clear.

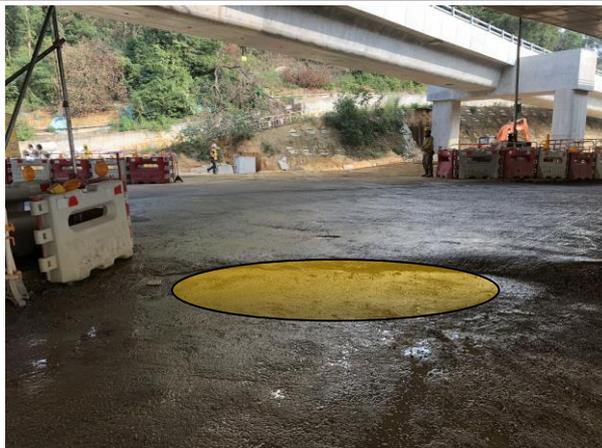
**Photo 3 (Bridge Y exit under LT/C6)**  
Wheel washing facilities were provided on a paved road within works area of Bridge Y. The condition of Bridge Y Site Exit and adjoined LMH road was satisfactory without mud and debris.

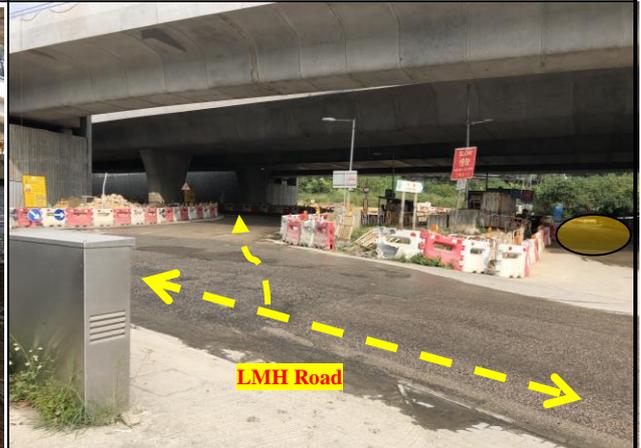
**Photo 4 (Chuk Yuen Road exit under LT/C6)**  
Wheel washing facilities were provided on a paved road within works area of Chuk Yuen Road. The condition of Chuk Yuen Road Site Exit and adjoined LMH road was satisfactory without mud and debris.

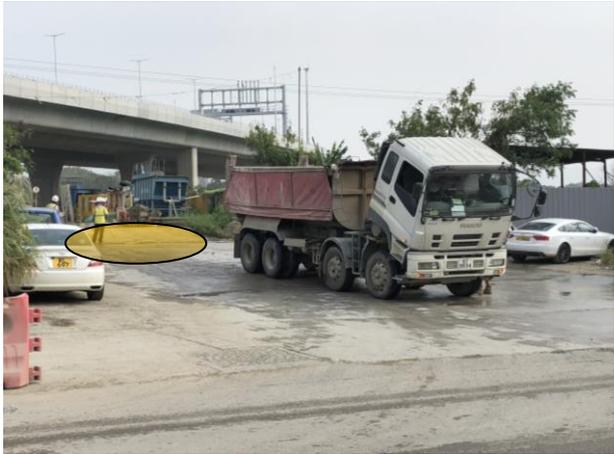
**Photo 5 (Bridge D Site Exit under LT/C6)**

Wheel washing facilities were provided on a paved road within works area of Bridge D. The condition of Bridge D Site Exit and adjoined LMH road was satisfactory without mud and debris.

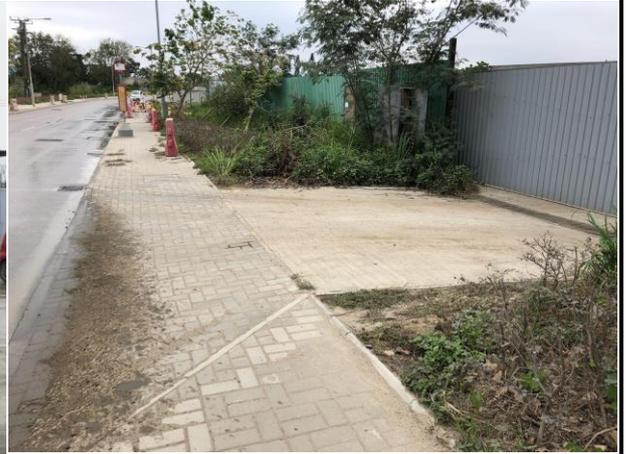
**Photo 6**

There were several site exits along LMH Road and maintenance party/ ownership of these site exits were unknown. Fugitive dust was observed when vehicles travelling on the road.

<p>vehicles apart from the project using LMH Road which causing traffic dust problem especially during dry season.</p> <p>(e) As advised by CCKJV, road bowser for water spraying on LMH Road was carried out in every normal working day as dust suppressive measure. The LMH Road was maintained wet and no fugitive dust was observed during vehicles travelling. <b>(Photos 9 &amp; 10)</b> Moreover, road sweeper would also deploy on LMH Road in order to remove debris and gravels on road surface and minimize generation of muddy water during rain. The route of water tanker and road sweeper are fully covered the works area of LT/C6 which shown in <b>Figure 1</b>.</p> <p>3. In our investigation, CCKJV has implemented dust mitigation measures to control the dust generated under the Project and there was no adverse dust impact observed during site inspection. Since there were many other heavy vehicles apart from the project using LMH Road, it is considered that the major dust source leaded to the TSP exceedance was the traffic dust along Lin Ma Hang Road and unlikely due to the works under Contract works.</p> <p>4. The Contractor should fully implement the dust mitigation measures as recommended in the implementation schedule for environmental mitigation measures in the EM&amp;A Manual.</p>

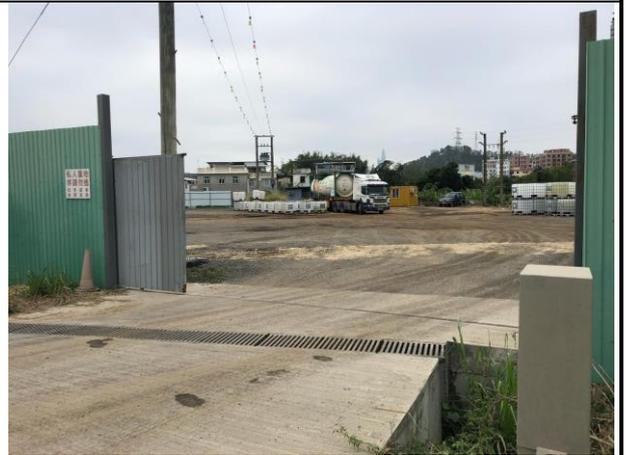
**Photo 8**

There were several site exits along LMH Road and maintenance party/ ownership of these site exits were unknown. Fugitive dust was observed when vehicles travelling on the road.

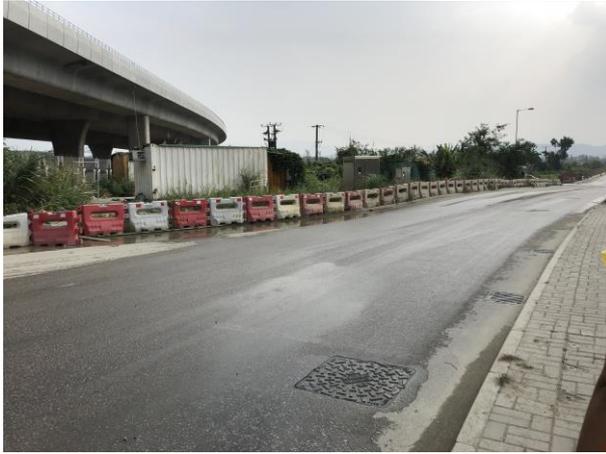
**Photo 9**

Road bowser for water spraying on LMH Road was observed as dust suppressive measure. The LMH Road was maintained wet and no fugitive dust was observed during vehicles travelling.

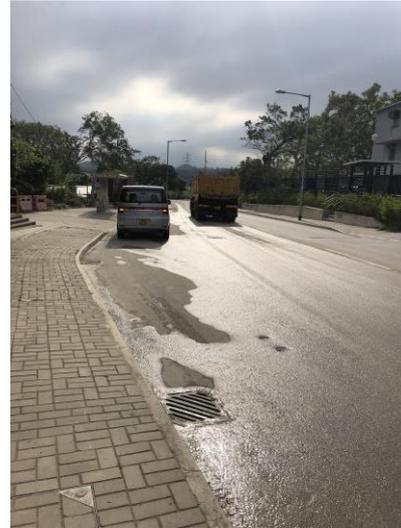
**Photo 10**

Road bowser for water spraying on LMH Road was observed as dust suppressive measure. The LMH Road was maintained wet and no fugitive dust was observed during vehicles travelling.
