**AGREEMENT NO. CE 45/2008 (CE)
LIANTANG/HEUNG YUEN WAI
BOUNDARY CONTROL POINT AND ASSOCIATED WORKS**

**MONTHLY ENVIRONMENTAL MONITORING AND AUDIT
REPORT (NO.66) – JANUARY 2019**

**PREPARED FOR
CIVIL ENGINEERING AND DEVELOPMENT DEPARTMENT
(CEDD)**

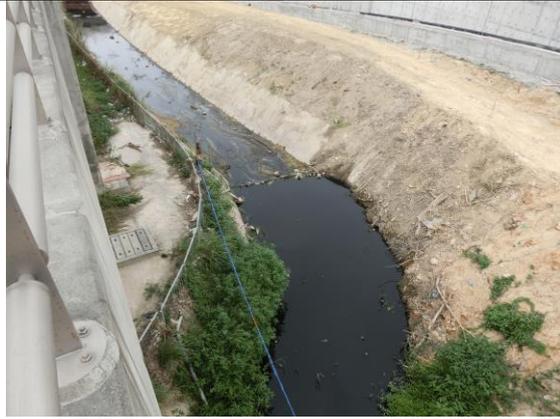
**Photo 1**

On 9 January 2019, black water was observed at Impact Station WM1.

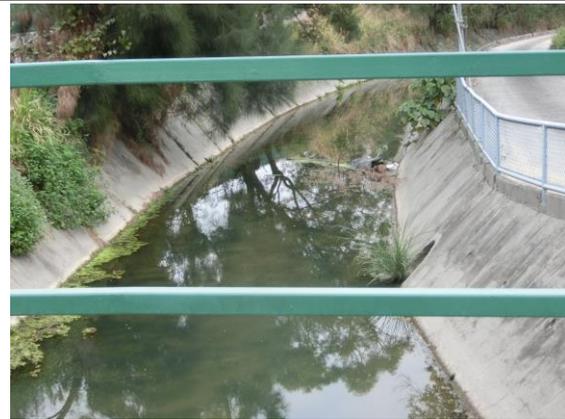
**Photo 2**

On 9 January 2019, the water observed at WM1-C was clear.

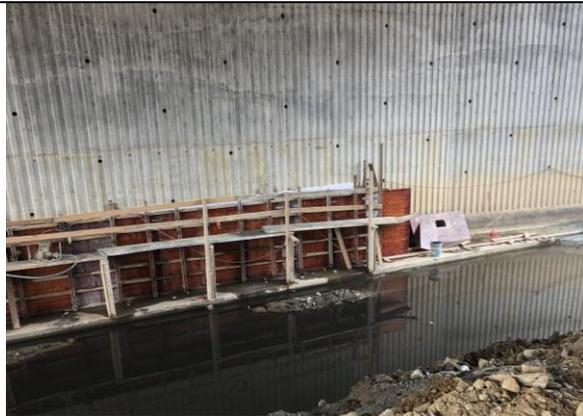
**Photo 3**

During site inspection on 10 January 2019, accumulation of black water was observed in the existing stream adjacent to the site area of Bridge Y.

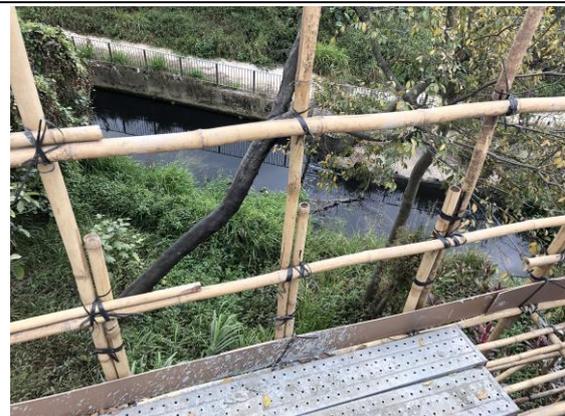
**Photo 4**

Black water was also observed at upstream of the construction site. The source of black water was unknown.

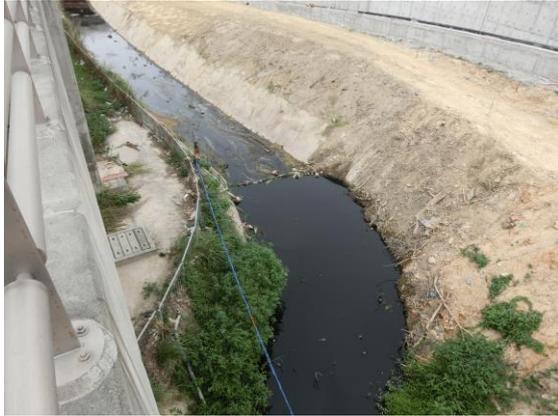
Photo 1
On 9 January 2019, black water was observed at Impact Station WM1.

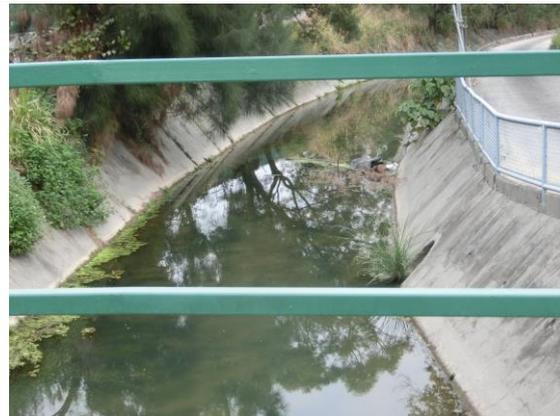
Photo 2
On 9 January 2019, the water observed at WM1-C was clear.

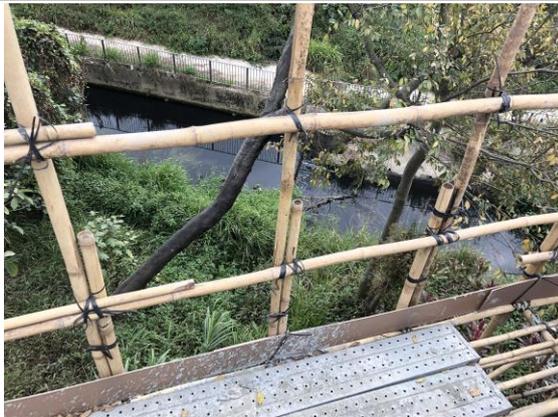
Photo 3
Black water was also observed at upstream of the construction site. The source of black water was unknown.

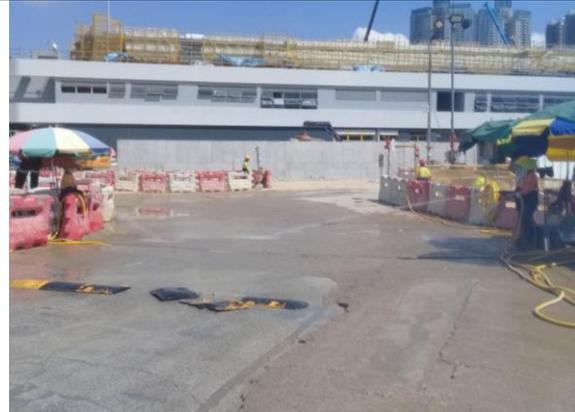
Photo 4
During site inspection on 9 January 2019, wheel washing facility was implemented at the site exit, a ditch was constructed to collect the wastewater generated by wheel washing for recycling purpose.

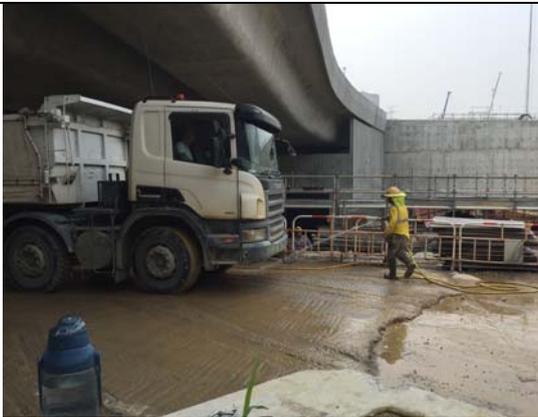
Photo 3

During site inspection on 23 August 2018, wheel washing was observed carried out on the hard paved road before the site exit of Bridge Y.

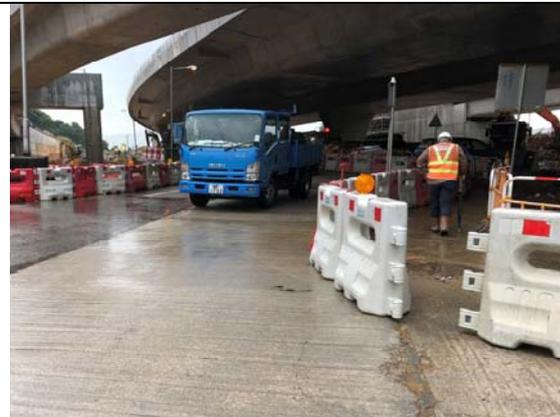
Photo 4

Silt observed near water-filled barriers at works area of Bridge Y had rectified by the CCKJV after the site inspection on 23 August 2018.

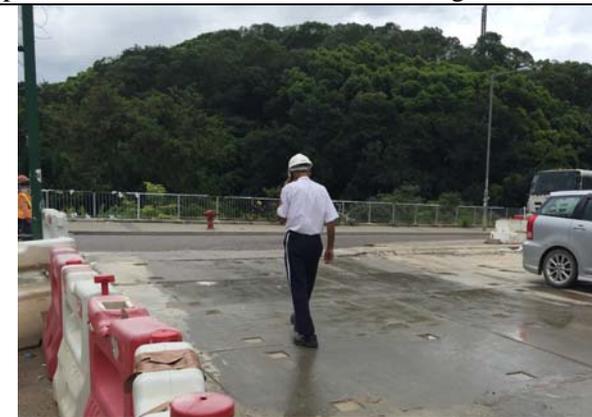
Photo 5

According to the joint site inspection by RE, Leighton and ET on 29 August 2018, the condition of site exit Gate 3 was kept clear of mud and no muddy trails were observed.

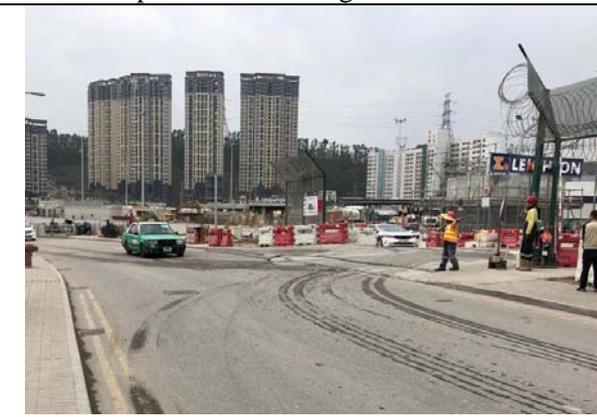
Photo 6

During site visit on 7 January 2019, wheel washing facilities were provided for Gate 3 by Leighton without muddy trail. The cleanliness of the adjoined LMH Road was also in good condition without mud and slurry.

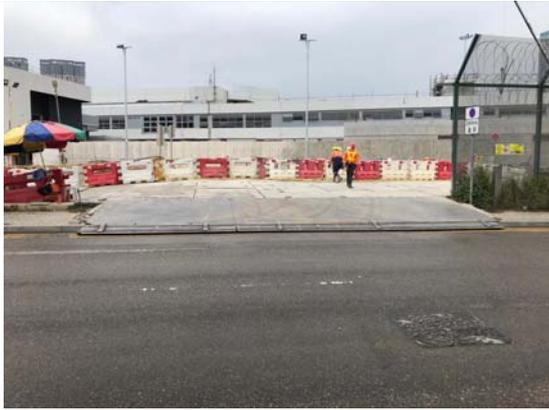
Photo 7

During site visit on 7 January 2019, wheel washing facilities were provided for Gate 2 by Leighton without muddy trail. The cleanliness of the adjoined LMH Road was also in good condition without mud and slurry.

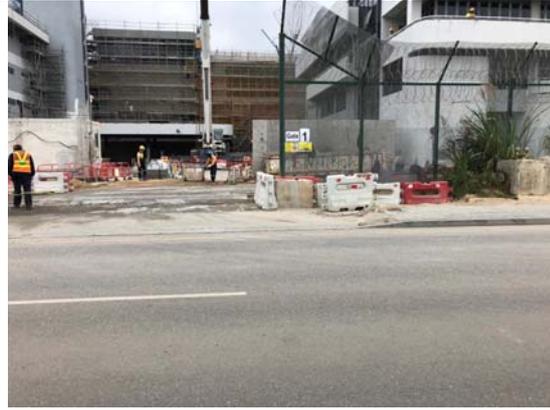
Photo 8

During site visit on 7 January 2019, wheel washing facilities were provided for Gate 1 by Leighton without muddy trail. The cleanliness of the adjoined LMH Road was also in good condition without mud and slurry.

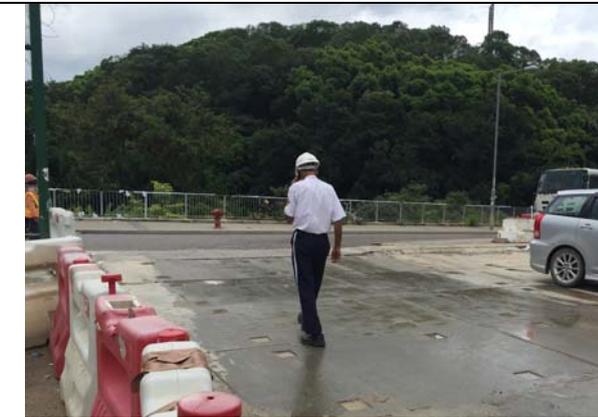
Photo 4

According to the joint site inspection by Ronald Lu, Leighton and ET on 29 August 2018, the condition of site exit Gate 3 was kept clear of mud and no muddy trails were observed.

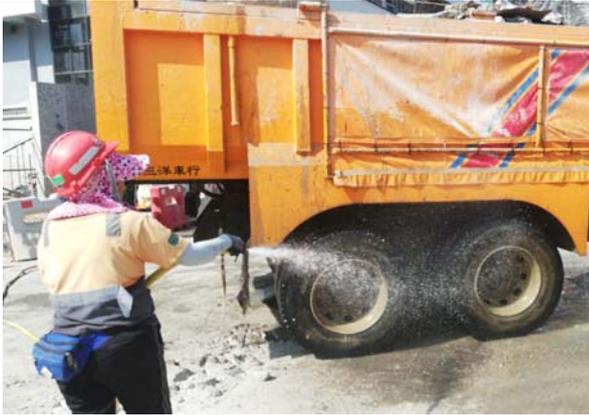
Photo 5
Manual wheel washing was provided at site exit at Gate 1.

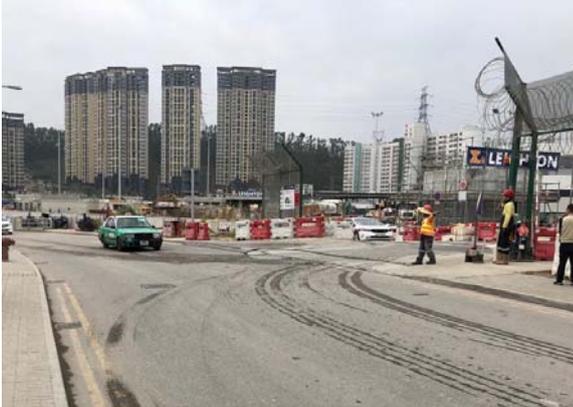
Photo 7
During site visit on 7 January 2019, wheel washing facilities were provided for Gate 3 by Leighton without muddy trail. The cleanliness of the adjoined LMH Road was also in good condition without mud and slurry.

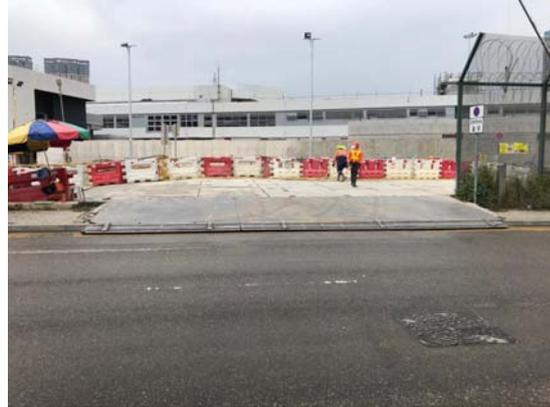
Photo 8
During site visit on 7 January 2019, wheel washing facilities were provided for Gate 2 by Leighton without muddy trail. The cleanliness of the adjoined LMH Road was also in good condition without mud and slurry.

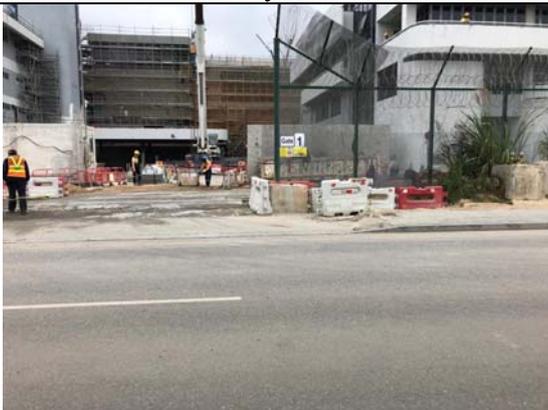
Photo 9
During site visit on 7 January 2019, wheel washing facilities were provided for Gate 1 by Leighton without muddy trail. The cleanliness of the adjoined LMH Road was also in good condition without mud and slurry.
