AGREEMENT NO. CE 45/2008 (CE)
LIANTANG/HEUNG YUEN WAI
BOUNDARY CONTROL POINT AND ASSOCIATED WORKS

MONTHLY ENVIRONMENTAL MONITORING AND AUDIT REPORT (NO.36) – JULY 2016

PREPARED FOR
CIVIL ENGINEERING AND DEVELOPMENT DEPARTMENT (CEDD)

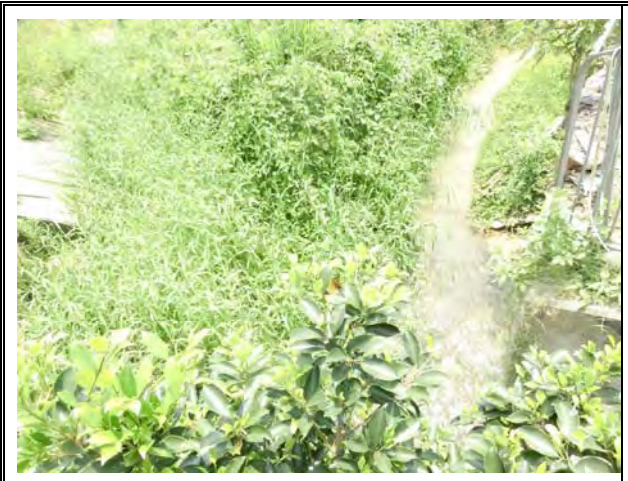
Photo 1
On 8 July 2016, it was observed that water at WM2B was slightly turbid.
