JOB NO.: TCS00694/13

AGREEMENT NO. CE 45/2008 (CE)
LIANTANG/HEUNG YUEN WAI
BOUNDARY CONTROL POINT AND ASSOCIATED WORKS

MONTHLY ENVIRONMENTAL MONITORING AND AUDIT REPORT (NO.61) – AUGUST 2018

PREPARED FOR
CIVIL ENGINEERING AND DEVELOPMENT DEPARTMENT (CEDD)

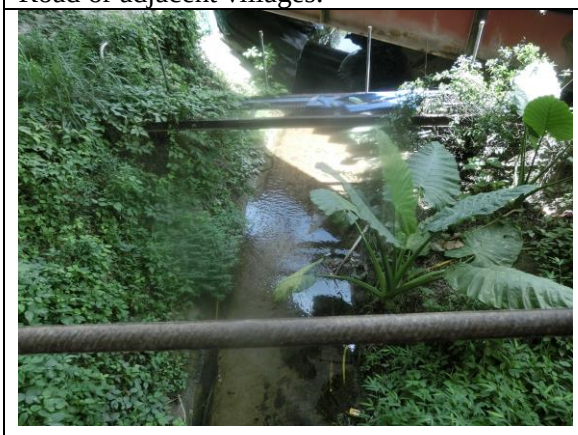
Photo 3
Inspection was carried out at the river channel crossing of works area of Contract 6 on 30 July 2018 and it was observed that water flowing from site area of Contract 6 was clear.

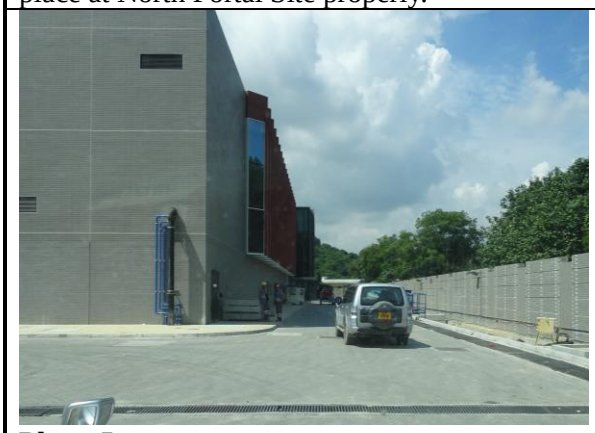
Photo 5
At Admin Building Site, the recent condition of site area was hard paved and wastewater generated from the construction works was limited.

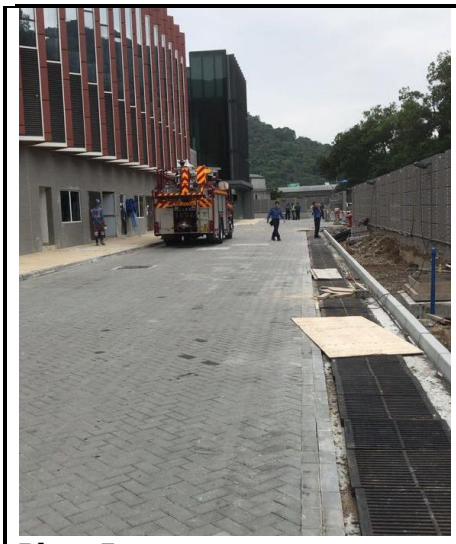
**Photo 7** At Admin Building Site, the recent condition of site area was hard paved and wastewater generated from the construction works was limited.	 **Photo 8** At Admin Building Site, the water quality at the adjacent channel was clear.

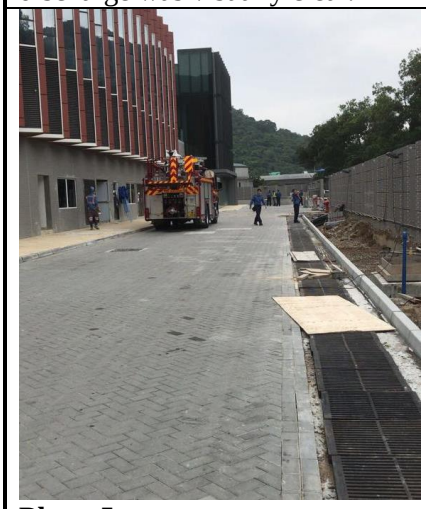
Photo 5
At Admin Building Site, the recent condition of site area was hard paved and wastewater generated from the construction works was limited.

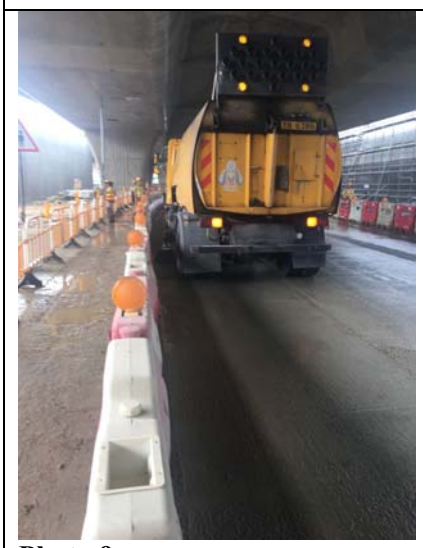
**Photo 9** The condition of road after cleaning by road sweeper on 24 August 2018.	 **Photo 10** The condition of road after cleaning by road sweeper on 24 August 2018.
