AGREEMENT NO. CE 45/2008 (CE)
LIANTANG/ HEUNG YUEN WAI
BOUNDARY CONTROL POINT AND ASSOCIATED WORKS

MONTHLY ENVIRONMENTAL MONITORING AND AUDIT REPORT (NO.67) – FEBRUARY 2019

PREPARED FOR
CIVIL ENGINEERING AND DEVELOPMENT DEPARTMENT (CEDD)

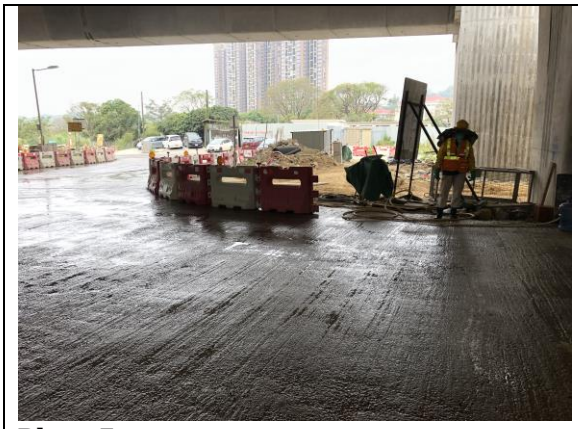
**Photo 7** At vehicle site exit of Chuk Yuen Village, manual wheel washing was provided on the hard paved road within the site to avoid carrying of dust and soil to public road by site vehicles. The condition of site exit and adjoined LMH road were wetted without noticeable dust problem.	 **Photo 8** At vehicle site exit of Bridge Y, manual wheel washing was provided on the hard paved road within the site to avoid carrying of dust and soil to public road by site vehicles. The condition of site exit and adjoined LMH road were wetted without noticeable dust problem.
