AGREEMENT NO. CE 45/2008 (CE)  
LIANTANG/HEUNG YUEN WAI  
BOUNDARY CONTROL POINT AND ASSOCIATED WORKS

MONTHLY ENVIRONMENTAL MONITORING AND AUDIT  
REPORT (NO.42) – JANUARY 2017

PREPARED FOR  
CIVIL ENGINEERING AND DEVELOPMENT DEPARTMENT  
(CEDD)

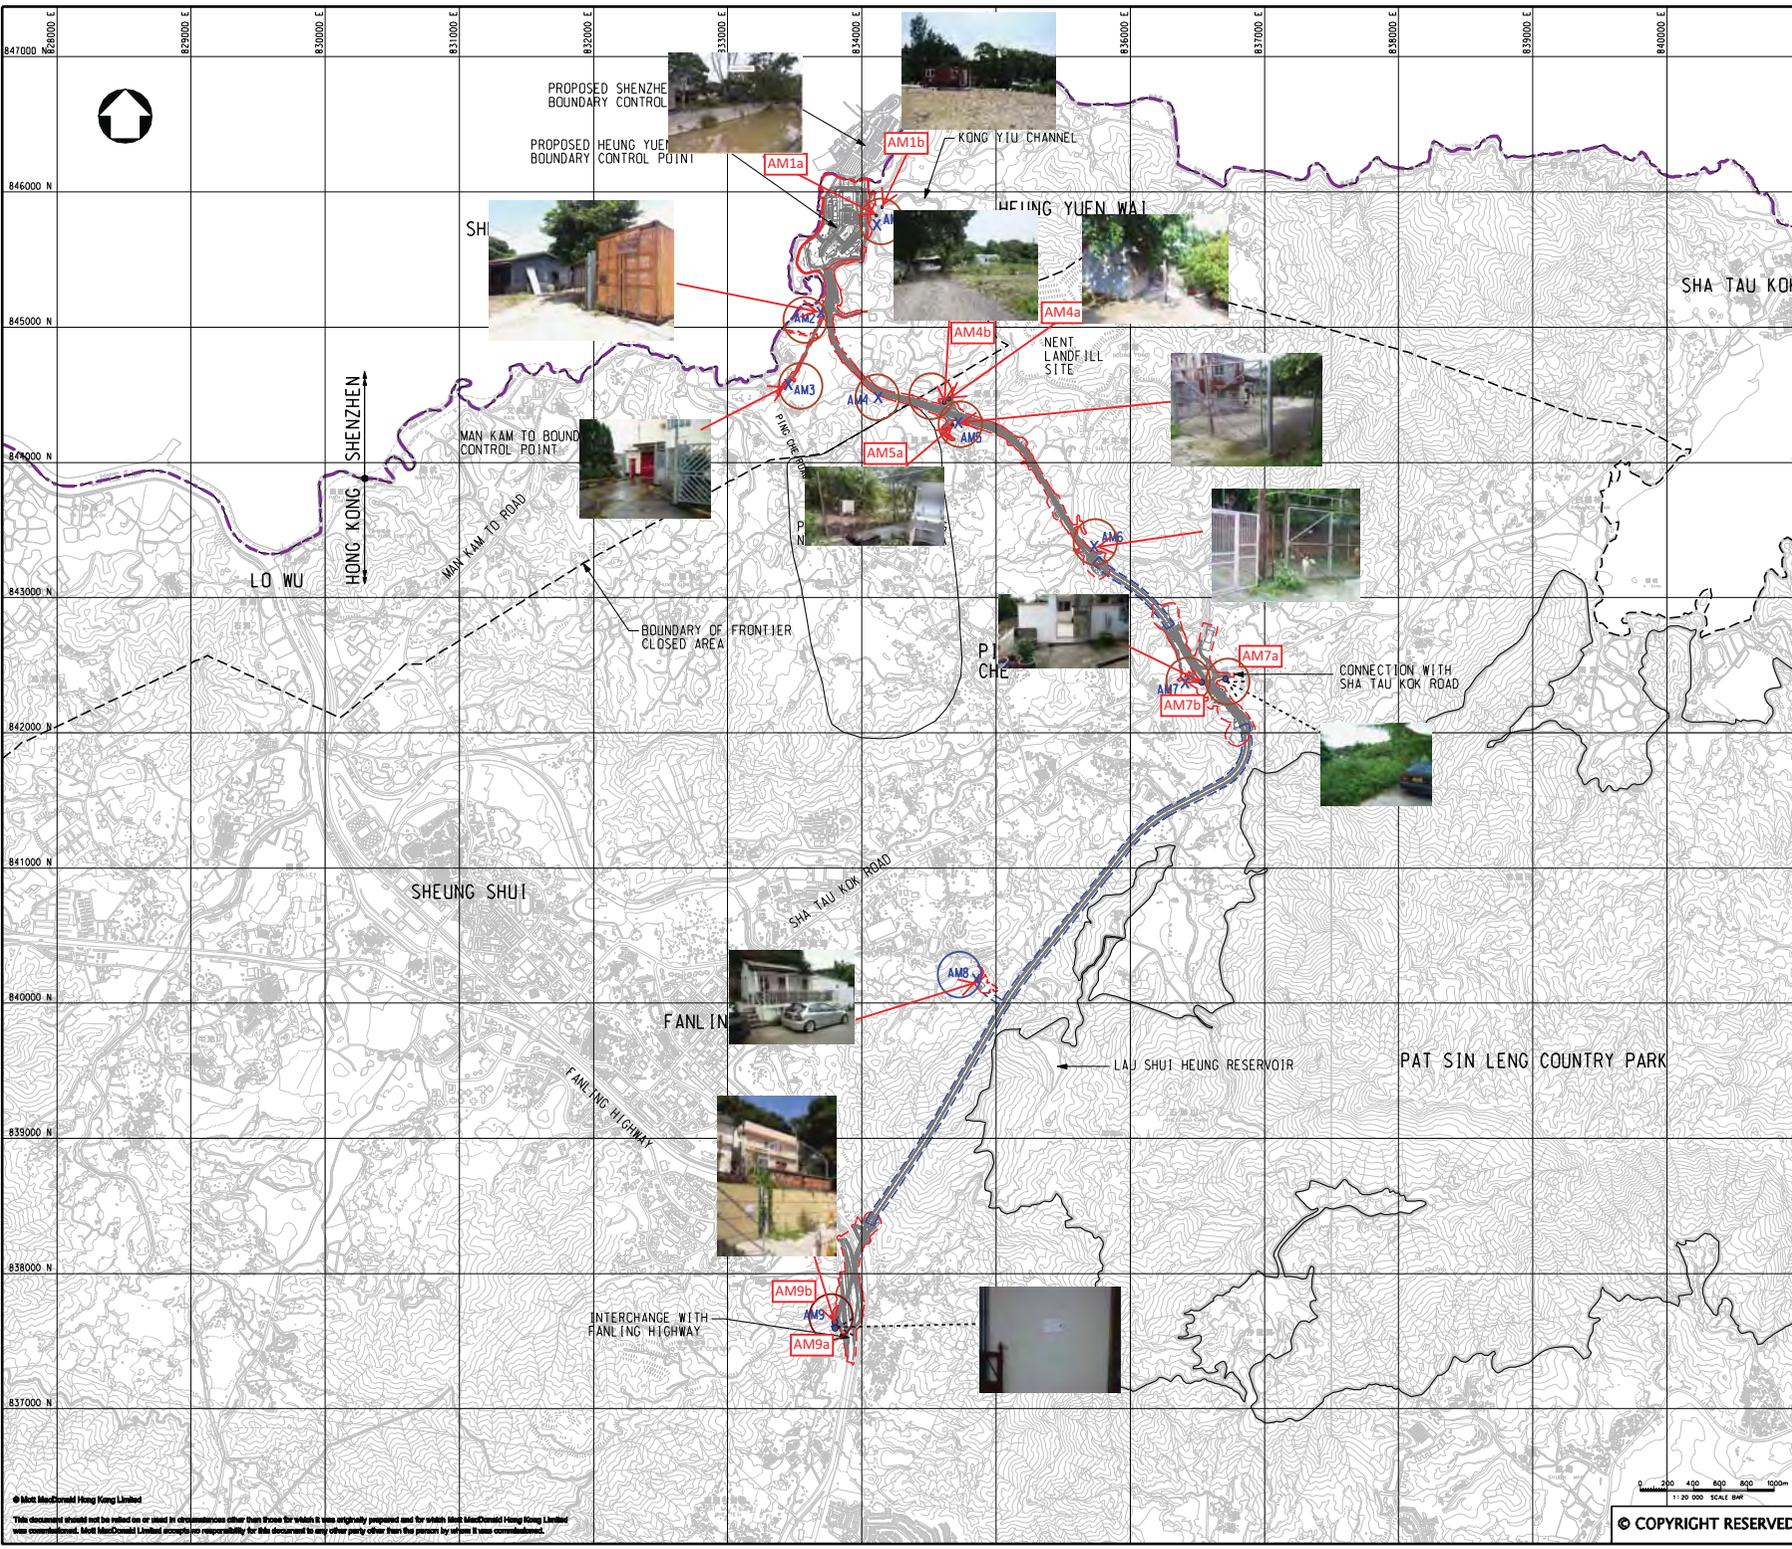
### **Monitoring Locations for Impact Monitoring**

- LEGEND:**
- BOUNDARY OF HKSAR
  - WORKS AREA (ABOVE GROUND)
  - WORKS AREA (TUNNEL)
  - X Air Monitoring Stations in the EM&A Manual
  - Proposed Air Monitoring Stations

3.3.1 The designated monitoring locations as recommended in the *EM&A Manual* are shown in *Appendix D*. As the access to some of the designated monitoring locations was questionable due to safety reason or denied by the landlords, alternative locations therefore have had proposed. The proposed alternative monitoring locations has updated in the revised EM&A Programme which verified by IEC and certified by ET Leader prior submitted to EPD on 10 July 2013. *Table 3-2*, *Table 3-3* and *Table 3-4* are respectively listed the air quality, construction noise and water quality monitoring locations for the Project and a map showing these monitoring stations is presented in *Appendix E*.

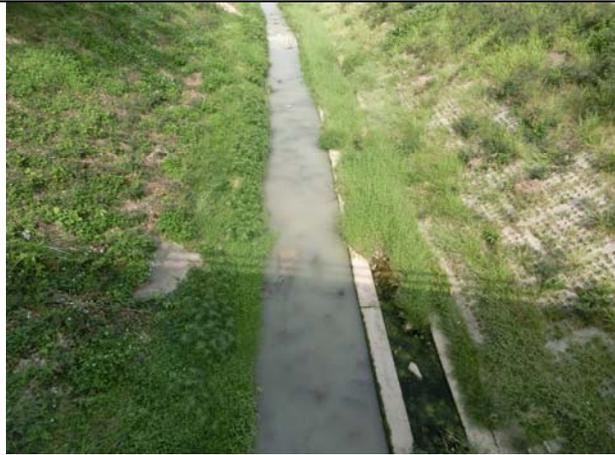
**Photo 1**

Turbid water was observed at WM4 on 21 January 2017.

Date of Exceedance	Location	Exceeded Parameter	Cause of Water Quality Exceedance In Brief
21 Jan 2017	WM4 (C2 and C3)	NTU &SS	<p>During weekly site inspection at South Portal of Contract 2, it was observed the wastewater treatment facility implemented on site was function properly and the treated water to be discharge was visually clear. The site condition was generally in order and no adverse water quality impacts and abnormal situation under the Contract were identified. Moreover, there was no rain recorded on 21 January 2017 and runoff from the site was unlikely to occur. In our investigation, it is considered that exceedances were due to natural variation and unlikely related to the works under the Contract.</p> <p>During weekly site inspection by ET at Contracts 3 in January 2017, it was observed that no excessive wastewater was generated from the active construction works and the water quality in the existing river channel adjacent to the construction site was clear. The site condition was generally in order and no adverse water quality impacts and abnormal situation under the Contract were identified. Moreover, there was no rain recorded on 21 January 2017 and runoff from the site was unlikely to occur. In our investigation, it is considered that exceedances were due to natural variation and unlikely related to the works under the Contract 3.</p>

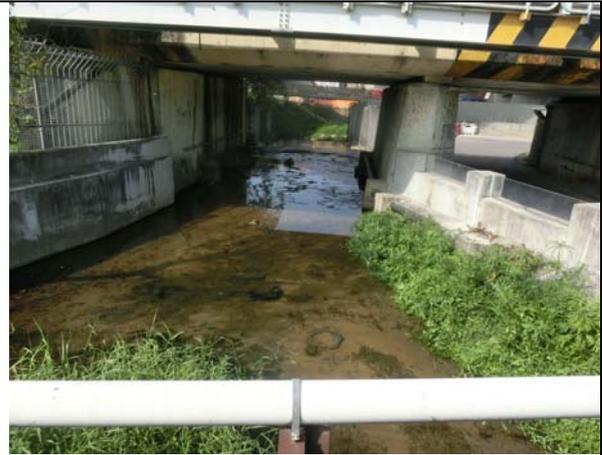
**Photo 2**

The water quality at WM4-CA was visually clear on 21 January 2017.

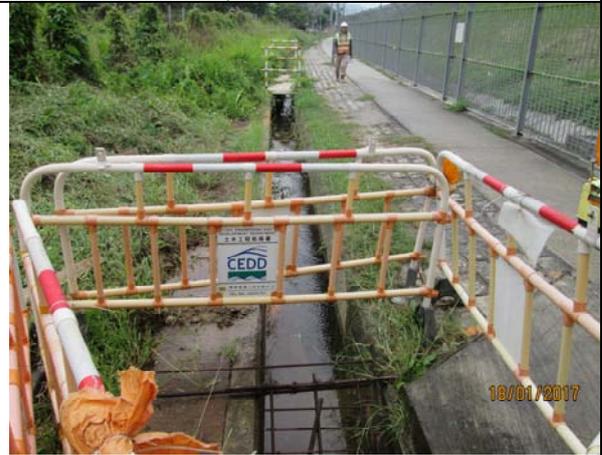
**Photo 4**

During weekly site inspection by ET in January 2017, it was observed that the water quality in the existing river channel adjacent to the construction site was clear.

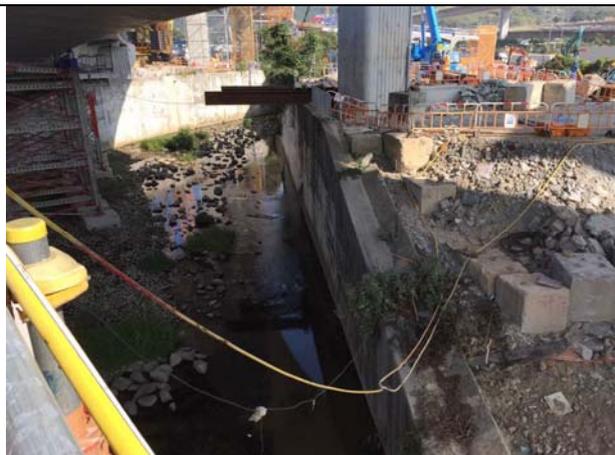
**Photo 5**

During weekly site inspection by ET in January 2017, it was observed that no excessive wastewater was generated from the active construction works and the water quality in the existing river channel adjacent to the construction site was clear.

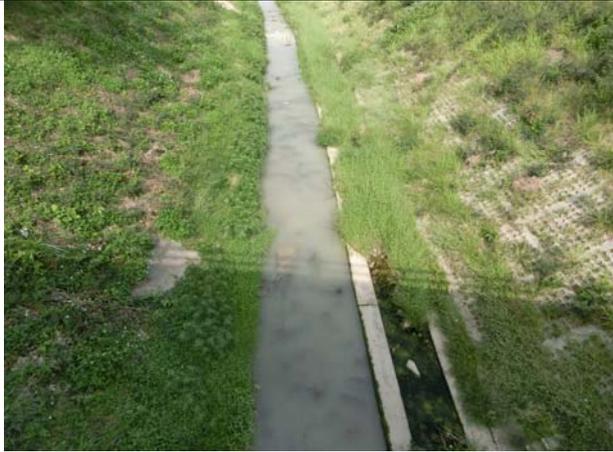
**Photo 1**

Turbid water was observed at WM4 on 21 January 2017.

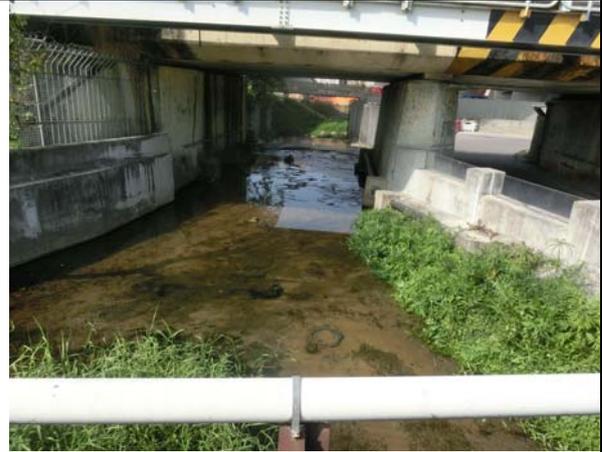
**Photo 2**

The water quality at WM4-CA was visually clear on 21 January 2017.

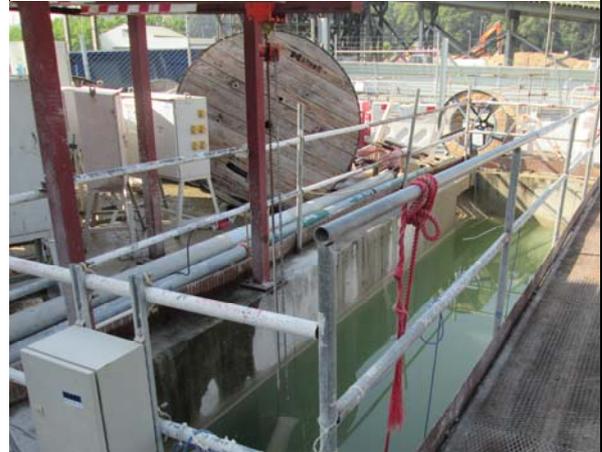
**Photo 4**

During weekly site inspection at South Portal by ET in January 2017, it was observed the wastewater treatment facility implemented on site was function properly and the treated water to be discharge was visually clear.
