AGREEMENT NO. CE 45/2008 (CE) LIANTANG/HEUNG YUEN WAI BOUNDARY CONTROL POINT AND ASSOCIATED WORKS

MONTHLY ENVIRONMENTAL MONITORING AND AUDIT REPORT (No.28) – NOVEMBER 2015

PREPARED FOR
CIVIL ENGINEERING AND DEVELOPMENT DEPARTMENT
(CEDD)

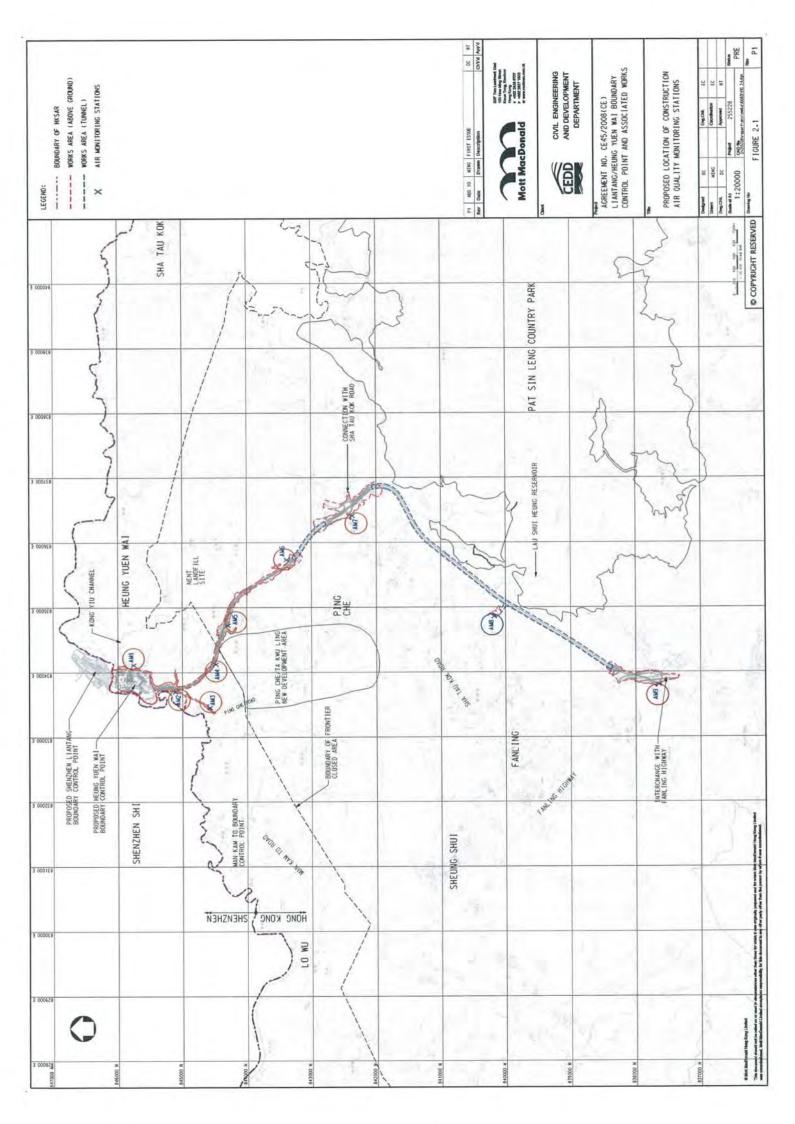
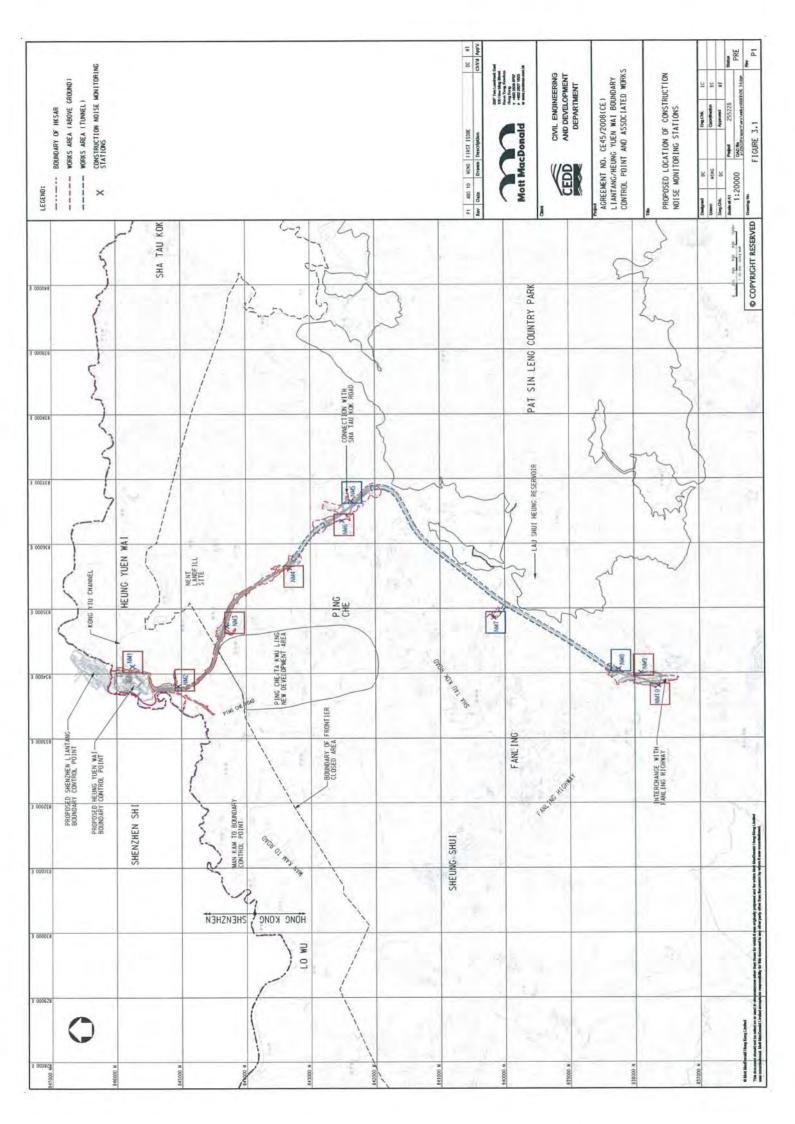
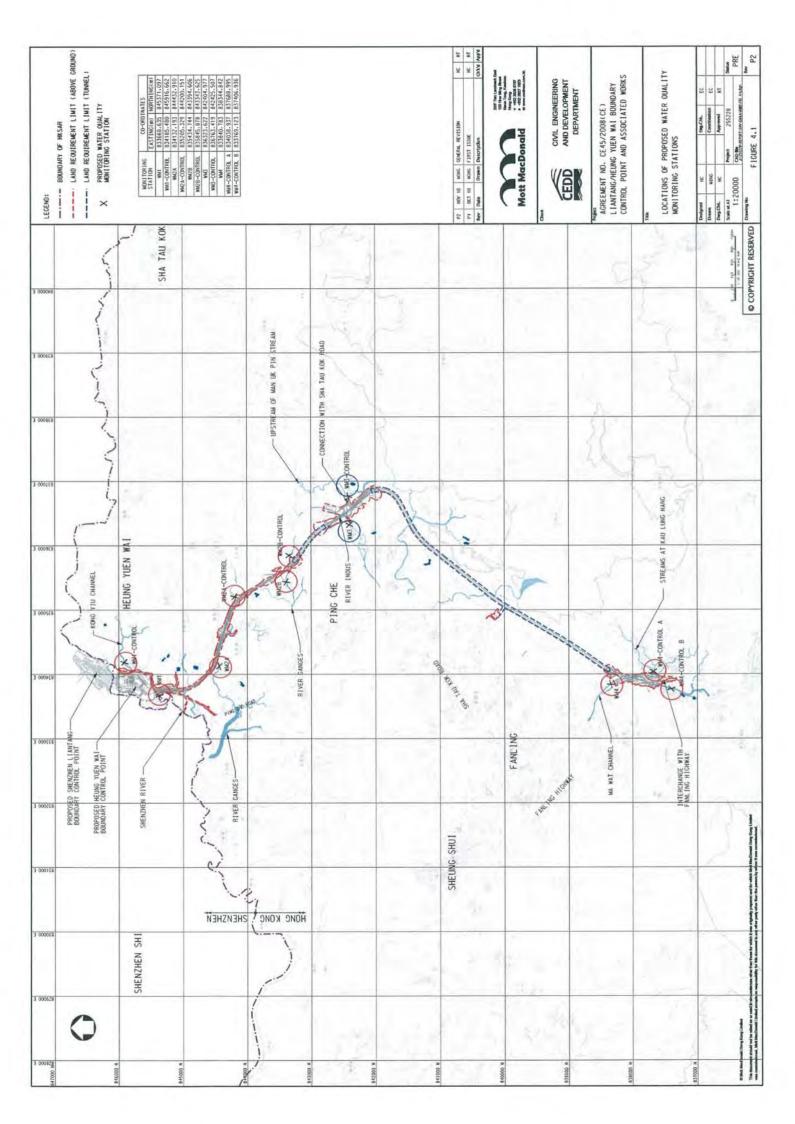
Designated Monitoring Locations as Recommended in the Approved EM&A Manual

3.3.1 The designated monitoring locations as recommended in the *EM&A Manual* are shown in *Appendix D*. As the access to some of the designated monitoring locations was questionable due to safety reason or denied by the landlords, alternative locations therefore have had proposed. The proposed alternative monitoring locations has updated in the revised EM&A Programme which verified by IEC and certified by ET Leader prior submitted to EPD on 10 July 2013. *Table 3-2*, *Table 3-3* and *Table 3-4* are respectively listed the air quality, construction noise and water quality monitoring locations for the Project and a map showing these monitoring stations is presented in *Appendix E*.
